IMMEDIATE IMPACTS OF HURRICANE IKE ON THE TEXAS COAST

Billy L. Edge¹, Lesley Ewing², Robert G. Dean³, James M. Kaihatu⁴, Margery Overton⁵, Spencer M. Rogers⁶,
Paul A. Work⁷

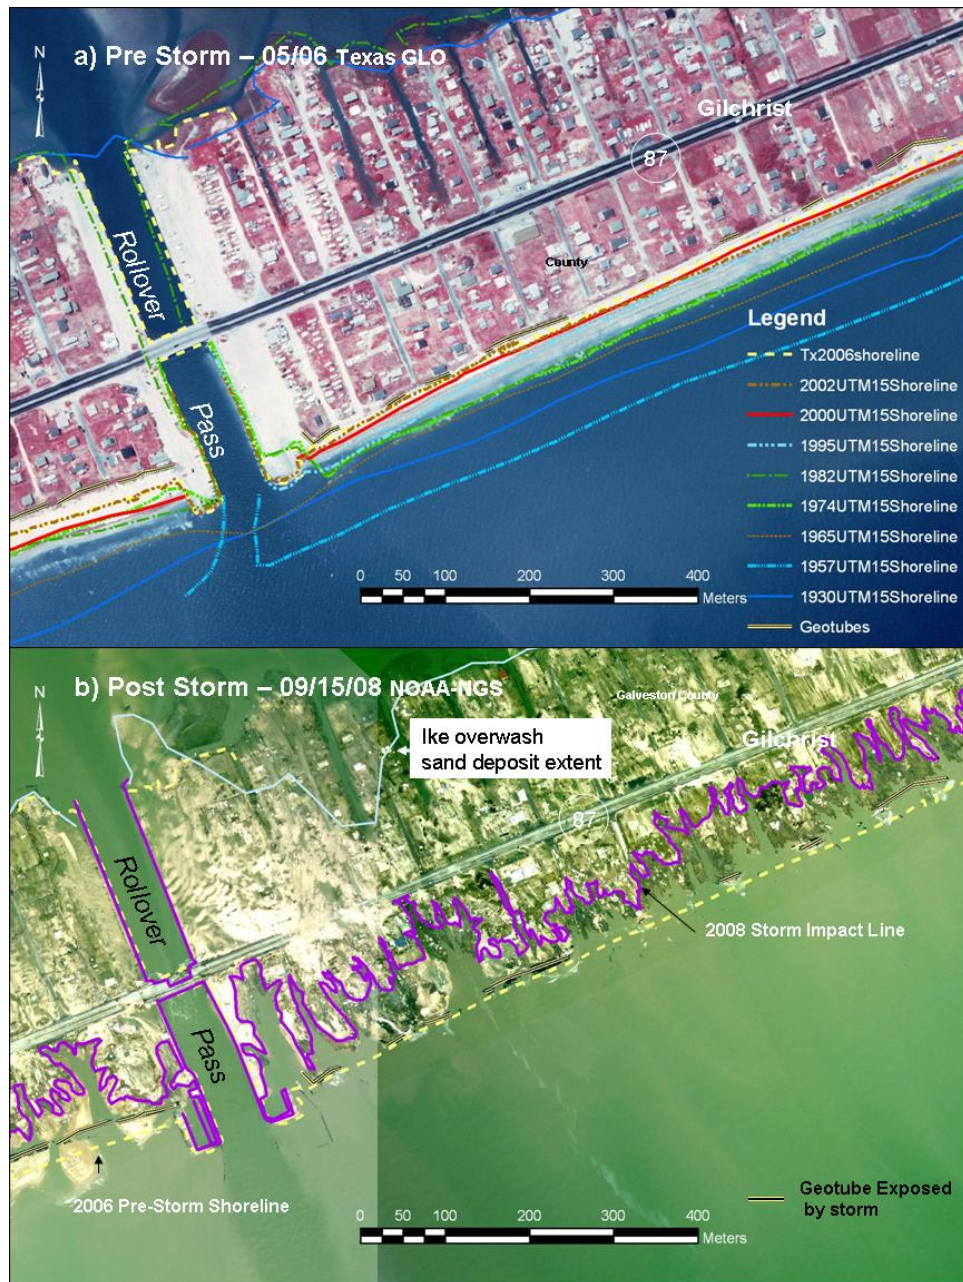
These photos showed severe erosion of the beach and near total destruction of upland structures in the Rollover Pass area of Gilchrist that is on Bolivar peninsular. The pre- and post-storm photos in Figure 8 shows that sand had overwashed the entire narrow width of this part of Bolivar Peninsula. Despite the geotextile protection, the beachfront experienced major erosion with the formation of localized erosion channels due largely to the thin veneer of sand in this area. The geotextiles appeared to somewhat reduce, but not prevent, the extent of erosion farther landward compared to unprotected sections and areas where the tubes were damaged.

Figure 8 (a) Pre-storm aerial photography of Rollover Pass and Gilchrist with historic shorelines and location of buried geotextile tubes and (b) post-storm impacts of overwash extent and shoreline position

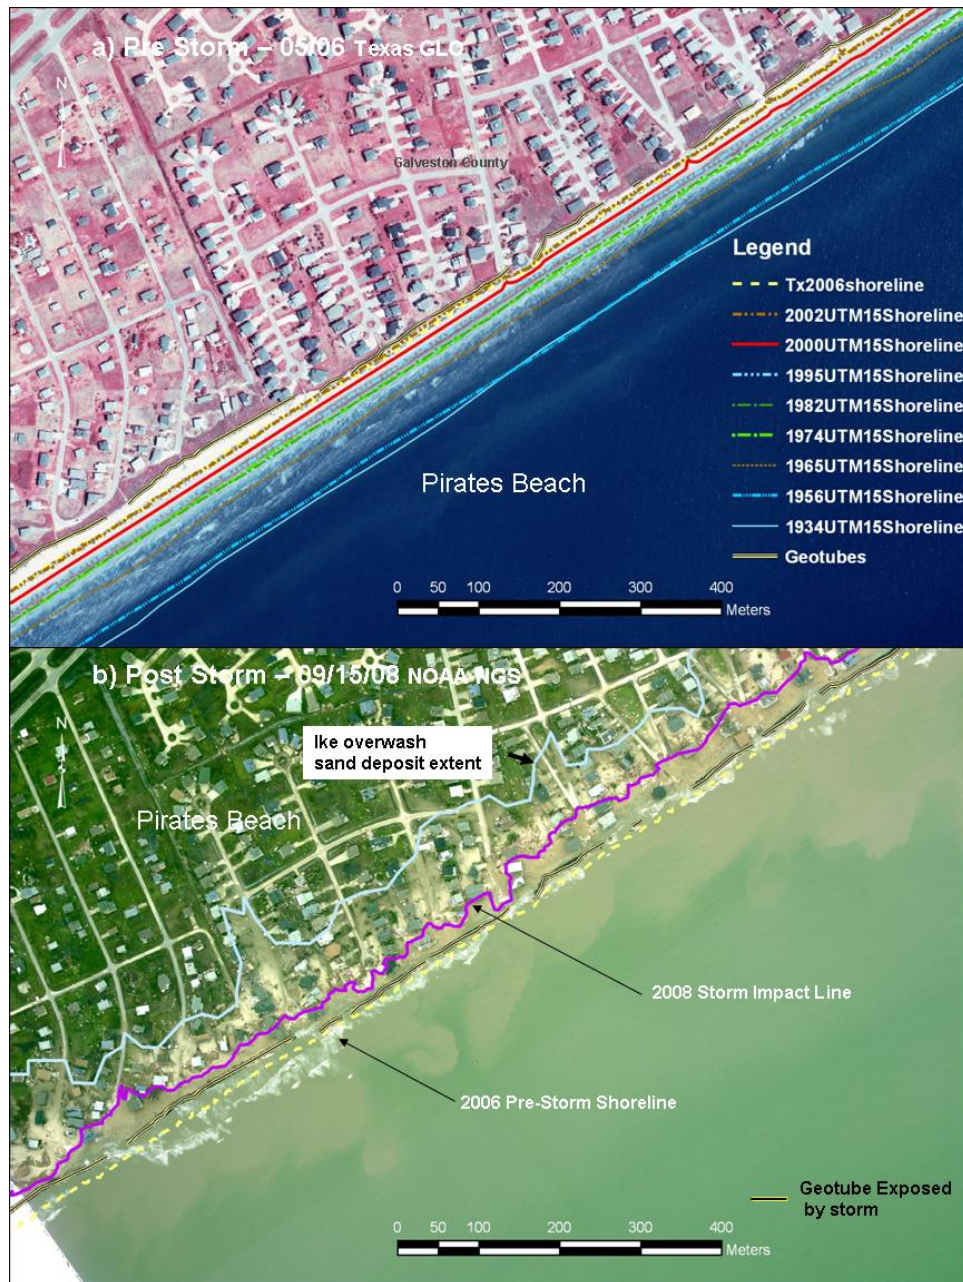
On Galveston Island, west of the seawall, the beaches of West Beach are narrow (30- to 50-m-wide) with low dunes. This area was equally affected by the storm surge as shown in Figure 9 at Pirates Beach on West Beach. Here the shorelines have steadily moved landward since 1930. In about 2005, a sand-filled geotextile tube was constructed at this location and was buried below a dune feature, which is about 20 m in front of the first row of homes. In the post storm conditions shown in the lower photograph it is clear that overwash penetration occurred between 100 and 150 m landward of the 2006 shoreline. The dune was completely eroded, and the geotextile tubes were exposed. The landward extent of the post-storm beach is marked with a line.

Figure 9 (a) Pre-storm aerial photography of the Pirates Beach area of West Beach showing the historic shorelines and dune over geotextile shore protection and (b) post-storm impacts to geotextile tubes, overwash extent, and shoreline position

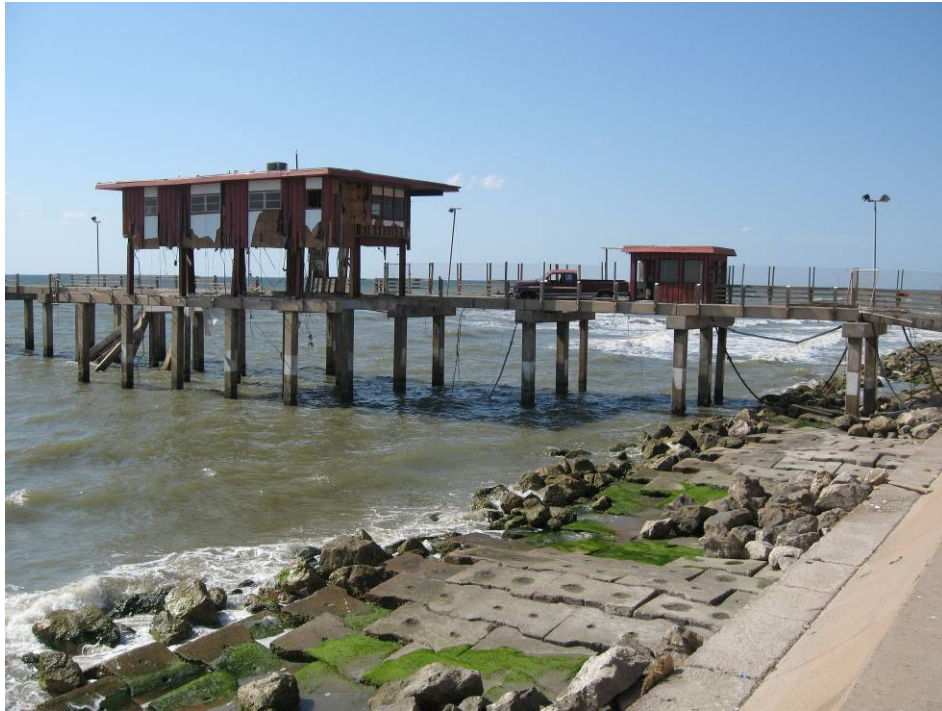
Figure 10 shows the concrete fishing pier located near 89th Street in Galveston. The total length was about 340 m of which only 125 m remain standing. The two-story building on the pier located near the seawall was heavily damaged, and the first floor was completely lost. These damages were mainly caused by the uplift and horizontal wave forces inside the surf zone. The concrete decking panels were lifted upward by the waves and fell through the girders onto the beach or seafloor. The end of the pier remained because it was located outside the surf zone.

Figure 10 89th Street fishing pier

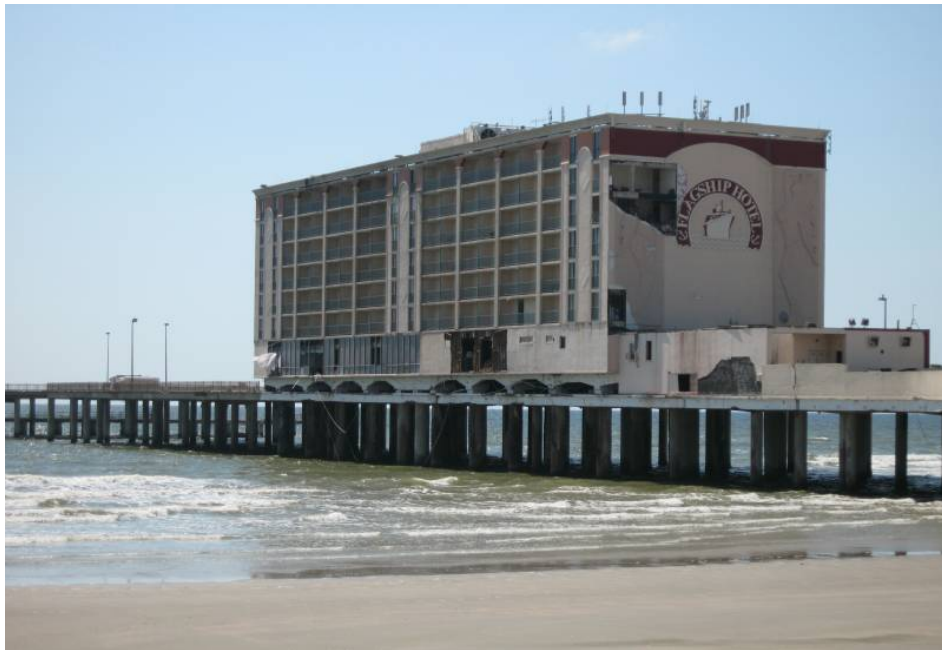
The 25th Street pier (also called the Pleasure Pier or Flagship Hotel Pier) with a total length of about 350 m was the only pier that remained largely intact despite heavy damage to the hotel after Hurricane Ike (Figure 11). Almost all piles of the 25th Street Pier remained in contrast with those of the 89th Street fishing pier. There are several reasons for the differing damage between the 25th Street (hotel) Pier and fishing pier. The clearance between the sea surface and the horizontal beams of the hotel pier was higher than for the fishing pier. Also there was likely deeper embedment of the piles to support the load of the hotel structure and resist the wave forces. Additionally, the water depth seems

much shallower than that at the fishing pier, which would have made the wave height smaller than that under the fishing pier.

Figure 11 Flagship Hotel Pier

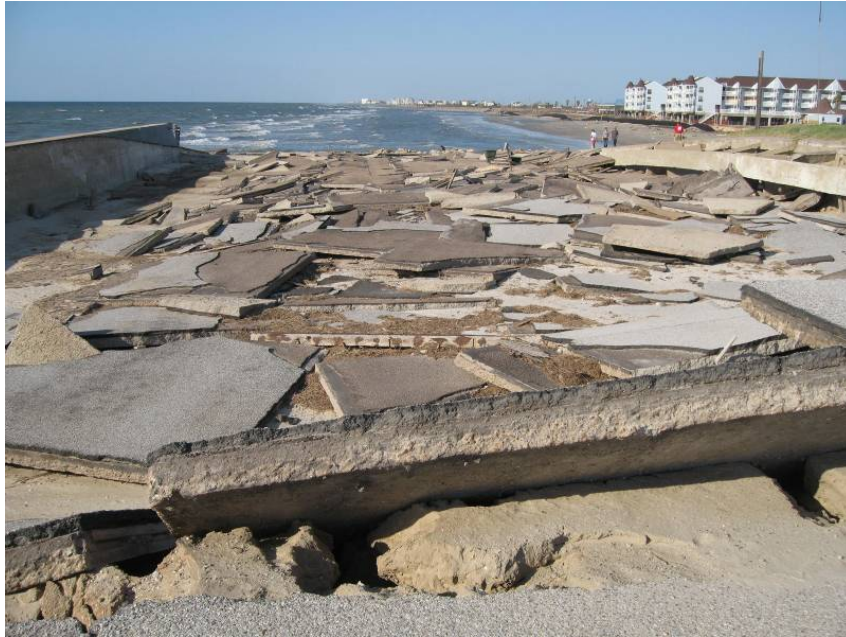
The Galveston Seawall has been very effective in protecting against storm surge and waves since it was constructed after the 1900 Hurricane. It was effective in preventing erosion of the upland and wave overtopping. Although the highest winds and storm surges were east of Galveston Island, the seawall prevented substantial damage to upland structures. The only substantive damage to the seawall itself occurred at the western end where the seawall was flanked and erosion occurred behind the seawall (Figure 12). Minor damage to the seawall occurred from the loss of backfill in some locations causing a failure of the sidewalk (Figure 13). Although the Galveston Seawall apparently performed well during Hurricane Ike, several observations suggest that the seawall might only be marginally stable during a future major hurricane. Observations during the field investigation suggest that the

Figure 12 Damage at southwest end of seawall

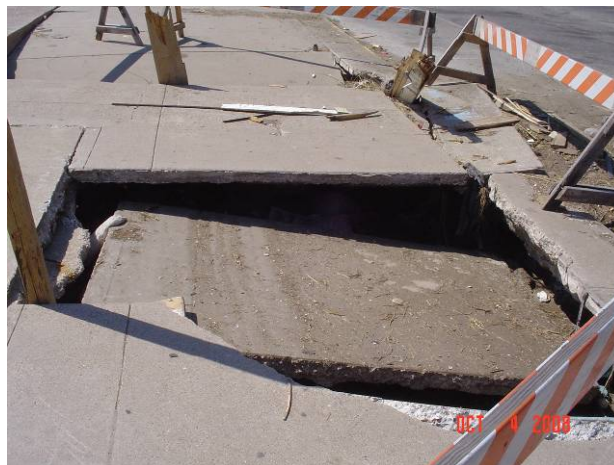
water level in the backfill behind the wall may have been at a high level, perhaps near the surface, while the water level seaward of the wall was much lower. Elevation of the water level behind the seawall is indicated by failure of numerous locations where an apparent “piping” failure occurred. The piping failure would have occurred if the hydrostatic water head behind the wall caused migration (piping) of the sand backfill through joints in the wall or along utility trenches or similar pathways causing loss of backfill.

Figure 13 Settlement of slabs behind the seawall caused by piping failures

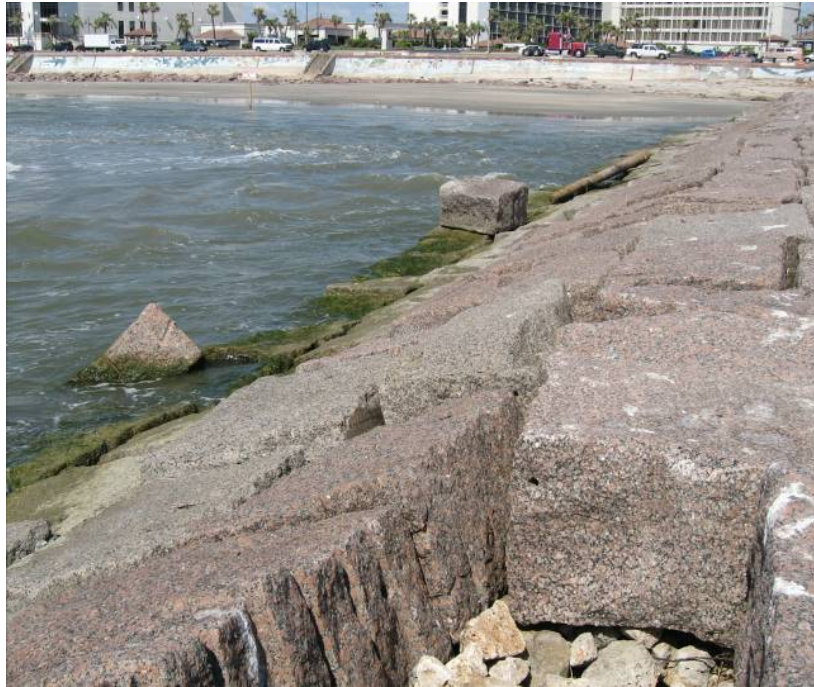
There are 15 groins perpendicular to the Galveston Seawall. Nearly all of these groins were constructed from cut stone. Most of the groins had minimal damage. Four of them had a concrete cap to allow walking access on the groin. The concrete surfaces were damaged and some of the rocks were displaced at the gulfward end or along the water line. On the groins with cut stone, some of the stones were dislodged as shown in Figure 14. These stones were picked up by the waves and were displaced to lower levels, leaving a void in the crest and slope of the groin. The stone appeared to be 3 to 5 ton granite.

Figure 14 Displaced armor stone at 53rd Street groin

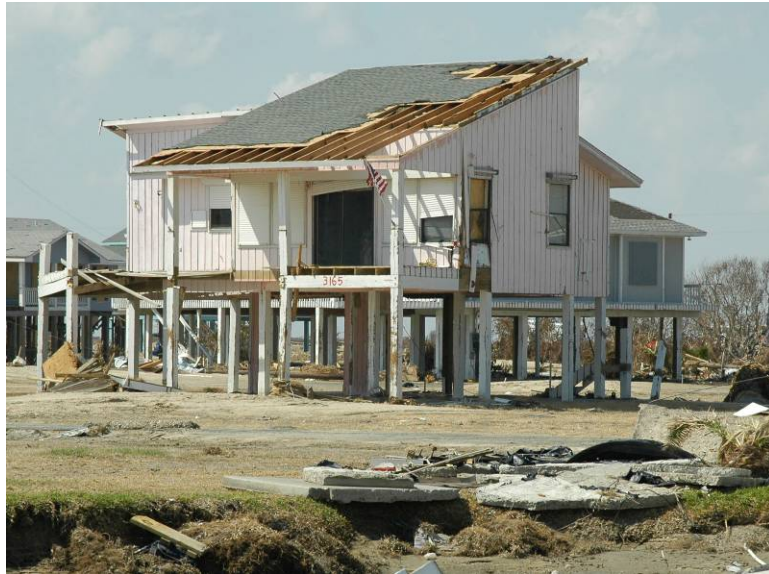
Wind. Peak wind speeds appeared to be below design levels in the areas inspected. Minor wind damage to buildings was widespread, but serious structural damage was rare with a few exceptions as shown in Figure 15. Damage to roof coverings, often one of the most damage-prone components, was common but not uniformly present, as observed in other recent high-wind hurricanes. Many flood damaged buildings appeared to be undamaged by the wind. Wind damage to the single-family houses along West Beach appeared to be much less severe than that observed following Hurricane Alicia in 1983 (Rogers et al. 1985). The likely differences are somewhat lower wind speeds across that specific shoreline; prior damage to the older, most wind-sensitive buildings; and post-Alicia improvements in general construction practice, building codes, and inspections.

Figure 15 Partial failure of roof deck due to wind uplift

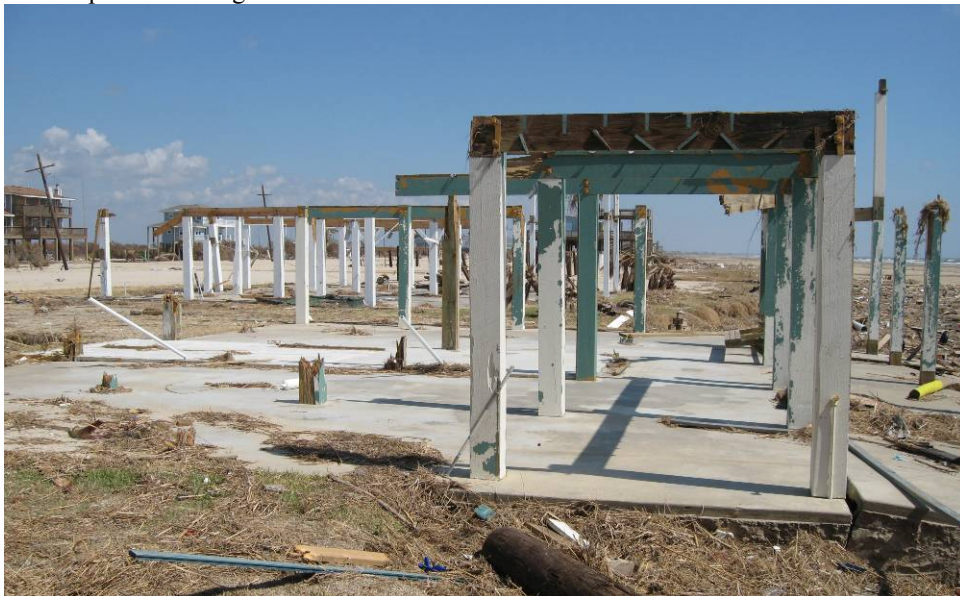
Waves. Storm surge and wave elevations caused increasing frequencies of structural damage along the gulf shoreline from the Galveston Bay jetties east along the Bolivar Peninsula to the end of the development near High Island. Most of the buildings were single-family houses. Once the wave elevations exceed an open piling foundation elevation, severe structural damage occurs quickly. The floor systems of most houses are highly susceptible to failure after only a few waves. Typical structural damages leave nothing but the pilings (Figure 16) or, with shallow piles, total removal of the building. A section of homes considered total losses due to wave damage extended several blocks wide along the east end of the peninsula as shown in Figure 17. The first two rows experienced erosion landward of a geotextile tube. More landward buildings were destroyed by waves. Surviving buildings, circled on the left side of the photos had higher floor elevations.

Figure 16 Structural failure due to wave uplift and lateral forcing

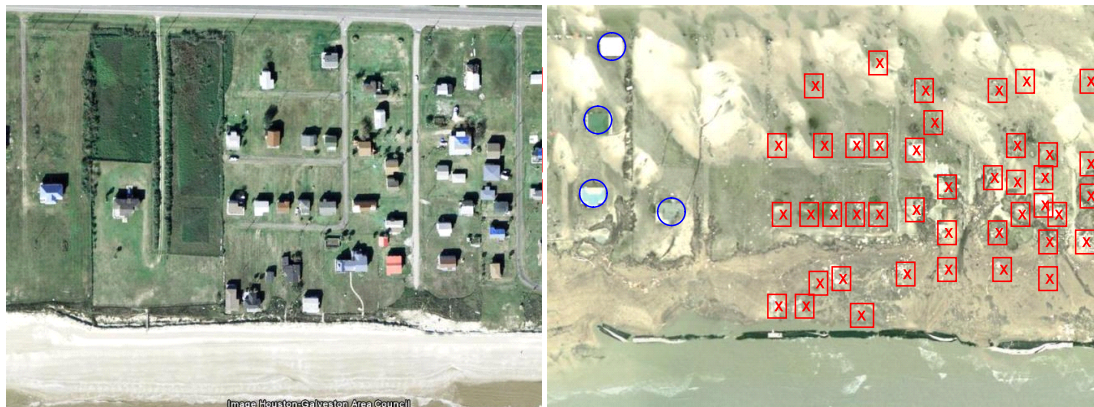
Farther landward, damage gradually reduced in severity, evidenced by decreasing levels of breakaway wall failures, which suggests a likely gradual drop in wave height. Farther west on Bolivar Peninsula around Gilchrist and Rollover Pass, losses of buildings across the peninsula approached 100 percent, and wave damage was apparent across the entire peninsula. The common characteristic of the surviving and partially remaining houses was an open, piling foundation with a higher floor elevation. The remaining pilings with no superstructure suggest that lower elevation houses disintegrated or were washed into the bay. Preliminary analysis of building wave damage elevations based on LIDAR ground

elevations suggest that wave crests reached elevations of +5.5 to +6.2 m NAVD and 0.5 to 1.2 m above the minimum floor elevation requirements on the flood maps in effect at the time of the storm. Many houses constructed at the minimum elevation requirement were also destroyed in the storm.

Figure 17 Building survivors and failures on the Bolivar Peninsula. Source: Houston Area Council and NOAA images

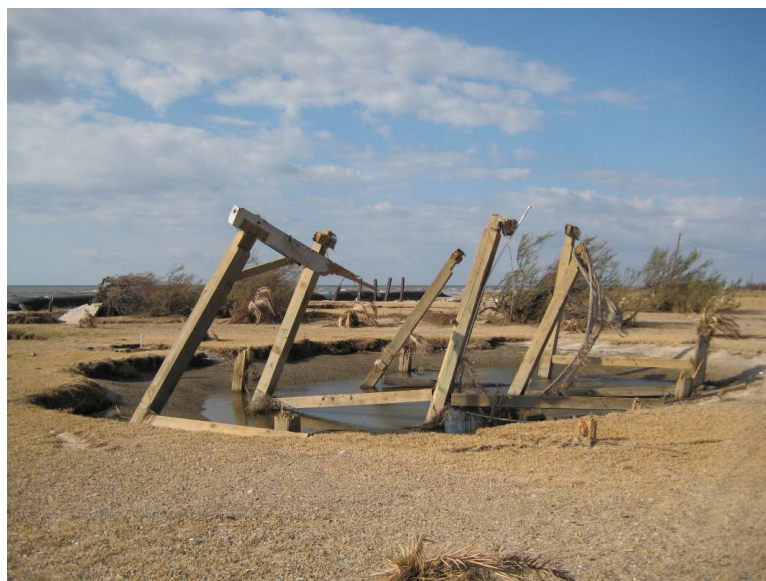
Erosion Damage. As noted previously, the entire study area has low ground elevations and dunes with little to no elevation. Erosion damage to building foundations was observed from two causes: wave-induced retreat of the shoreline and localized scour as the storm surge moved over the flooded landform. The shoreline erosion affected the first row or two of buildings from West Beach to Surfside and along the Bolivar Peninsula. Localized scour was highly irregular across the developed areas. Scour frequently appeared to be deeper around foundations, likely due to increased turbulence and/or ground-disturbing activities associated with the original construction. Observed ground disturbances included auger installation of shallow piling foundations and the replacement of originally consolidated clays with unconsolidated material around the building footprints (Figure 18). Often the scour appeared random but was likely affected by local sediment variations in addition to buildings, roads, canals, and other surface structures (Figure 19). Not surprisingly, localized scour was more likely closer to the gulf or bay shorelines and was more widespread where the landforms were narrowest, as observed near Rollover Pass. The erosion patterns suggested both onshore and offshore flow on the Bolivar Peninsula. Figure 20 illustrates how the scour at slab foundations typically caused failure of the limited structural support provided by the slabs to the columns. Moreover, it can be seen how this erosion pattern grew to cover a large area including other foundations.

Figure 18 Localized scour engulfing the full footprint of the short pile foundation

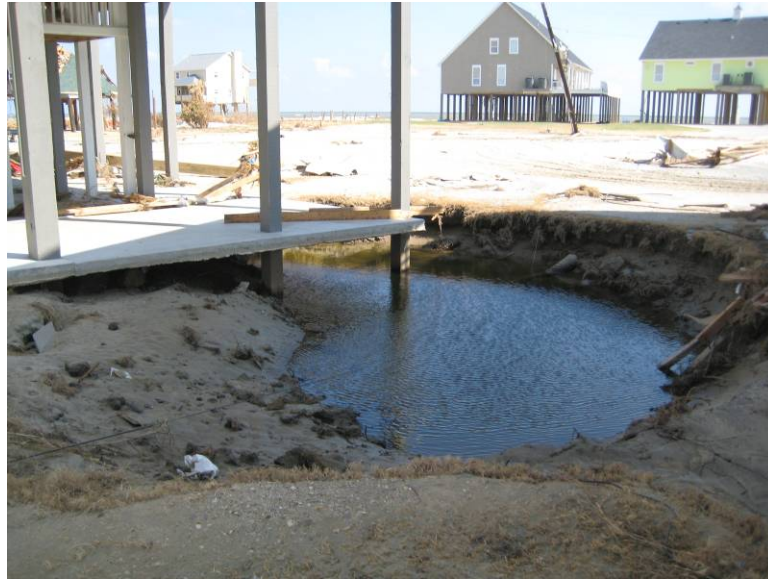
Figure 19 Local scour at the corner of the ground slab

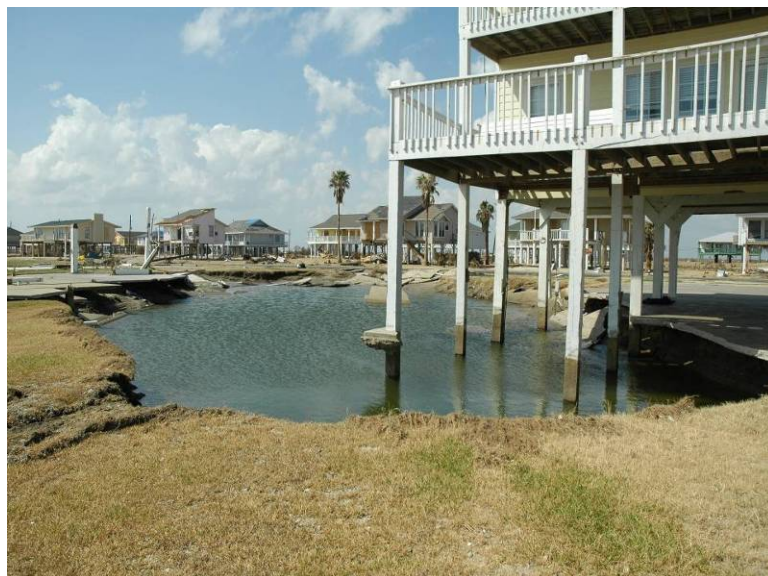
Figure 20 Illustration of growth of scour from slab foundation

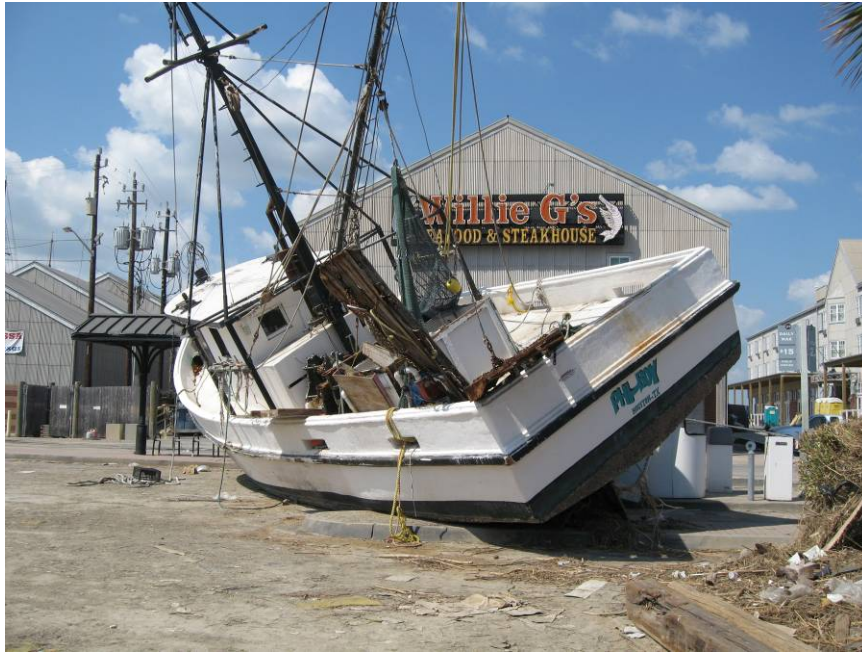
However, it is clear that the improper securing or maintenance of boats to survive a storm contributes to facility damage. Boats that break free of their moorings (Figure 21) or that still have masts and sails in place when a storm arrives can cause tremendous damage; they can collide with docks, bulkheads, other boats, and even buildings. While it is likely that broken piles and detached cleats (as seen at Galveston Yacht Basin) also contributed to boats becoming loose during the storm, much damage can be mitigated by properly securing vessels and providing an appropriate amount of fenders for them. Additionally, slinging small powerboats out of the water does not provide sufficient protection for them during a storm.

Figure 21 Boats breaking mooring lines during the storm can be a battering ram
