# DESIGN AND PERFORMANCE OF SEA WALLS IN MISSISSIPPI SOUND

Francis F. Escoffier, Engineer,  
Mobile District, Corps of Engineers,  
Department of the Army, Mobile, Alabama

The purpose of this paper is to describe briefly the various types of sea walls that have been constructed on Mississippi Sound, the performance of each type, and the conclusions with regard to sea wall design that can be drawn from this information.

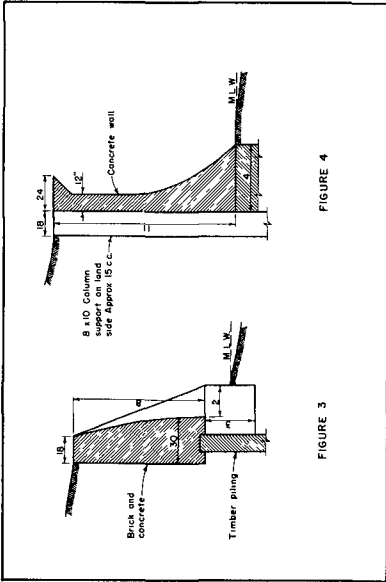
FIGURE 3

The type A wall shown in Figure 3 was originally of brick masonry construction. The concrete face and the buttresses were added several years after the original construction. It is understood that the wall is equipped with tie backs but the position and type of construction of the tie backs are not known. During a minor hurricane in 1940 this wall tilted seaward and some backfill was lost. The wall was repaired and survived the 1947 hurricane with little or no damage.

The type B sea wall is shown in Figure 4. The depth to which this structure extends is not known. Neither is it known whether it is provided with tie backs. This wall survived the 1947 hurricane with little or no damage.

Fig. 3. Type A sea wall.  
Fig. 4. Type B sea wall.

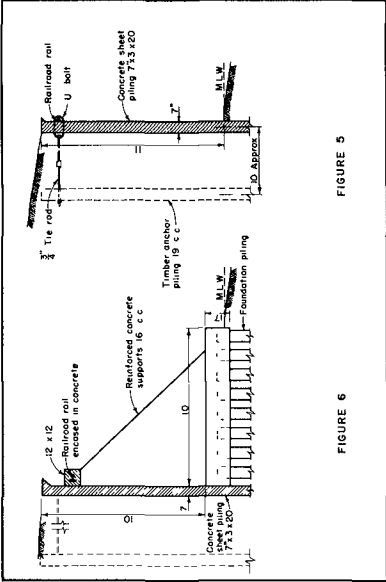
FIGURE 5

It is probable that the type D wall, shown in Figure 6, was originally a continuation of the type C wall which is shown in Figure 5. If this is correct, then the buttresses are later additions made to strengthen the wall. Along part of this wall some backfill has been lost and the wall has tilted landward. Where this has occurred severe cracking has taken place at the junction of the buttresses and the horizontal beam near the top of the wall. Along much of the type C wall the tie backs have failed and the wall has tilted seaward. Some backfill has been lost. It is apparent that corrosion of the tie backs has been a factor in causing this damage.

Fig. 5. Type C sea wall.  
Fig. 6. Type D sea wall.

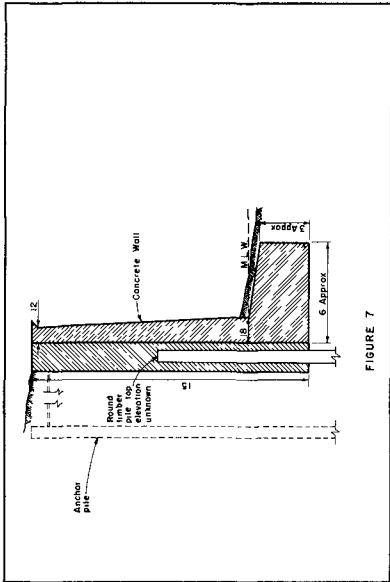
FIGURE 7

Much of the type E sea wall, shown in Figure 7, has failed by falling seaward. The concrete anchor piles were broken apparently because the backfill had been washed away from around them and the piles were not capable of functioning as cantilevers. The wall itself failed by breaking at the juncture of the wall and the footing.

Fig. 7. Type E sea wall.

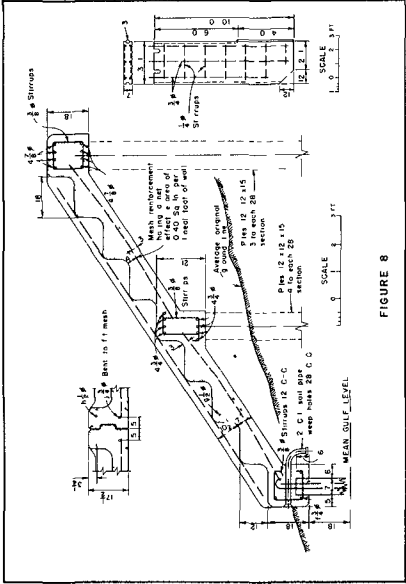
FIGURE 8

Fig. 8. Type F sea wall.

The type F or stepped sea wall shown in Figure 8 represents the predominant type of construction on the coast. There are about 10.7 miles of this type of wall in Hancock County and 24.0 miles in Harrison County. The number of steps varies from 3 to 10. When the number of steps is less than nine the middle row of pilings is omitted. The reinforcement shown in these sections is that used in the Harrison County walls which were designed by H. D. Shaw of Gulfport, Mississippi. The stepped walls in Hancock County are similar in design although timber piling has been substituted in some cases for the concrete piling.

Cracks appeared in many of the stepped slabs soon after they were completed. In the Harrison County walls a crack appeared at the intersection of the bottom step and the riser of the second step. A transverse crack from top to bottom also appeared at the center of many of the slabs. In some of the stepped slabs in Hancock County a crack appeared along the line of support of the middle row of piles.

To explain these cracks it should be considered that the joints between the stepped slab and its supporting piles are rigid or nearly so. The maximum bending moments produced by differential settlement or other causes therefore occur in the vicinity of these joints. Some cracks were of sufficient size to permit sea water to reach the reinforcement. The result at many points was rust bleeding, expansion of the reinforcing steel by corrosion, and further cracking and breaking of the concrete.

The stepped sea walls also suffer from the defect of not being sand tight. The storm sewers that pass through the sea walls were placed directly on sand. Through differential settlement or otherwise the joints in the sewer pipes failed and permitted the escape of backfill. The concrete sheet-piling cut-off wall also permitted the escape of sand. The sheet piles used in the cut-off wall were provided with tongue and groove joints only for the lower parts. See Figure 8. Above that, two grooves were provided, the theory being that the cavity formed by two adjacent grooves would be filled with grout and thus rendered sand tight. During construction it was found that the cavities filled with sand and could not effectively be grouted; consequently the cut-off wall could not be made sand tight. The loss of backfill caused the further deterioration of the storm sewers and the collapse of the sidewalks adjacent to the sea wall.

During the 1947 hurricane the stepped sea walls failed in a number of places. Available evidence indicates that in most cases the slabs moved seaward when they failed. What probably happened is that the alternating downward and upward forces exerted by the peaks and troughs of the waves as they reached the wall produced continually reversing stresses in the wall which caused the concrete in the vicinity of the supporting piles to crack and crumble until finally the joints failed entirely. The slab was then lifted from its supports and moved seaward. As a general rule the sheet piling cut-off wall tilted seaward but the bearing piles broke away from the slab without tilting.

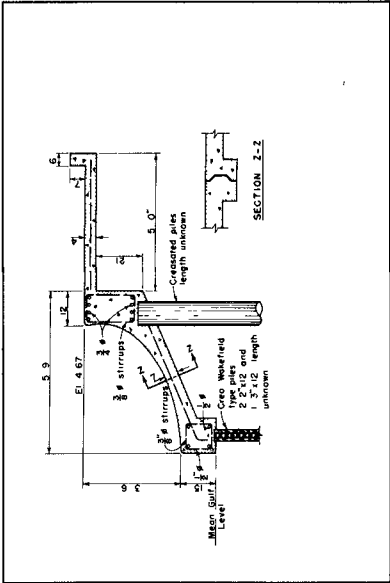
Fig. 10.

There are about 1.3 miles of the type H concave sea wall shown in Figure 10 at Biloxi in Harrison County. Several sections of this wall were lifted from its supporting piles by hydrostatic pressure and moved seaward during the hurricane.

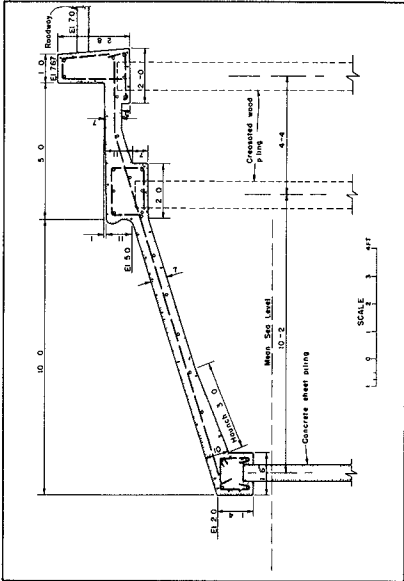
Fig. 9.

There are about 2,500 feet of the type-G sea wall shown in Figure 9 on the east and south sides of the causeway at the Gulfport small-craft harbor. Several sections of this sea wall were lost during the hurricane. These sections were lifted from their supporting piles by hydrostatic uplift and moved seaward. The concrete slab broke at the point where it meets the cap on top of the sheet-piling wall.

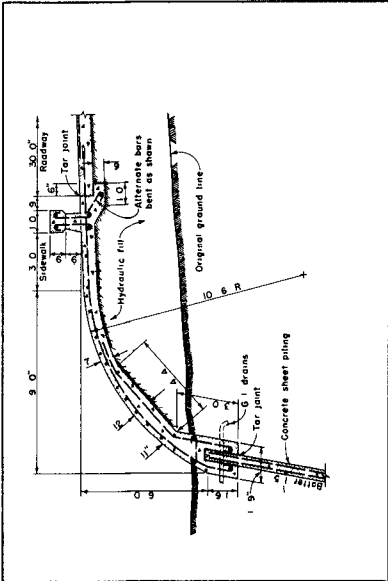
Fig. 11.

The type I sea wall, shown in Figure 11, has a convex face instead of the usual concave face. There is about 0.65 mile of this wall at Biloxi in Harrison County, 1.6 miles at Ocean Springs, and 2.0 miles at Pascagoula, both of which are in Jackson County. This wall depends on backfill for all of its support except that provided at the toe by the sheet-piling cut-off wall. It suffers from the defect that it facilitates rather than hinders the movement of waves over the wall and onto the adjacent roadway. This wall has lost little or no backfill and there is no evidence of settlement in either the wall or the adjacent roadway. It weathered the 1947 hurricane with practically no damage. It should be mentioned, however, that all three of the locations where this wall is found are in relatively sheltered positions where the wave action during the 1947 hurricane was not as severe as it was elsewhere in the sound.
