## CHAPTER 152

### ENVIRONMENTAL PROBLEMS ASSOCIATED WITH A PIPELINE LANDFALL IN COASTAL DUNES AT CRUDEN BAY, ABERDEENSHIRE, SCOTLAND.

Dr. William Ritchie, Senior Lecturer in Geography,  
University of Aberdeen, Scotland.

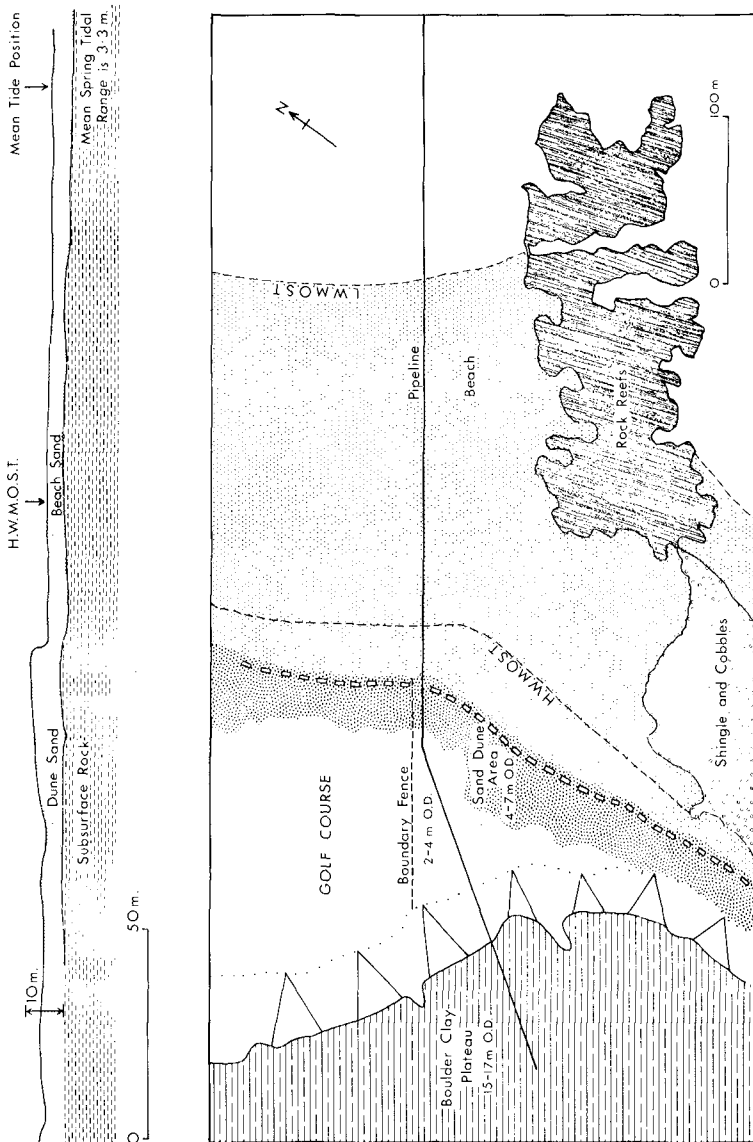
The danger of dune undercutting and the initiation of beach drifting was never a major threat since the site was in a bay-head location and protected by a tombola and reef configuration offshore (Figure 2). The beach trench was only open for a brief period and

coincided with low wave energy conditions. In addition, excess sand from site work was fed into the small bay south of the rock reef below low water mark to artificially nourish the low sand tombola and ultimately feed the beach backshore. Both results were

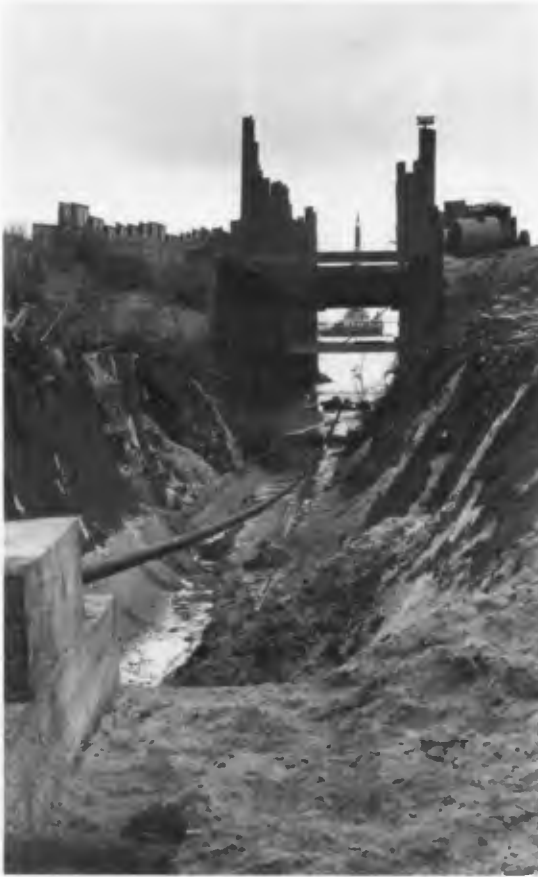
Pipe-pulling through the dune trench in May 1973. Note bitumen spray on trench sides.

These three devices effectively held the entire site area stable from February 1973 until pipe pulling in May 1973 (Plate 1) and the final restoration work which took place in two phases, June 1973 and July 1974. As a result of these devices, there was no wind erosion, no deflation and absolutely no sand deposition on the golf course. Since the bitumen spray as will be described below encourages vegetational growth, the appearance of the site also remained reasonable throughout the period.

1. All susceptible areas were sprayed with a commercial bitumen compound "Crelawn". This is a water-based, bitumen emulsion and is easily and cheaply spread by a hand sprayer.

2. Larger sand spoil heaps (most of it required for back filling) and bare surfaces were covered by a 5-10 cm. layer of soil. This was the overburden material from the access road. It was not topsoil. The material was clay rich and intended as a temporary cohesive, water retentive cover. Since it contained the seeds of grasses and agricultural weeds, vegetation grew spontaneously, and rapidly hid the visually unattractive appearance of these wasted areas.

3. Brushwood fences were built using standard fence posts and 3-strands of wire with coniferous branches interwoven by hand. The brushwood was obtained locally. Some attempt was made to achieve a 40% porosity; a value suggested by the research literature of tree shelter breaks as being the ideal wind screen. These fences acted as a barrier between the golf course and the site. They were approximately 1 m. high. Other fences were placed along the dune crest and short sections were placed in the dangerous corridors created between the sheet pile walls of the trench and the pre-existing sand surface. The sheet

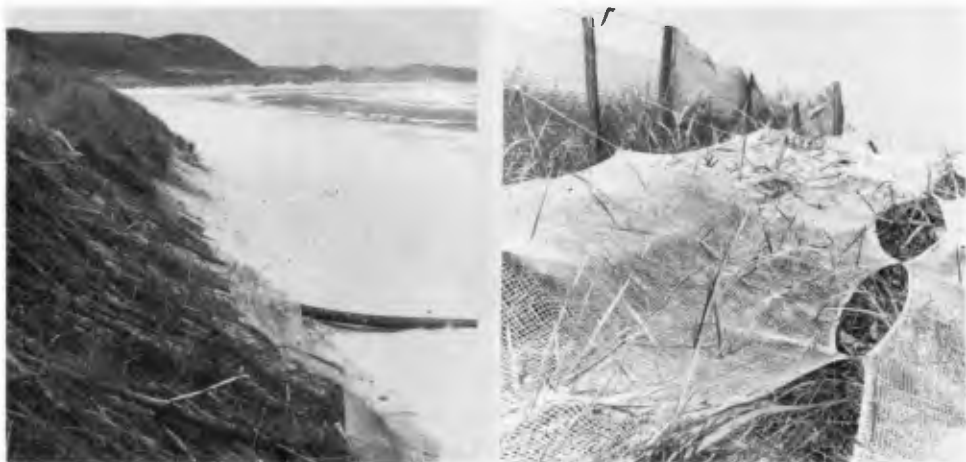
Dune face showing low-cost thatching in July 1973 and the same area in May 1974 with Marram and Sea Lyme grass coming through the branches and hessian cover.

of hessian to bind-down the tree branches. There has been considerable sand accretion and strandline, and dune species have started to recolonise the dune face. Hand planted Marram and Sea Lyme grass (*Elymus arenaria*) were planted in Spring 1974 to increase the rate of colonisation and the appearance of the dune face in July 1974 is shown in Plate 3. The general appearance of the site can be seen in Plate 4 and compared with Plate 1.

As shown in Plate 2, low cost thatching was used to physically protect the slope and encourage accretion. This thatching included a cover

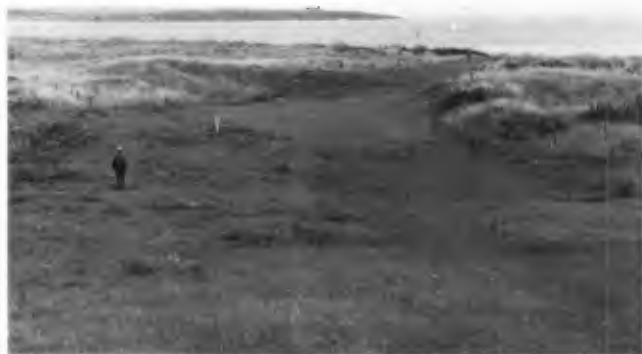
A general view of the site area in August 1974.
