### PROBLEMS OF DESIGN AND CONSTRUCTION OF AN OFFSHORE SEAWATER INTAKE

D.W. STANDISH-WHITE<sup>\*</sup>

J.A. ZWAMBORN<sup>\*\*</sup>

#### ABSTRACT

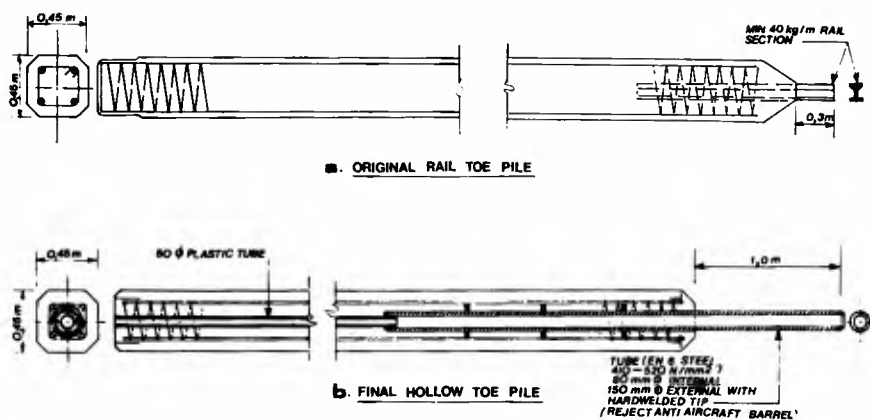
The design adopted was for a light precast concrete jetty carried on slim precast concrete piles, each with a stub rail toe to penetrate the heavy seabed gravels (see Fig. 1.a). This type of construction had been used successfully by the contractors in other situations along the same coast. Construction commenced late in 1974, but it soon became apparent that adequate penetration of the piles to the bedrock through the overlying layer of boulders and gravels was not being achieved and various means of grout stabilization of the toes were attempted in 1975. After 180m had been completed this jetty failed in a storm, partly through excessive pile settlements from the scouring action around some of the pile toes and partly because the whole structure was set too low, and this jetty was abandoned.

After full scale tests on shore, a redesigned special pile which would penetrate down to the bedrock and then allowed for subsequent axial drilling, rock anchoring and grouting was developed. The modified pile toe adopted consisted of a long, thick-walled steel tube with a specially hardened cutting edge (see Fig. 1.b). A new similar jetty 321 metres long (but 1.5m higher) was successfully constructed on this basis adjacent to the old one between September 1975 and February 1976 (see Figs. 2 and 3).

FIG. 1 SPECIAL PILE TOES

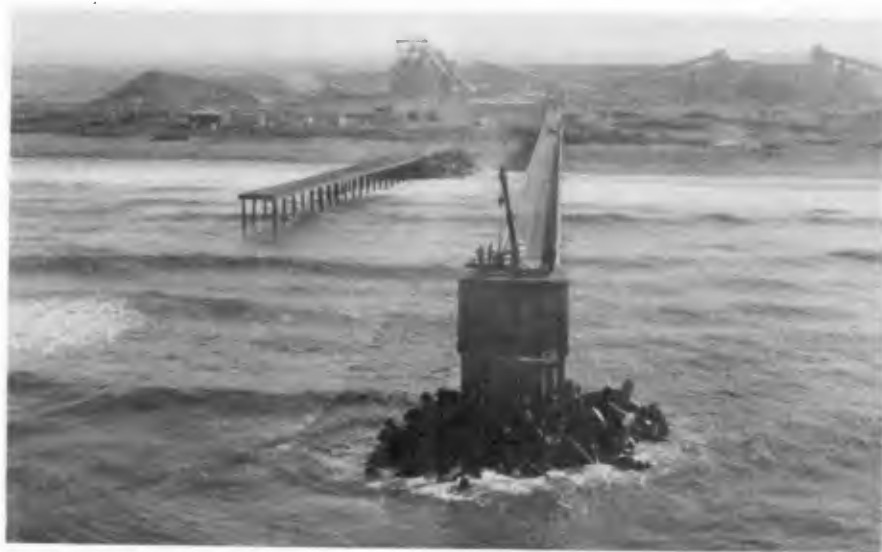
FIG. 2 NEW AND OLD JETTIES WITH DIAMOND RECOVERY PLANT  
IN THE BACKGROUND

The old jetty was partially demolished to avoid any possible future interference with the stability of the new one due to its further collapse. Both the embedded and attached steelwork of the new structure were cathodically protected against corrosion using a constant impressed current and sacrificial anodes.

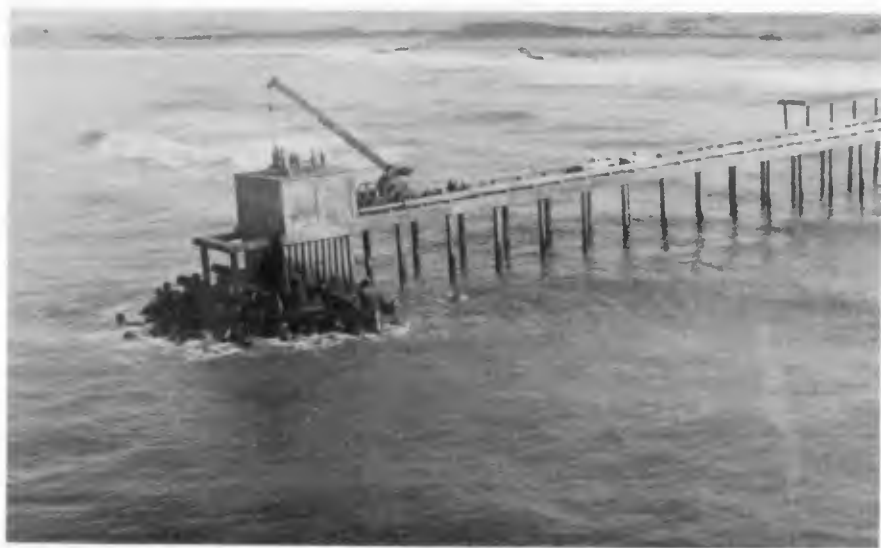
FIG. 4 CLOSE-UP OF DAMAGED DOLOS MOUND

foundation of a carefully placed gravel mat. A total of 1100 6 ton and 120 10 ton dolosse were placed between April and June of 1976 but the mound settled considerably more than expected. At this stage, the National Research Institute for Oceanology was called in for advice and during an inspection in September 1976 it was noted that several 6 and 10 ton Dolosse had broken and the mound had slumped by about 3 to 4 m, exposing the pump chamber (see Fig. 4).

1. The dolos mass was too small, resulting in their removal from the mound.
2. Sea-bed changes of up to 4 to 5m have been recorded in the jetty area, and underscour of the mound itself could well have occurred, also resulting in larger waves.
3. Dolos breakage of up to 5 per cent occurred during placing and further breakages may have occurred due to excessive movements during heavy seas.
4. Possibly insufficient tensile strength of the original dolos concrete for the wave loads imposed.

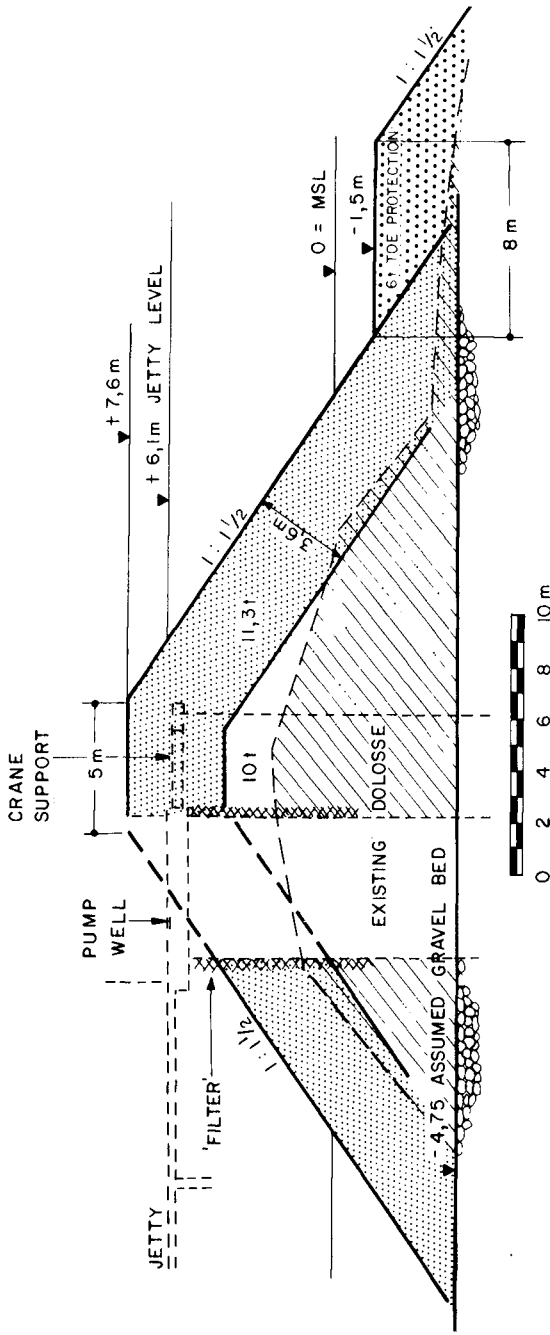
The structure was originally designed for a wave height of 6m, but a further study using more extensive wave data revealed that a 7,1m deep-sea wave could occur once in 25 years, which would increase (due to shoaling) to 7,7m at the seaward toe of the structure. The original foundation of the dolos mound was set at about -5m to mean sea level, but the water depth immediately seaward of the structure could well increase up to about 10m due to scour, and thus a 7,7m wave could reach the structure. A 7,7m wave height was therefore adopted for the re-design of the dolos mound.

Considering that the mound is effectively a 'double breakwater head', this mass should be further increased by 50 per cent to 18,5t as compared with the original 6 to 10t dolos design.<sup>2</sup>

to the third power<sup>2</sup> and an 11,3t dolos should theoretically be as stable as an 18,5t dolos, if cast in the same moulds as the earlier 10t units, but with a nett density of  $2,7\text{t/m}^3$ . Moreover, the available tower crane could still handle these units. A re-design, using 11,3t dolosse of higher density to protect the pump well and an 8m wide toe protection of 6t normal density dolosse was therefore adopted as the best expedient in all the circumstances of the problem (see Fig. 5).

FIG. 5 RE-DESIGN OF DOLOS MOUND

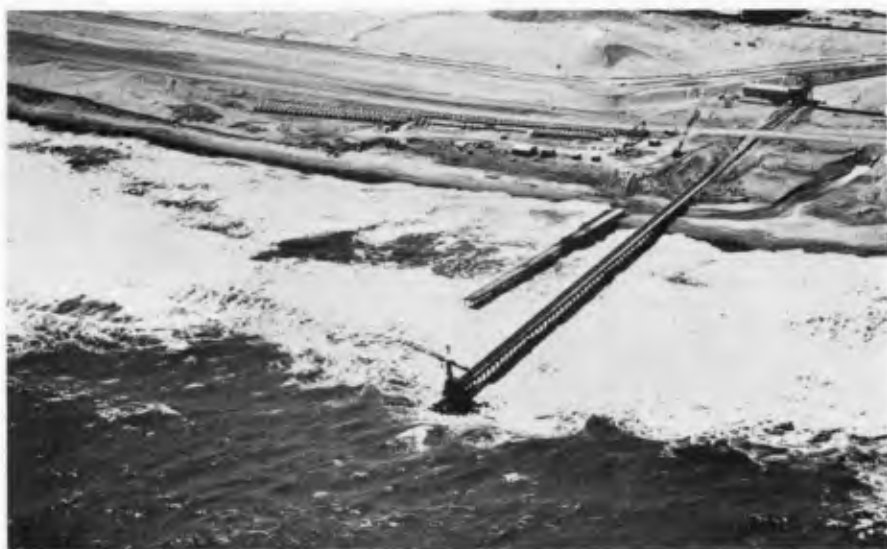
Due to the exposed position of the structure - right in the breaker zone during heavy seas (see Fig. 6) - and because of its dissimilarity to usual breakwater structures, it was considered necessary to carry out confirmatory hydraulic model tests. Due to severe lack of time, only two simple tests using a 'half model' in a wave flume could be done, one test using normal density dolosse ( $2,3\text{t/m}^3$  in the model representing  $2,37\text{t/m}^3$  prototype), and a second test with higher density dolosse ( $2,57\text{t/m}^3$  representing  $2,63\text{t/m}^3$  prototype). The tests were done in a 1,5m wide and 0,7m deep regular wave flume with the model built on the available 1:20 slope (prototype slope was about 1:30). A water depth of -7,5m below mean sea level at the centre of the mound was used. The entire mound (half model) was built of 530 82 and 92 gr dolosse, representing 10,3 and 11,5t full scale units. Model wave heights were increased in small intervals up to the equivalent of 7 m high waves with a period of 11,5s. A model view is shown in Fig. 7.

FIG. 6 HEAVY SURF POUNDING THE STRUCTURE

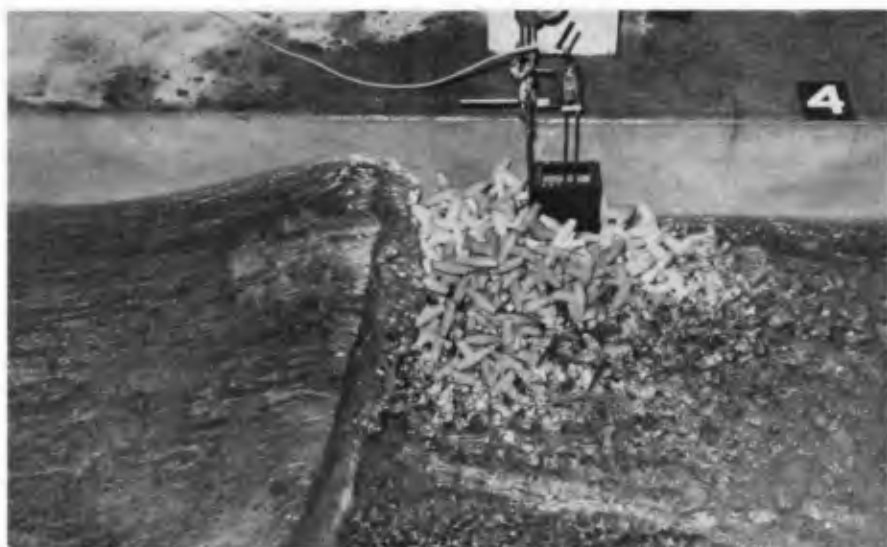
With the *normal density* dolosse, the model showed the first damage for 5m high waves. The damage, particularly on the side of the mound, increased rapidly with the 7m waves causing a 2m slump thus exposing the pump sump to the direct wave forces. A marked improvement was obtained using the *high density* dolosse. With the 5m waves, very few dolosse were displaced (< 1%) while a total of only 17 model dolosse were displaced with the 7 m waves (about 4%).

FIG. 7 FLUME TEST ON 'HALF MODEL'  
7 M BREAKING WAVES

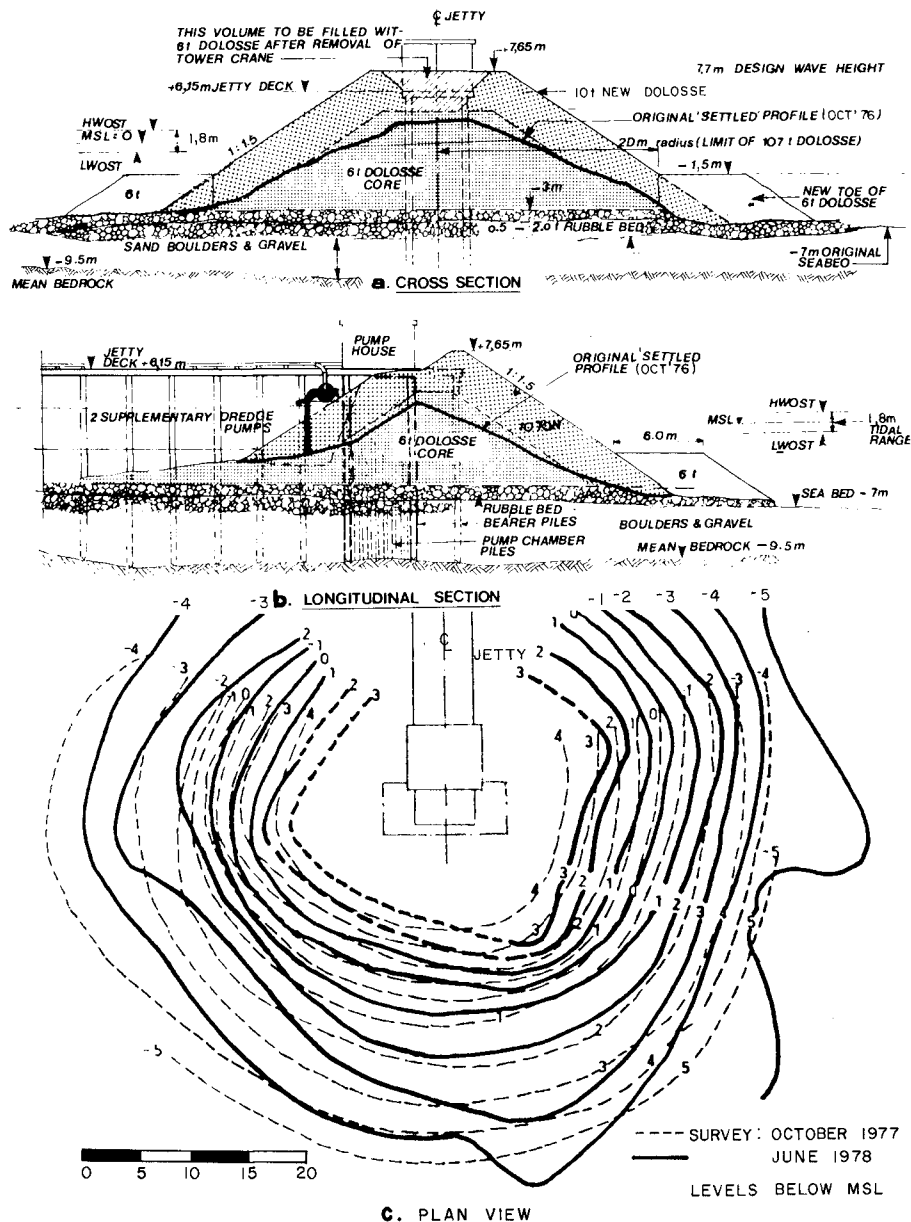
It finally took a total of 2 414 six ton and 853 ten ton dolosse to complete the dolos mound in accordance with the profile shown in Fig. 8 (August 1977).

Settlement of approximately 1 metre has since occurred during its first winter season, but no heavy storms have been experienced so far. Considerable stability does now seem to have been achieved, together with calm pumping conditions. A close watch will be kept of the island's future performance and its behaviour will be correlated with wave heights recorded seaward of the jetty with a waverider buoy.

FIG. 8 DOLOS MOUND AFTER COMPLETION

Although attempts to produce high density dolosse have not been abandoned, the need to complete the dolos island, which forms the protection of the pump chamber, dictated an urgent 'engineering' solution. Accepting that the 10,7 ton dolosse were too light for the 7,1 m incident design wave height, it was decided to 'reinforce' them using sections of old 20 kg/m railway lines readily available on the mine. This rail reinforcement was tack-welded in a dolos shape to provide core reinforcement. Experience has since shown that this reinforcement holds the dolosse together well, even if the concrete cracks. Thus, although the steel may eventually corrode, it meanwhile contributes to the mound's stability by keeping the dolosse intact for a much longer period. A small beneficial increase in total mass also results from the steel inclusion but these 'reinforced' dolosse were made of normal density concrete (S.G. 2,4) and the mass of these units was therefore only about 10,0t.

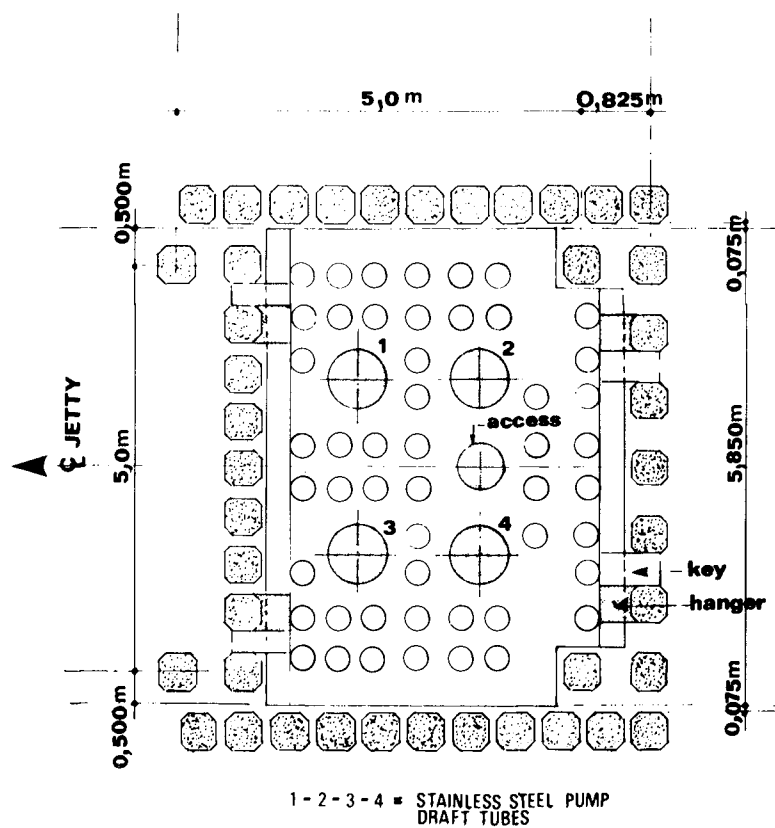
During the early commissioning of the large (175 kw) vertical spindle centrifugal pumps (Early 1977), it became apparent that surging and turbulence in the pump chamber was far greater than had been expected. A concrete baffle platform was then cast and lowered down the chamber and set at mean sea level, and the pumps were encased in stainless steel sleeves (see Figs. 9 and 10). These measures were highly successful in both supporting the pumps and in damping out the surges in the chamber. Completion of the final mound has also had a beneficial effect on surging and sand build-up in the sump.

FIG. 10 PLAN OF BAFFLE SLAB IN PUMPING CHAMBER

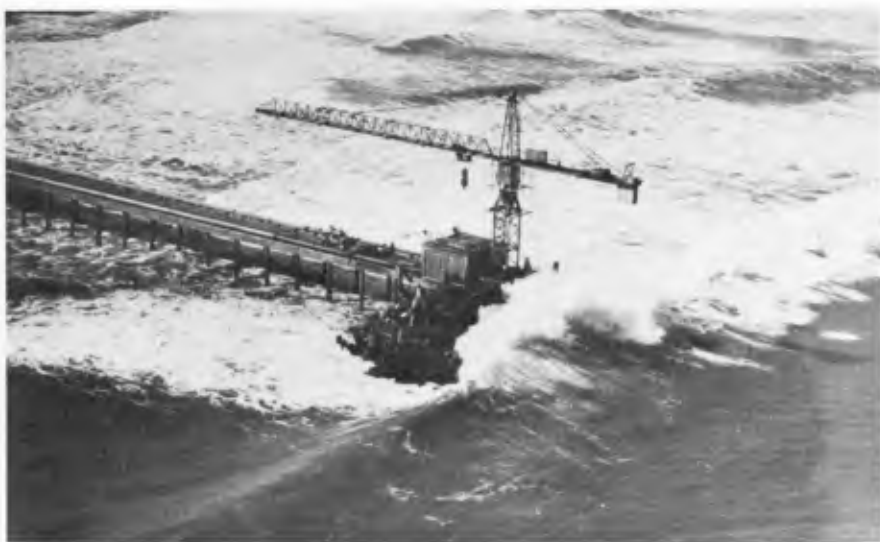
percentage of sand suspended in the seawater inside the chamber. Each of the four pumps had an average initial life of only 30 days before lifting for replacement of the wearing components. A number of mechanical solutions were tried but no suitable vertical spindle pumps of this size and duty are on the market at present.

FIG. 11 DREDGE PUMPS IN LEE OF DOLOS MOUND

Very reluctantly, recourse had to be made to installing a pair of horizontal spindle, rubber-lined dredge pumps mounted on a platform underslung below the jetty in the immediate lee of the mound (see Fig. 8). This system has proved embarrassingly effective and reliable up to date. Two standby submersible pumps are installed in two of the draft tubes and an experimental vertical spindle pump with continuously grease-fed bearings is being operated in the third tube with good results over the past six months.

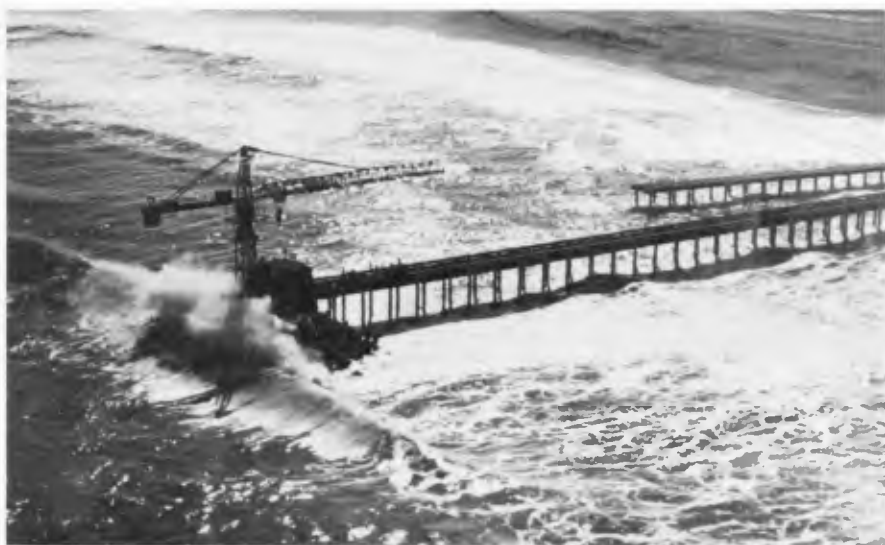
FIG. 12 COMPLETED INSTALLATION, JULY 1978
