REPORT ON THE DAMAGES TO THE  
SINES BREAKWATER, PORTUGAL

Possible contributing factors to the 1978 failure of the massive main breakwater at Sines, Portugal are presented in a selective summary of the report of the Port Sines Investigating Panel. A failure scenario involving the impact breakage of unreinforced concrete armor units is developed.

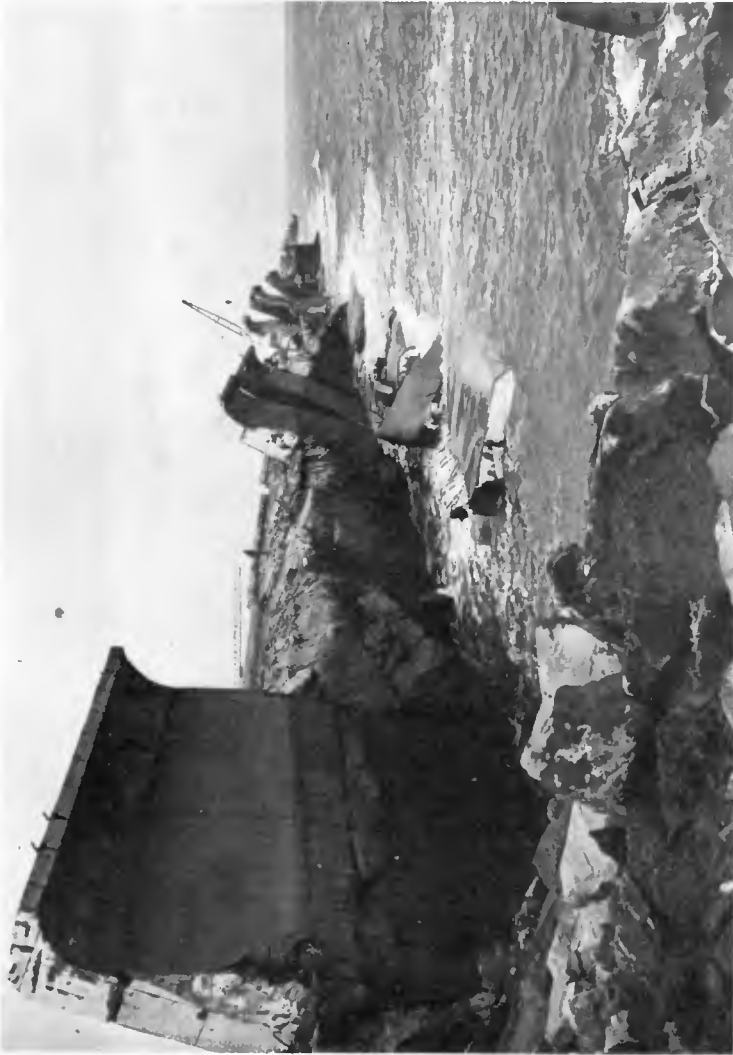
Figure 1 Damage to the seawall and dolos, taken immediately after the February 1978 storm (photo from GAS)

As the wave height and period increased, the movements became more severe and the units were accelerated to the velocity of the uprushing wave. The following impact with adjacent units produced stresses in the units that exceeded the strength of concrete. This resulted in breakage, and frequently the pieces were carried away by the uprushing or downrushing wave. During this process, the pieces themselves collided with other units, in some cases causing additional breakage.

At the peak of the storm, when the significant wave height exceeded 8 m, a large number of units located just below the water level broke. As the pieces were carried away, adjacent units were free to move and a rapid disintegration of the armor layer occurred. Initially the greatest damage occurred immediately below the mean water level. The broken pieces were moved by water motion and gravity from the armor layer to the lower part of the mound. The slope of the seaward side of the breakwater below the water level then became flatter.

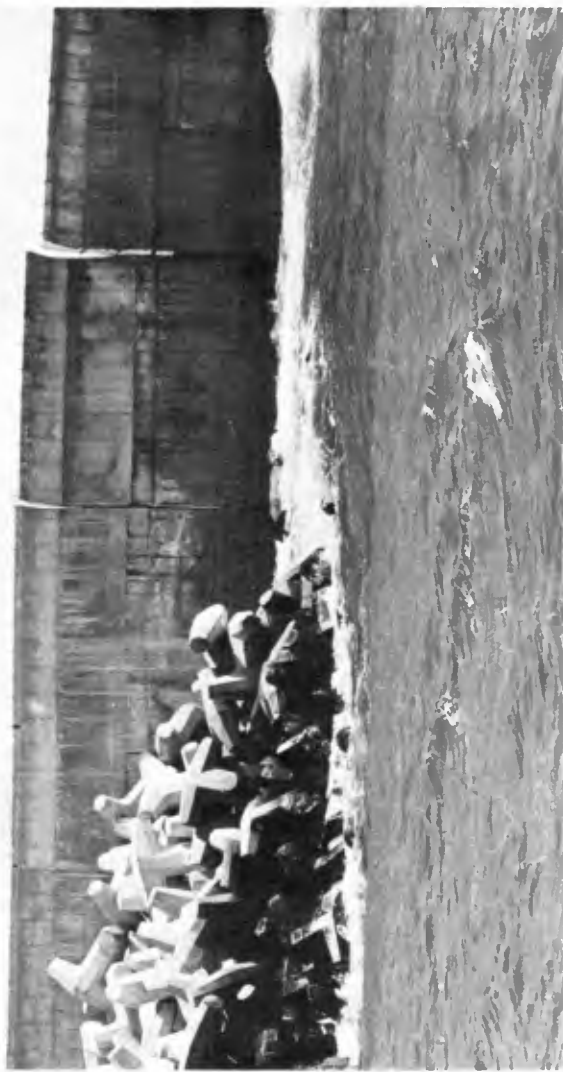
Figure 2 Dolos removed from the front of the seawall and broken dolos and superstructure  
(photo from GAS)

During the final stages of the storm the armor layer was completely removed at some locations. The broken dolos pieces were displaced to the base of the armor layer and the underlying stone layers were exposed. Wave action then moved these exposed stones over the broken dolos pieces. Continuing wave action eroded the core material and began to undermine the superstructure.

As the concrete superstructure was undermined it tilted forward. In some instances, the structure broke in the base (where the pipelines carrying petroleum from the berths to shore would be located) and at some of these locations the wave wall at the top of the structure was snapped off and thrown back as a result of wave impact.
