## CONSTRUCTION OF A BREACH CLOSURE IN A BARRIER ISLAND

A breach was opened in the barrier beach along the south shore of Long Island, New York during a winter storm in January, 1980. Due to public safety and environmental concerns, a contract to close the breach using sand fill was awarded to a local contractor. This paper discusses the evolution of the construction procedures developed to allow the contractor to successfully complete the project on schedule and on budget.

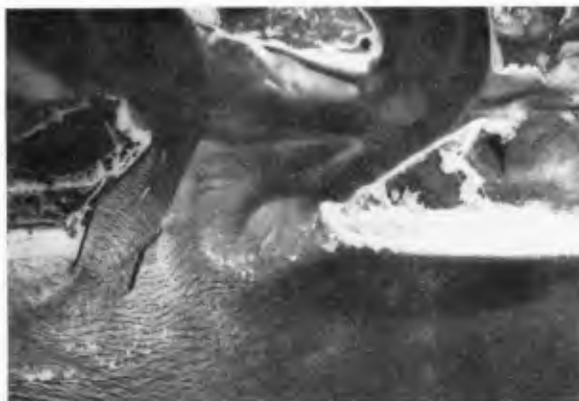
**Figure 2 - Breach Immediately Prior to Closure (7/12/80)**

Tidal currents and wave action in the area resulted in the rapid growth of the breach until the fall of 1980 when, due to local concerns regarding exposure to storm induced flooding and effects on shellfish beds, construction was begun to effect its closure. At that time, the breach, shown in Figure 2, had expanded to nominally 885 meters (2900 feet) in width with an average depth of 3 meters (10 feet). The plan selected for the closure consisted of the placement of 1.2 million cubic yards of beach fill with a final crest elevation of +4 meters (+13.25 feet) MLW and side slopes of 1:25.

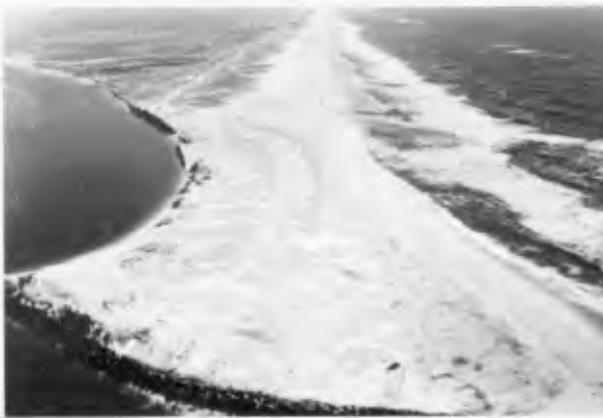
Figure 4 - Erosion Along Pikes Beach (2/70)

The present stone jetties were constructed during 1952 and 1953, and extended in 1954. Despite the presence of the jetties, navigation through the inlet has been considered unsafe due primarily to the shifting shoals offshore of the inlet. The stabilized inlet has also experienced progressive erosion along the bay shoreline to the east of the jetties, as shown in Figure 4. This erosion was noted in a 1958 U.S. Army Corps of Engineers review of the inlet and has been described numerous times since then as the erosion became more pronounced, culminating in the breach during the January, 1980 storm.

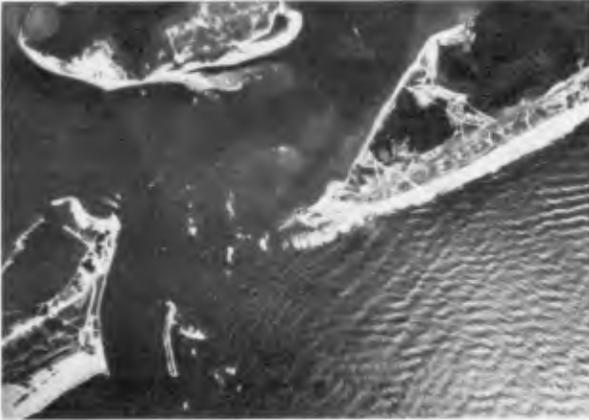
**Figure 6 - Initial Construction (10/12/80)  
(note sheet pile retaining walls)**

Construction operations began in early October ,1980. Initial operations consisted of cutting and stabilizing a haul road over the dunes leading to the construction site and moving in equipment and sheet piles. Placement of fill material from upland sources and driving of sheet pile walls commenced on October 10. Figure 6 is an aerial view of the construction site made on October 12, showing a short section of the sheet pile wall in place and the beginning of a sand bar along the ocean side of the closure. This bar was in evidence throughout the closure operations and seemed to be due to the entrapment of the westward littoral transport. In any event, the bar migrated westward as closure operations progressed and provided additional protection from the ocean waves to both the fill material and the exposed portions of the sheet pile wall.

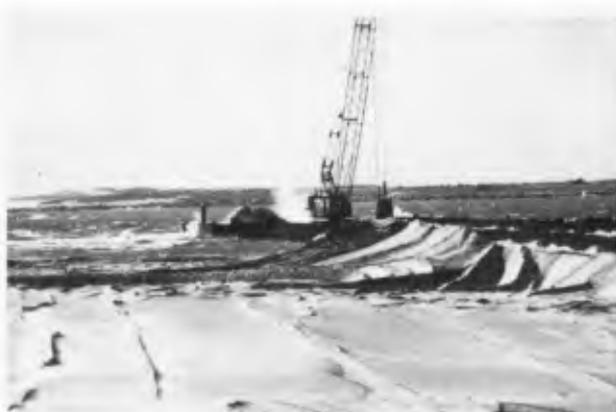
**Figure 8 - Pile Driving Activities in Rough Conditions**

Placement of the sheet pile walls was accomplished using a Link Belt 138, 70 ton crane fitted with a vibratory hammer as shown on Figure 7. Construction operations were able to be continued during most weather and sea conditions although at several times the safety of the construction crew guiding the sheet piles into position required shutdown of these activities as shown on Figure 8.

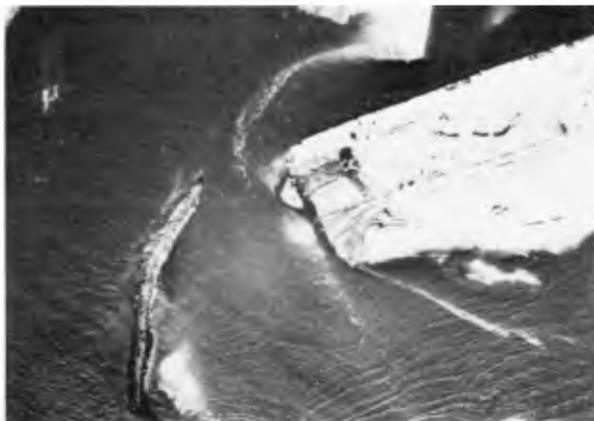
**Figure 11 - Preparations For Final Closure (12/4/80)**

Final closure operations were begun in the beginning of December. As shown on Figure 11, the tidal currents were primarily moving in and out of the bay through the old inlet, due in part to the cut made by the dredge through the sand bar. To further channel the flow into the inlet a long spur was constructed to deflect the ebb tide away from the breach. These procedures worked as sand began to naturally accumulate in the remaining breach opening and closure operations were completed with no further difficulties on December 15.
