REPAIR TO A DOLOS ARMoured BREAKWATER

C.W. Glodowski, B.Eng., Marine Directorate, Public Works Canada
D.L. Lajoie, Ba.Sc., Marine Directorate, Public Works Canada
Y. Ropars, Ma.Sc., Quebec Region, Public Works Canada

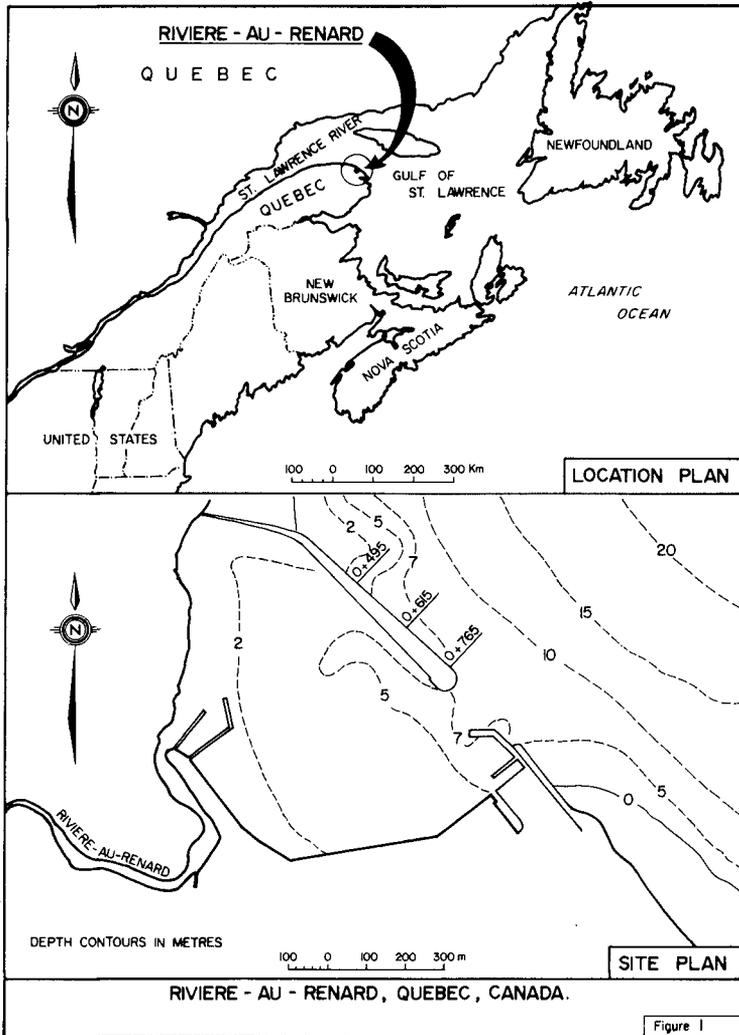
Rivière-au-Renard is located on the eastern end of the Gaspé Peninsula on the Gulf of St. Lawrence in Québec, Canada. The main breakwater is about 785m in length and encloses a natural bay to protect a fishing harbour facility. The breakwater construction was completed in 1972 (see Figure 1).

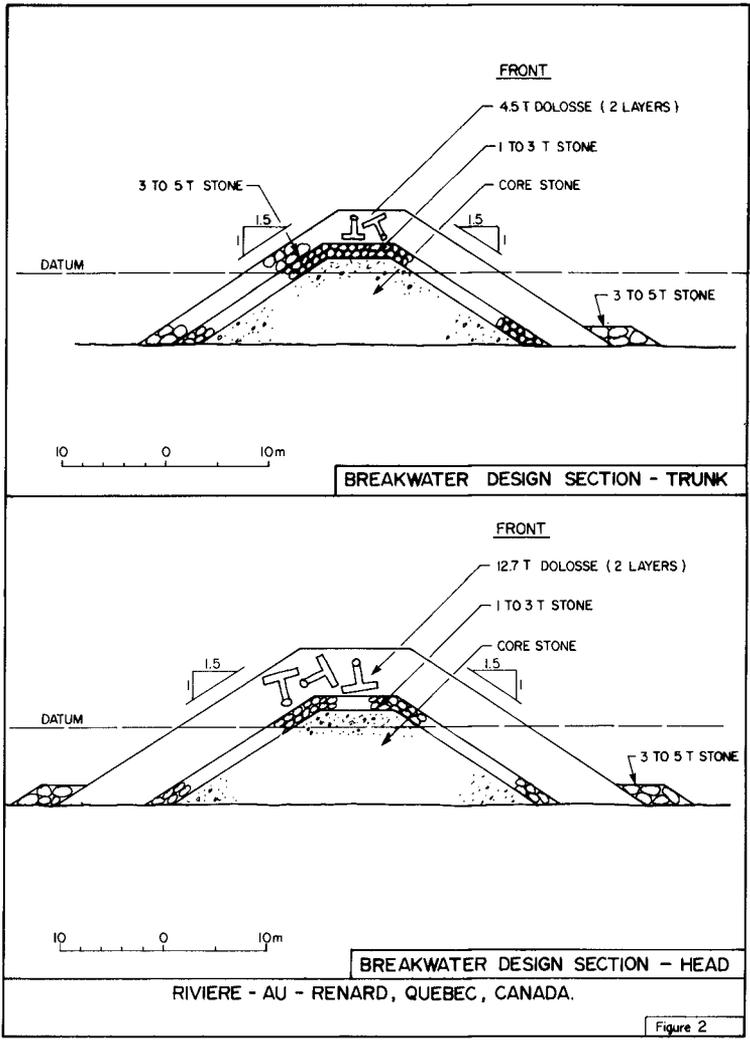
The outer portion of the structure of about 350m in length, was armoured with concrete dolos units of two sizes. Units at the head are 12.7t and extend back about 30m on both front and back slopes in water depths of 7 to 8m. Dolosse in the trunk are 4.5t and cover the crest and front slope only in depths of 4 to 7m. Typical cross-sections are shown in Figure 2. Unit placement was in double layer random in the densities estimated from the S.P.M. (1)

- There was a high percentage of broken dolosse along the full length of the structure including the 12.7t head section. Estimates for broken units on the front slopes above and below mean water level ranged from 10 to 50% not including the areas of the breaches.
- The major breach extended for a length of about 50m and a typical section is shown in Figure 3 (i.e. Section +615). Estimates of broken dolosse in the breach are about 30% on the front below low water, 90% on the crest and front above low water and 65% on the back.
- The secondary breach was in deeper water but extended only 10m in length and was not as extensively damaged. However, dolosse were also piled at the back side of the breakwater (section not shown).

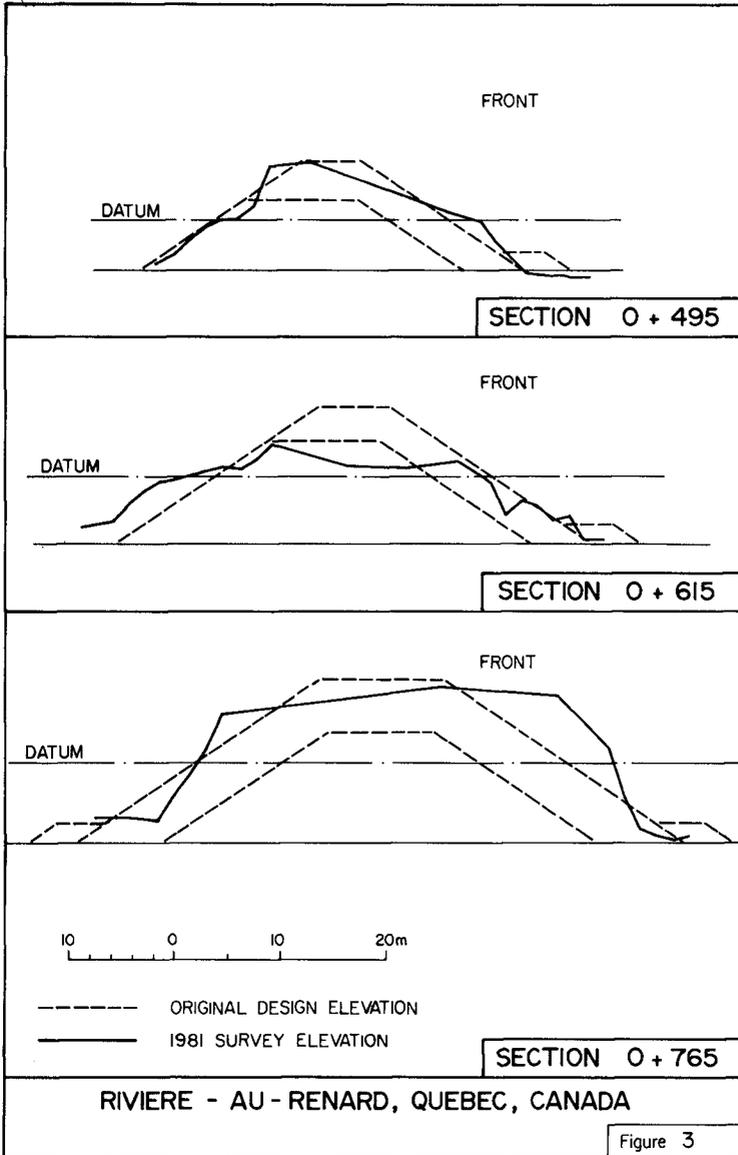
- Overall the slopes were very steep on the landward side of the structure in the area above mean water level. It appeared as if the dolosse in the crest area had been pushed back en masse (see Figure 3 of Section +495), however it is not known whether the original placement met specifications. Seaward side slopes were varied and irregular but showed some tendency to form an 'S'-shape.

- The 12.7t dolosse at the breakwater head showed unusual and steep slopes that could not be accounted for without assuming significant deviations from the design specifications (see Figure 4 of Section +765).
