THE MONITORING OF RUBBLE MOUND BREAKWATER STABILITY USING A  
PHOTOGRAPHIC SURVEY METHOD

ABSTRACT

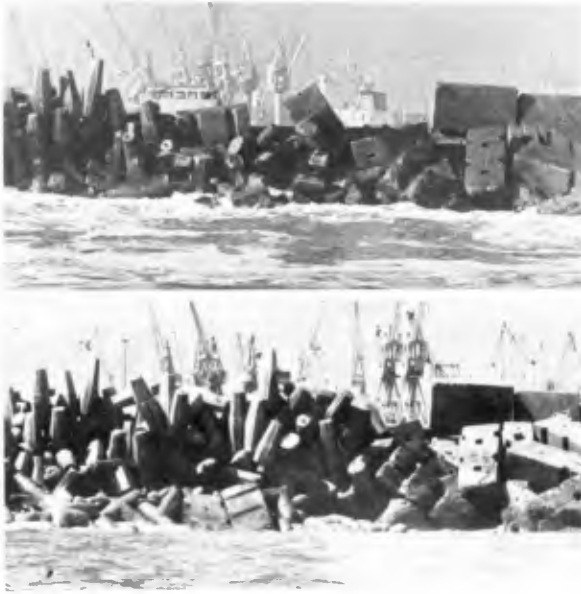
Figure 2 Loss of dolosse at section P10

used there to monitor the effectiveness of the repairs as well as the general stability of the breakwater. Examples of photographs of damage on the breakwater are shown in Figure 2.

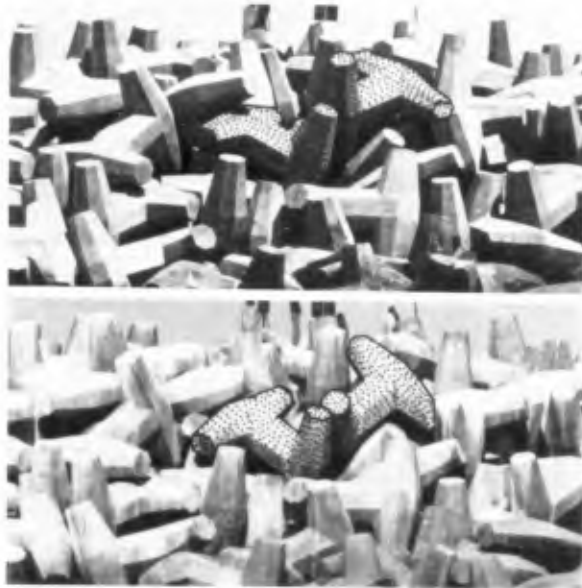
The two breakwaters of the cooling water intake at Koeberg were completed recently (1980). Both breakwaters are rubble mound constructions overlaid with dolos armour units. Regular breakwater surveys have been undertaken as part of the post-construction monitoring programme. Very limited settlement of a few individual dolosse has been recorded on the two breakwaters. An example of settlement (two dolosse) on the head of the breakwater is shown in Figure 3.

Figure 3 Dolos settlement at section S2
