## THE RELINING OF SAICCOR'S EFFLUENT OUTFALL

This paper describes the method employed to refurbish an existing marine outfall which was deteriorating rapidly. It reviews the repair options that were available and how each was investigated and rejected until the best solution was obtained. Finally the execution of the project is described in detail through each stage to successful completion.

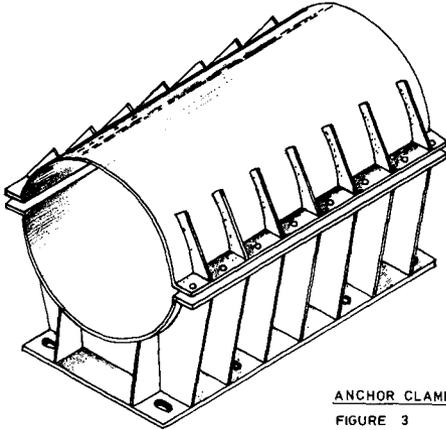
FIGURE 3

Each end of this new pipeline was restricted by means of heavy anchor clamps. Details of the anchor clamps are shown in Figure 3 and a feature of these clamps was the arrangement provided to allow for adjustment of lengths and location should this be necessary. The holding down plate

was drilled with oversize holes and large rectangular washers were fitted. These large washers allowed reasonable movement within the bolt holes and, after final tightening of the bolts, the washers were welded in position.

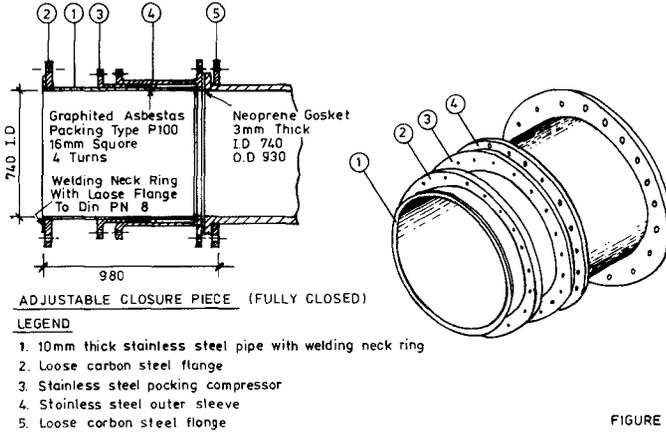
FIGURE 4.

This closure piece is shown in Figure 4 and comprised a temporary stuffing box which was welded up after commissioning. The anti-vacuum device consisted of a NORVAL type reflux valve with a stainless steel screen and diaphragm designed to allow air to enter the pipeline and prevent the creation of an air vacuum which could cause collapse of the plastic pipes.
