Case History of a Spaced Pile Breakwater at Half Moon Bay Marina
Auckland, New Zealand

P.S. HUTCHINSON*
A.J. RAUDKIVI**

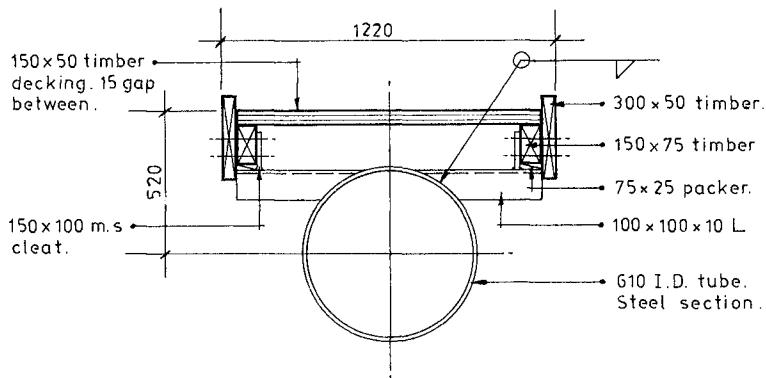
Figure 5 : Typical section through walkway

clear of piles and the marina structure, using four mooring lines, Fig. 4. With this method of mooring boats need little supervision and fenders are not required. At Half Moon Bay it is only the marina berths near the entrance where the sea condition has caused deterioration of the timber marina structure. During northerly winds the waves which enter the marina through the entrance, combined with the half wave height entering through the spaced pile breakwater, cause a considerable amount of wave disturbance over the area just inside the entrance.

The end fingers near the entrance have now been replaced using continuous 600 mm diameter steel pipe, Fig. 5, to support the walkway and fingers. This construction was first used over 20 years ago when the first marina berths were built by the Auckland Harbour Board at the Westhaven boat harbour.

A spaced pile breakwater has provided satisfactory economical shelter to a 485 boat marina. Only near the entrance did the original timber structure of the marina berths deteriorate due to wave action and it has been necessary to replace the light timber and fibreglass marina and fingers with more robust continuous 600 mm diameter steel pipes. Boats are moored to float clear of the fingers and do not require fenders.
