## CHAPTER 209

### BERM BREAKWATER FAILURE AT ST. PAUL HARBOR, ALASKA

Javier Weckmann,<sup>(1)</sup> Associate Member, ASCE  
George M. Watts,<sup>(2)</sup> Fellow Member, ASCE

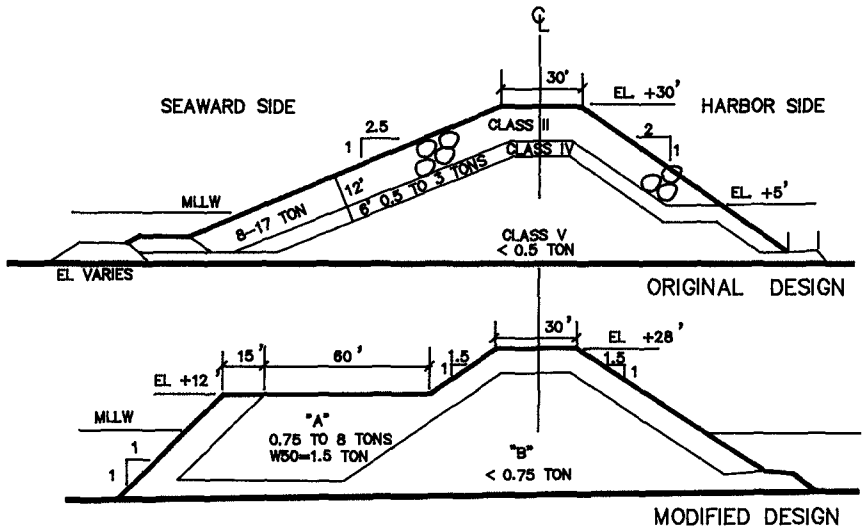
FIGURE 1 BREAKWATER CROSS SECTIONS

The St. Paul Harbor was to be constructed in Village Cove using a shore-connected breakwater commencing at the base of Village Hill, and extending approximately 2,000 feet (600m) in a north-northwest direction. The original design of the rubblemound breakwater followed a conventional 3 layer system. This consisted of a quarry stone core protected by 2 layers of 8-17 ton stone (Class II). The seaward slope of this structure would have been 1 vertical to 2.5 horizontal and have a crest elevation of +30 feet (9m) MLLW. The head section was to be constructed using a heavier armor layer of 17-24 ton stone (Class I) with a slope of 1:3. A typical cross-section is illustrated in Figure 1.

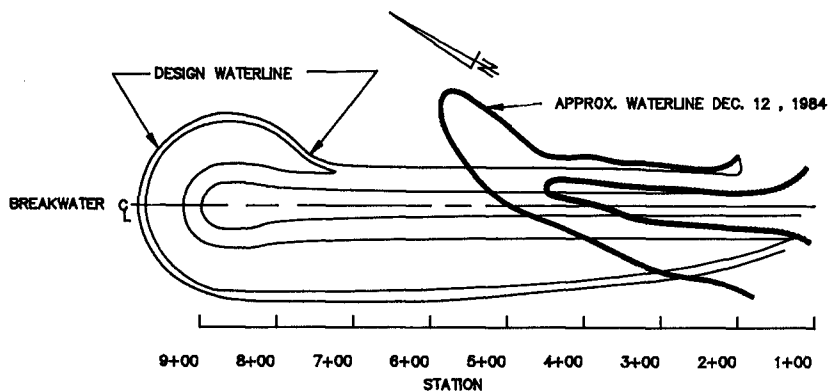
FIGURE 3 BREAKWATER PLANVIEW

wave height,  $H_s$ , of 30 feet (9.1m) with peak periods of 16 seconds, and the second storm had an  $H_s$  of 22 feet (6.7m) with 13 second peak periods. Storms of these magnitudes can be expected to occur several times a year in the Bering Sea. Tide levels were estimated at +3.5 to +4.0 feet (1.1 to 1.2m) MLLW for both storms. The 13 November storm resulted in considerable redistribution of the "A" stone along the entire structure length. Approximately 300 feet (91m) of the original crest and 100 feet (30m) at the waterline were lost. Data gathered after the 7 December storm indicated that an additional 200 feet (60m) of crest and 250 feet (75m) of waterline were lost, for a total damage of 500 feet (150m) of crest and 350 feet (100m) at the waterline. A comparison of centerline profiles before and after the storms is shown in Figure 2. It was evident that material at the head section was transported into the harbor area and formed a low, wide underwater mound east of the initial centerline, producing a reef type structures. Plan views of the before and after structure are shown in Figure 3.

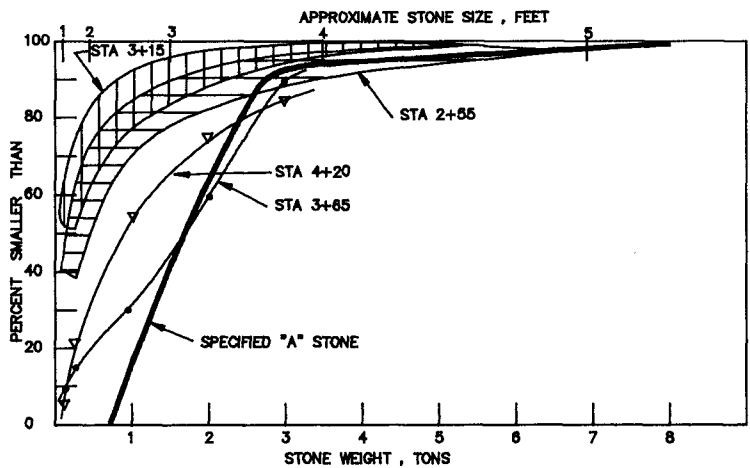
FIGURE 4 ESTIMATED GRADATION OF "A" STONE

Independent gradation estimates were made at various locations along the breakwater above the waterline. The results of this work showed that the in-place "A" stone outer layer was generally finer than the specified gradation for "A" stone (see Figure 4). Some signs of slumping on the harbor side south of STA 4+50 slope were also visible.
