## CHAPTER 244

### ST. PAUL BREAKWATER, PHASE 1

#### The Project, the Failure and the Subsequent Investigations

Torben Sørensen<sup>1</sup> and Ole Juul Jensen<sup>2</sup>

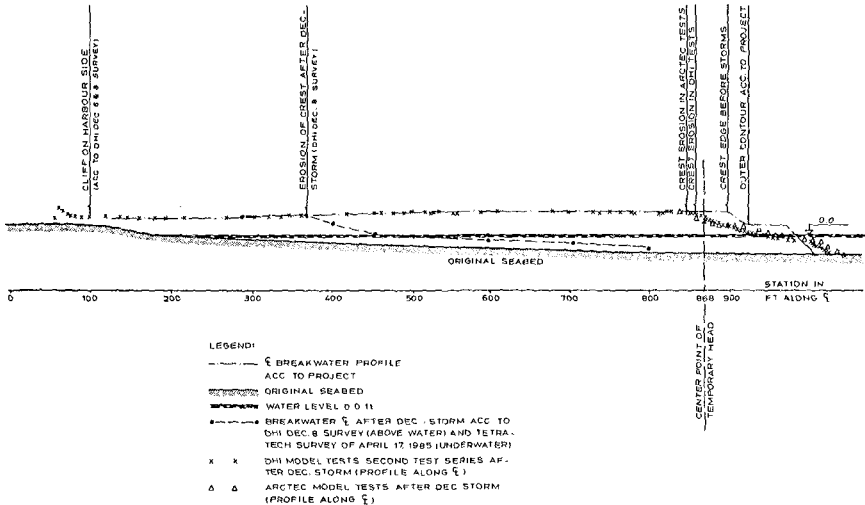
The Phase 1 breakwater was completed 2 October 1984 and was severely damaged during two storms in November and December the same year. At the end of the December storm, the length of intact crest of the breakwater was reduced from its original approximately 800 ft to less than 300 ft (Fig. 2).

Figure 2. Comparison of Model Test Results and In-Situ Damage.

In spite of a number of differences between the two sets of model tests, both in the hindcast wave conditions and in the physical modelling, the results of the two sets of tests were remarkably similar. In both tests, the damage observed in the models had no resemblance whatsoever to that experienced in nature. In the models, the damage was limited to the temporary breakwater head proper and fell well within what was predicted in DHI's final report of September 1984, whereas in the nature the breakwater had suffered virtually total destruction (Fig. 2), chiefly through the process of crest erosion caused by excessive overtopping.

In both sets of model tests, overtopping was insignificant and did not at any point cause damage to the crest of the breakwater. This is in sharp contrast to what was observed in nature where photographs taken during the storms show violent overtopping, and photos taken after the storms show extensive damage in the form of crest erosion over the entire outer portion of the breakwater.

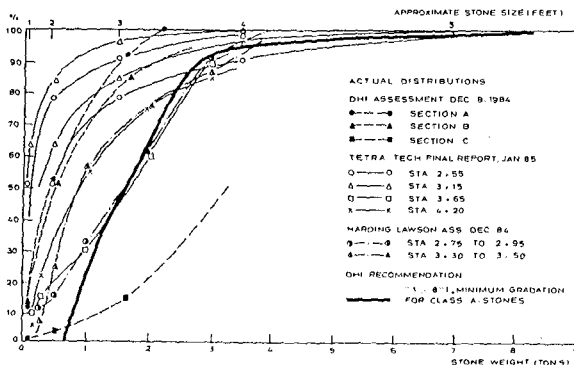
Various surveys of the A-stone gradations used for construction were made after the damage. Fig. 3 shows the results of all of these surveys. It appears clearly from the various surveys that the average weight of the A-stones used for construction was generally very much smaller than what was recommended by DHI.

Figure 3. Estimates of A-Stone Gradations As-Built.
