RESULTS OF FIELD MONITORING OF THE NEW CORE-LOC BREAKWATER at PORT ST FRANCES - SOUTH AFRICA

D Phelp ¹, A Holtzhausen ², J Melby ³

Abstract

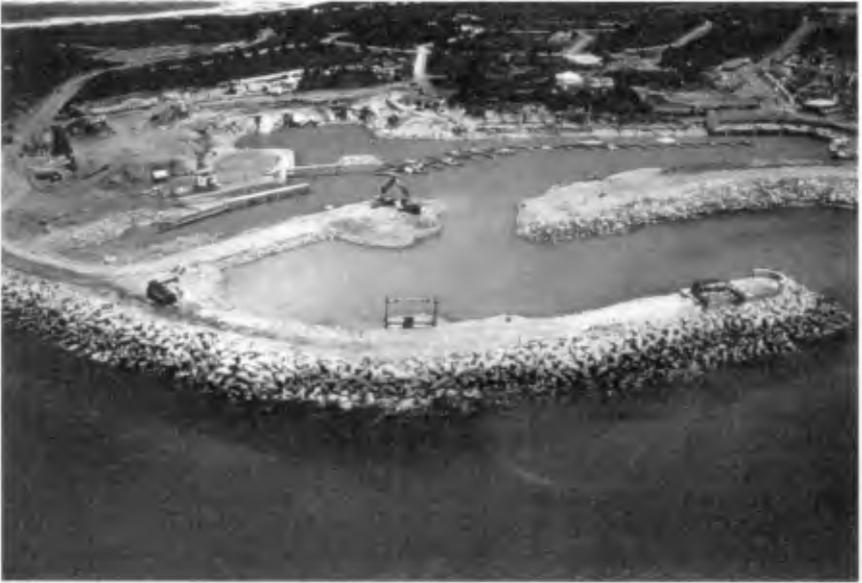
Figure 5: Breakwater, revetment and marina under construction

These problems experienced during the construction phase of the breakwater, contributed to the majority of damage (displaced and broken Core-loc units) found on the breakwater. During this phase the low crest (+3,5 m MSL) working level was unprotected against wave overtopping, resulting in the displacement of a number of units during the near design storms that were experienced before construction of the mass-capping. During one of the storms, overtopping caused a breach of the core material and the displacement of Core-loc units into the harbour. Most of these units were recovered and re-packed on the front slope. Some grading problems with the under-layer rock also caused an irregular profile. Figure 5 shows the breakwater, revetment and marina still under construction.

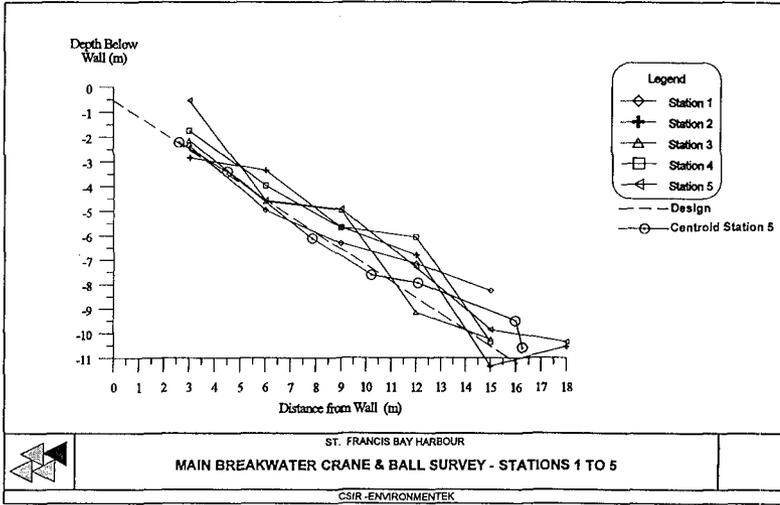
Figure 8: Main Breakwater crane and ball survey - stations 1 to 5

A DGPS satellite system was mounted on the top of the boom to fix the positions at which the levels were taken. The level of the ball were recorded by dumpy level from the capping and related back to the top of the splash wall at a level of +6,5 m. At each position the ball was lowered until it touched the Core-locs. The levels were then plotted with Figure 8 showing the plot for stations 1 to 5.

The ball survey gave a profile generally 1 metre higher than the design profile. The latter was closer to the levelling survey taken by holding a staff on the centroid of each Core-loc, as carried out by A.R. Wijnberg Inc. (Figure 8).

Figure 8 gives an example of the results of the “crane and ball” survey. Included on the figure is a plot of the design slope. The “S” shape damage apparent in the cross-sections nearest the bend in the breakwater was most likely caused by breaching during storm conditions and by poor placement.

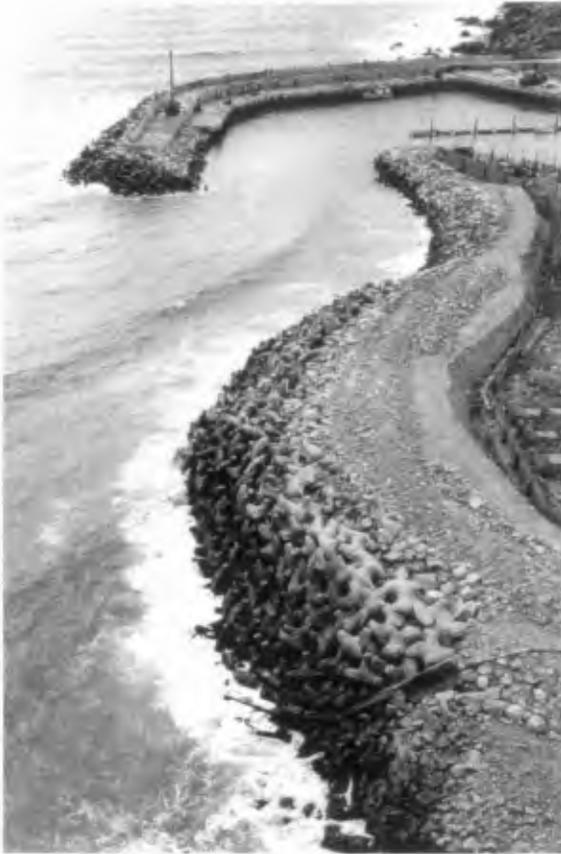
Figure 9: Revetment and main breakwater

Initial placement problems were largely overcome during the construction of the revetment as this was constructed after the breakwater. This led to a better constructed armor protection in this area, with good interlocking and a uniform slope (Figure 9). The revetment was also partially protected by the main breakwater and the working level during construction was higher, so that there were no serious overtopping problems.

The diving inspection also revealed the importance of the manner in which the first row of Core-locs are placed behind the toe berm. Where good toe placement was achieved, such as on the revetment, it provided a stable foundation on which to build the rest of the slope. Areas where the toe units were loose, the armour slope had become flattened (e.g. storm damage around the bend in the main breakwater) resulted in looser packing and poorer interlocking of the Core-loc above. The slope of the revetment was more uniform with each row of Core-loc anchored by the row above, resulting in a strong well interlocked slope (Figure 9).

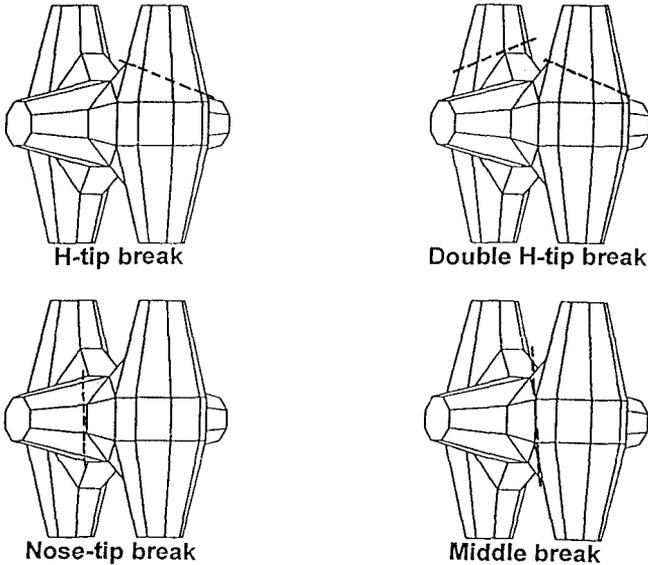
Figure 11: Types of breakages of Core-loc unit

It was however felt that it would be useful to classify the different types of breaks which took place during construction (see Figure 11). These were identified for each damaged Core-loc unit and totals were calculated accordingly. The percentages of the various breakage categories is indicated in the table below:

Breakage Type (during construction)	% Breakage
H-tip breaks (one tip only) = 5% wt. Loss	61%
Double H-tip breaks = 10% wt. Loss	5%
Nose-tip breaks = 5% wt. Loss	13%
Middle breaks (unit broken in half)	13%
Multiple breaks (more than 2 pieces)	8%

It is important to note that the units that experienced the H-tip and double H-tip breakages still retain 90% of their original weight allowing them to adequately provide the necessary protection. Furthermore, the majority of these units still appear to be well interlocked with the surrounding units. Other types of breakages recorded may also have occurred as a result of poor quality control during the making and placing of the units in the construction phase.
