The influence of Marina Construction in Beach Stability: El Milagro Case Study

Abstract

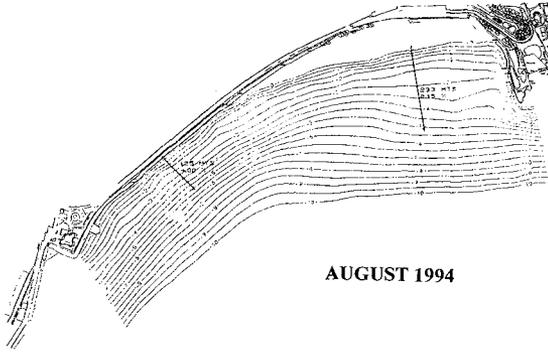
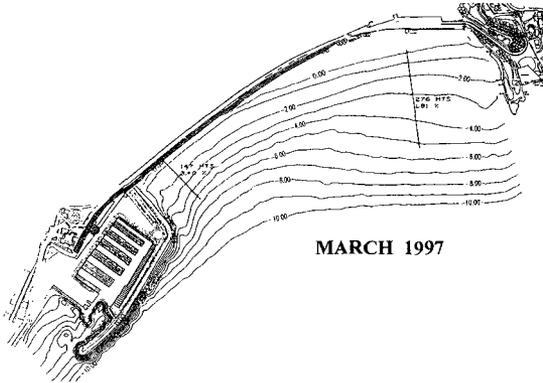
Figure 2.- Bathymetric map before marina construction.

Figure 3.- Bathymetric map after marina construction.

In 1995 a marina was built in the West Side, near the harbour breakwater. Its breakwater reaches the bathymetric -10 m and it is a total barrier to the longshore transport. This marina changed the beach behaviour as it can be seen in

the next paragraphs. Figures 2 and 3 show the bathymetric maps before and after marina construction.

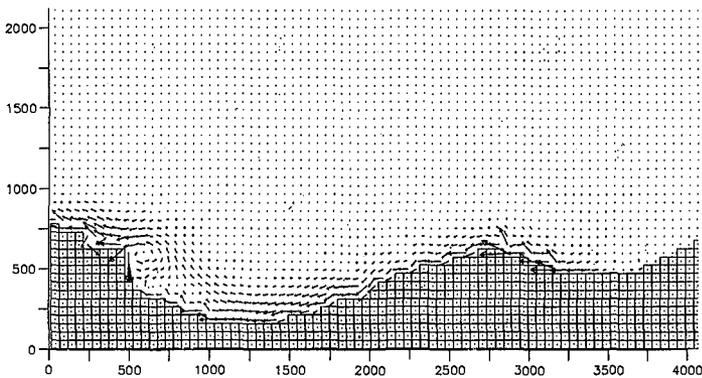
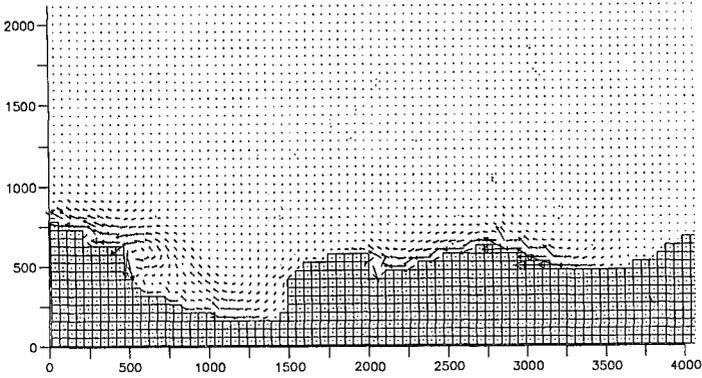
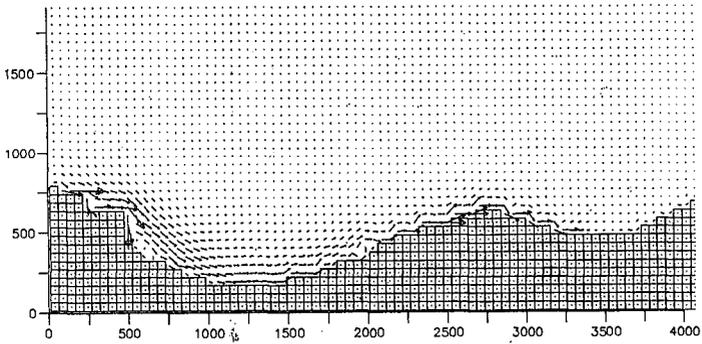
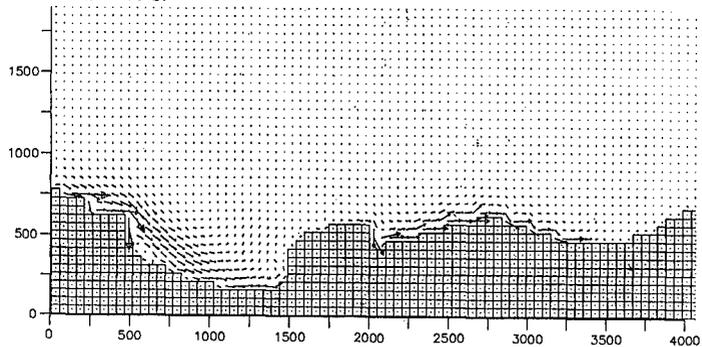
Figure 5.- Wave induced currents before marina construction, $H = 1.0$ m, $\alpha = -45^\circ$, $T = 10$ s.

Figure 6.- Wave induced currents after marina construction, $H = 1.0$ m, $\alpha = -45^\circ$,
 $T = 10$ s.

Figure 7.- Wave induced currents before marina construction, $H = 1.0$ m, $\alpha = +45^\circ$,
 $T = 10$ s.

Figure 8.- Wave induced currents after marina construction, $H = 1.0$ m, $\alpha = +45^\circ$,
 $T = 10$ s.

It can be seen that the breaking wave induced currents direction decrease in the boundary of marina. It means that the sand in the west part of the marina is retained and accumulates in this area. The storms from the Southeast transport the sand to this area and the storms from the Southwest part can not return the sand to the beach, the dynamics in the area change the behaviour of the beach. Figures 9 and 10 shows the qualitative behaviour of the beach before and after the marina construction deduced from the wave climate models.

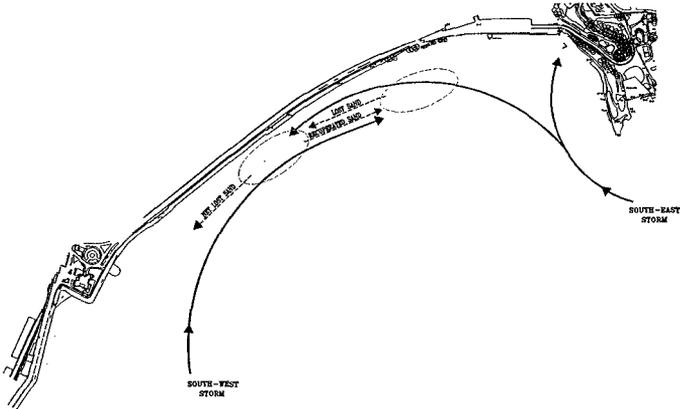
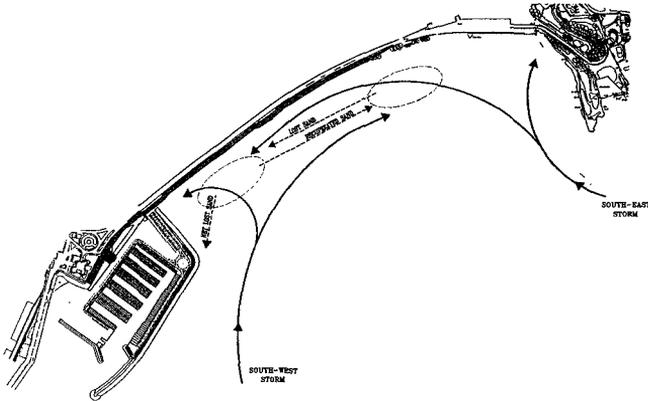
Figure 9.- Beach analysis before marina construction.

Figure 10.- Beach analysis after marina construction.

The recuperated sand, from the Southwest storms is minor after the marina construction than before, this sand is accumulated on the shadow area of the marina.

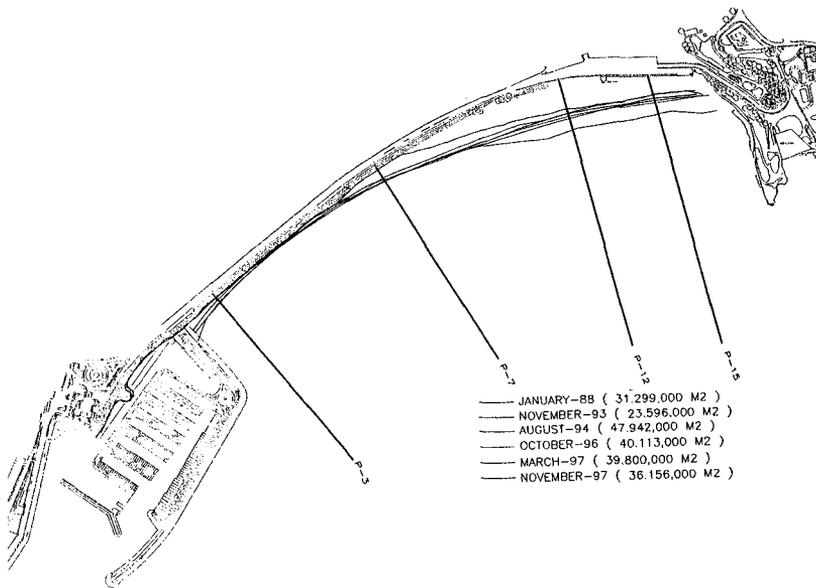
Figure 11 shows shoreline evolution taken from the most representative topobathymetric surveys, it is shown five shoreline position (jun-86, jan-88, nov-93, aug-94, mar-97) from the twelve it were taken. They represent the most significant date on beach behaviour the first one in before the first nourishment work, the second is after this works, the third is before the second nourishment works, the forth is after this works and before the marina construction and the fifth is after marina construction.

Figure 11.- Shoreline evolution from jun-86 to nov-97

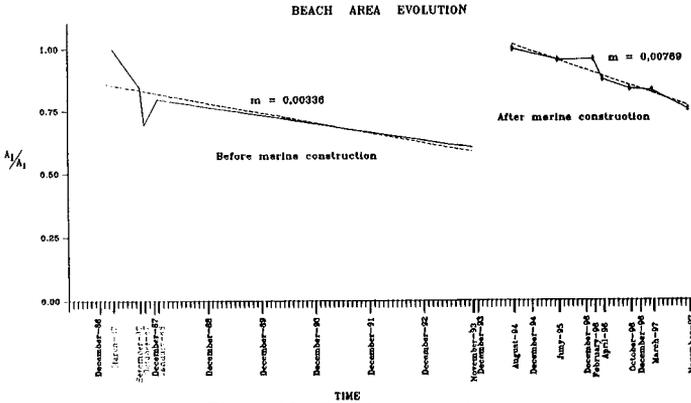
In Figure 12 the analysis of beach area evolution is made. It is compared the relation between the relation A_i / A_1 , where A_i is the area corresponding to the i topobathymetric survey and A_1 is the corresponding to the post nourishment work, to the time. The figure shows the evolution before and after marina

construction, A_1 in the first case correspond to march-87 and in the second case august-94. It can be inferred from this that comparing the graphic the medium slope is bigger after than before marina construction. It means that the erosion ratio, in El Milagro Beach, has been increasing since marina construction. A new beach appeared on the protected marina area, it is difficult to infer from the actual data about its stability, some consideration to profile slope must be considered in this analysis. The longshore transport calculated according with the field data surveys of the monitoring programs changes from 13.000 m³ before marina construction to 24.000 m³ after marina construction.

Figure 12.- Beach area evolution.

The erosion ratio after marina construction is greater than before, $24.000 \text{ m}^3/\text{year}$ and $13.000 \text{ m}^3/\text{year}$ are the respectively values calculated with the field surveys data from the monitoring programs.

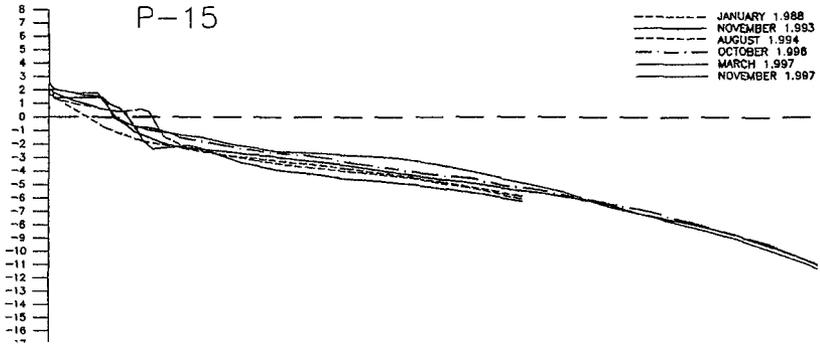
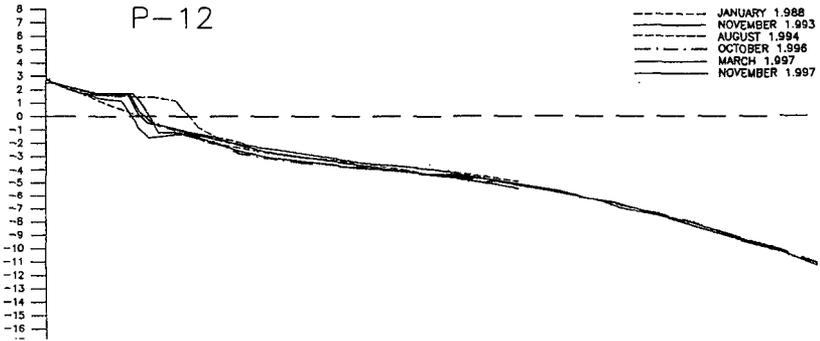
profiles the shoreline has an accretion compared with pre-nourishment shoreline, november-93, but the survey that was made in march-97 an erosion phenomena occurs in both in P-15 shoreline rise more than the situation in November-93 and in profile P-12 was in front of it. It means that the shoreline position is changing decreasing at the east part and accreting at the west.

Figure 14.- Profile 15 evolution.

Figure 15.- Profile 12 evolution.

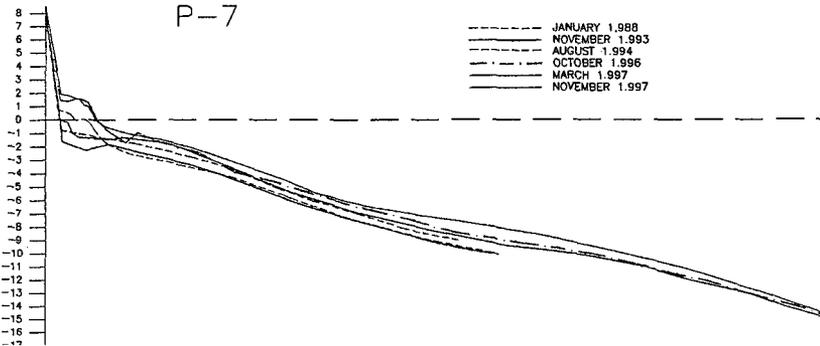
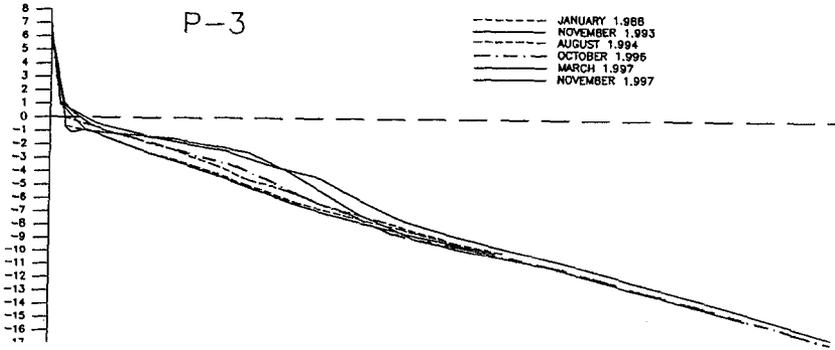
The analysis of P-7 and P-3, Figure 16 and 17, show the sand accumulation that occurs in this area this phenomena is especially important on P-3. In this point sand accumulation is really significant, but the profile form with borrowed sand is not compatible with the natural bottom. It appears two peaks in the profile that broke the equilibrium profile, and the sand is lost on the foot of the profile.

Figure 16.- Profile 7 evolution

Figure 17.- Profile 3 evolution

On the west part of the beach, close to the new marina, beach profile is milder than natural profile. In these area beach profile is not stable because of different bottom slope of natural beach and the profile formed by the borrowed sand. On the west part beach wide is decreasing.

- . The difference on beach slope, from 2% on the east side to 4% on the west side, has a lot of incidence on beach stability.
- . The erosion ratio is greater after than before marina construction.
- . The beach is not stable on the west side. Several alternatives must be studied in order to guarantee beach stability.
