TSUNAMI DAMAGES OF NAKOSO COAST DUE TO THE 2011 TOHOKU TSUNAMI

A post-2011 Tohoku earthquake tsunami survey was conducted at the Nakoso Coast, Fukushima Prefecture, Japan, on Mar 24-25 and Apr 1-2, 2011. Spatial distribution of the tsunami inundation height, together with the seawall height and damages, was investigated. We found a sharp contrast of tsunami damages within the target area; tsunami damage is the most serious in the north region (north of the Samegawa River) where seawalls with different heights played diverse roles for protection of local community. A relatively high seawall in this region kept intact after tsunami attack, and protected the lee side human properties; whereas, 71% of the low seawalls were broken during the tsunami and the disaster developed in the corresponding sheltered area. A sharp contrast at the boundary of these two types of seawalls was observed. Behind the high seawall, the tsunami intensity and velocity were significantly reduced and the inundation depth is only 0.6 m. Nevertheless, tsunami intensity was enhanced in the seawall-broken area with an inland inundation depth being 4.7 m, which ruins away the local houses. In the middle region be

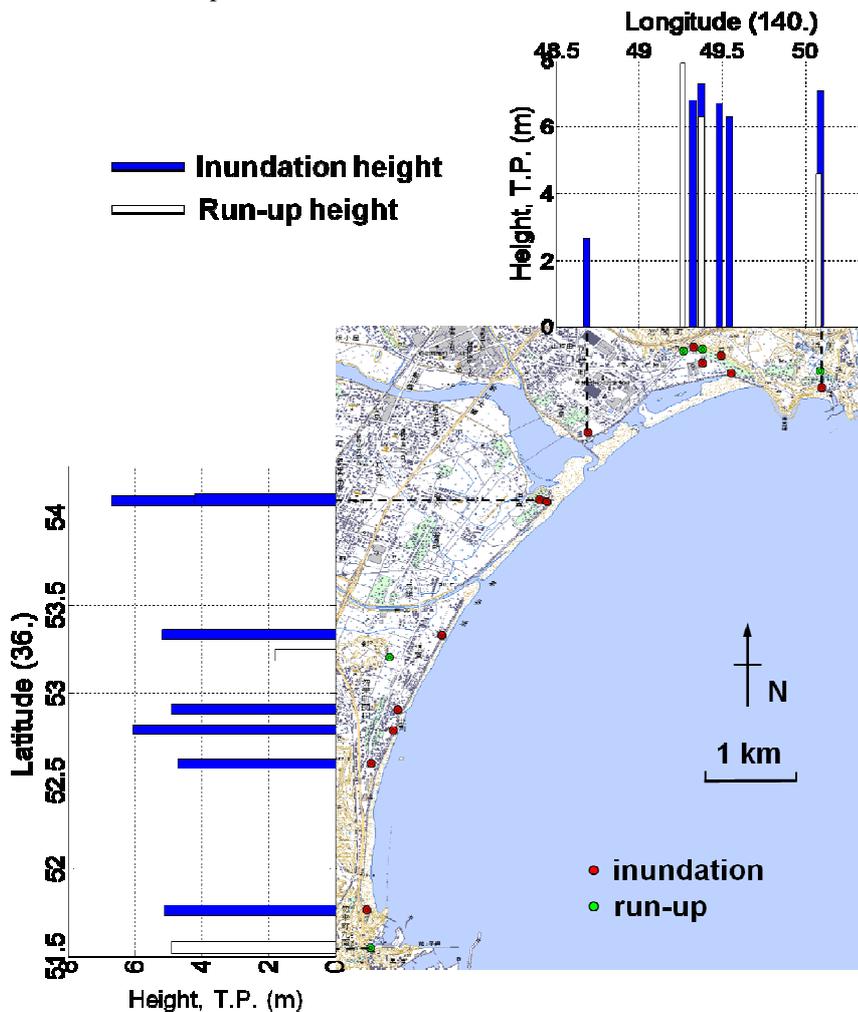
Figure 2 illustrates the height of watermarks. The blue bar indicates inundation height and the white bar denotes run-up height. Tsunami heights near the shoreline are found to be 6 to 7 m T.P. except for smaller tsunami observed in the southernmost region. The smaller tsunami height in the south region is considered to be due to the sheltering effect due to the Cape Unoko and breakwaters of two fishery harbours located at the Cape Unoko.

Figure 2. Distribution of tsunami watermark heights in the Nakoso Coast; The inundation height is 6 to 7 m except in the south region.

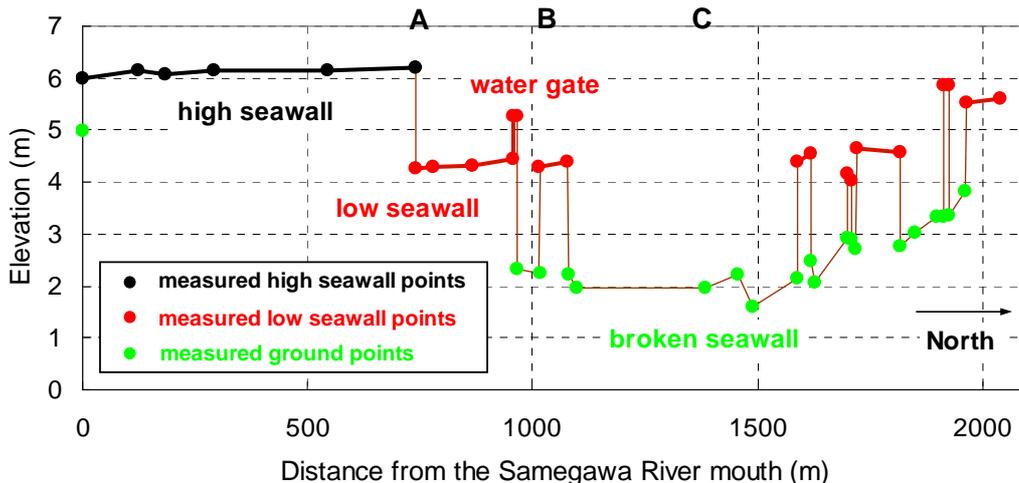
was collapsed. The measured spatial distribution of the post-tsunami seawall elevation in this region, starting from the Samegawa River mouth to the north, is demonstrated in Fig. 3. It is found the ground elevation is 5 m at the river mouth, which represents the Samegawa River bank height. Considering that the seawall height over here is 6 m, the relative seawall height is only 1 m. Moving north, the top of the seawall keeps the same height whereas the ground elevation decreases to 2.5 m. Figure 4 shows the seawall in the Ooshima District. Although the ground level of the Ooshima District is as low as +2m T.P. and the tsunami overflowed the 6m seawall, the damage was found to be insignificant. In this region, the seawall height was raised to the present 6 m after the overtopping of the high wave in 1950's. Figure 5 shows a typical damage behind the seawall. Although the parapet of the seawall remained intact there, some part of the concrete apron on the land side was broken with nearby land scoured by the overflowed tsunami.

At the location "A" in Fig. 3, the seawall height suddenly drops from 6 m to 4.2 m. This is considered to be due to the presence of barrier sand bar in front of the north part of the beach, which damps the height of storm waves. Figure 6 (A) shows a panorama image taken at this location. Regarding to the status of pine trees, steel fence and pipeline on the rear side, it is easy to confirm the different performance of seawalls: behind the 6 m seawall, most local properties were conserved; on the contrary, significant damage developed on the lee side of the 4.2 m seawall with pine trees, fence and pipeline being ruined away. Further going north beyond the water gate, some seawall was broken and moved landward by the tsunami. The panorama photo Figure 6 (B) taken at location "B" in Fig. 3 presents the local situation there. Since the highest water level due to the tsunami at the seawall is more or less 7m as we confirm in Fig. 2, it is considered that the criterion of the seawall collapse is in between 1m and 2.8m by the overflow depth. In this area, the relative seawall height keeps around 2 m with the ground elevation being around 2 m. At location between 1,100 m and 1,600 m (in the vicinity of point "C" in Fig. 3), all seawalls were broken as revealed from Figure 6 (C). Some seawall blocks were even pushed across the road, and stay far away inland as shown in Figure 7. During the field survey, we found one broken seawall block lying on the ground 35 m landward from its original location. This concrete block has a dimension of 0.5(upper boundary) \times 1.7(lower boundary) \times 2(height) \times 10 m (length) with an estimated mass of approximate 53 ton, which vividly demonstrates the great power of the tsunami attack. At location 1,500 m north from the river mouth, it is found the ground elevation increases to 4 m at the north end as it approaches to the Cape Ryuugu. Correspondingly, the absolute seawall height increases to 5.6 m finally. Nevertheless, the relative seawall height decreases to 1.6 m at the end. Collapse of seawall is intermittent in this section which induced different damages to the backside community.

Figure 3. Spatial distribution of the post-tsunami seawall I and ground elevation on the north of Nakoso coast; The seawall height was discontinuous at Point A. Most of the lower seawall was broken.

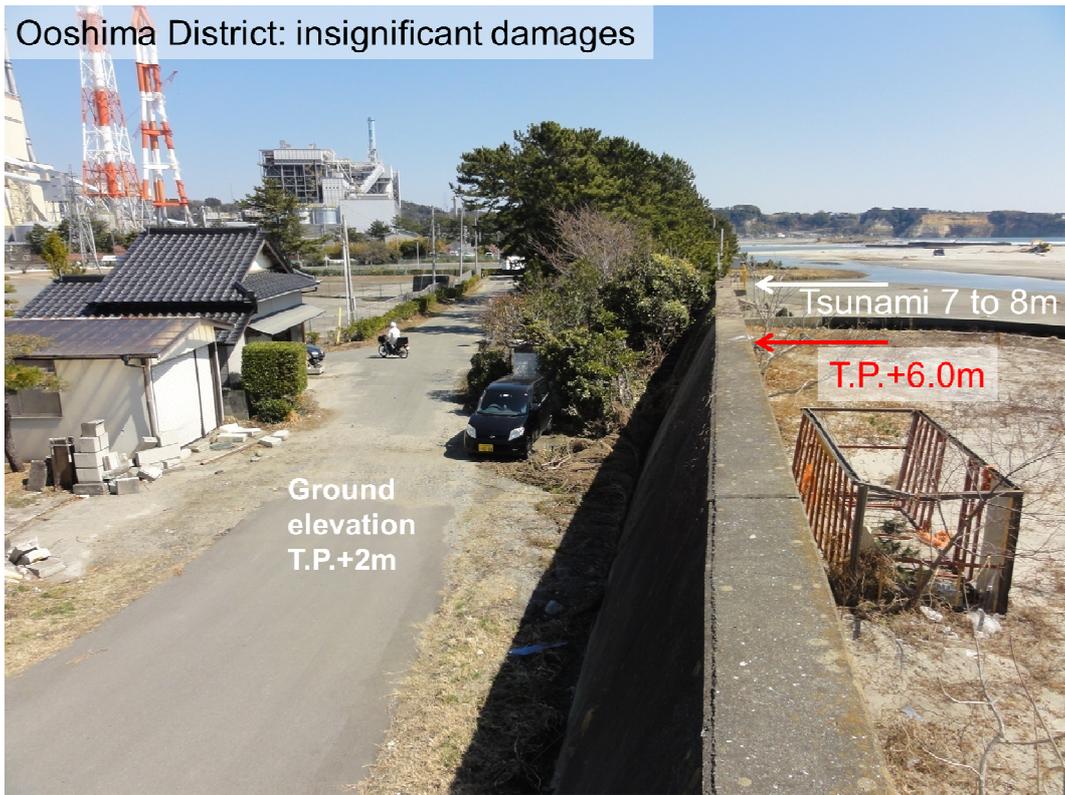
Figure 4. Insignificant damage behind a high seawall in Ooshima District. (March 25, 2011)

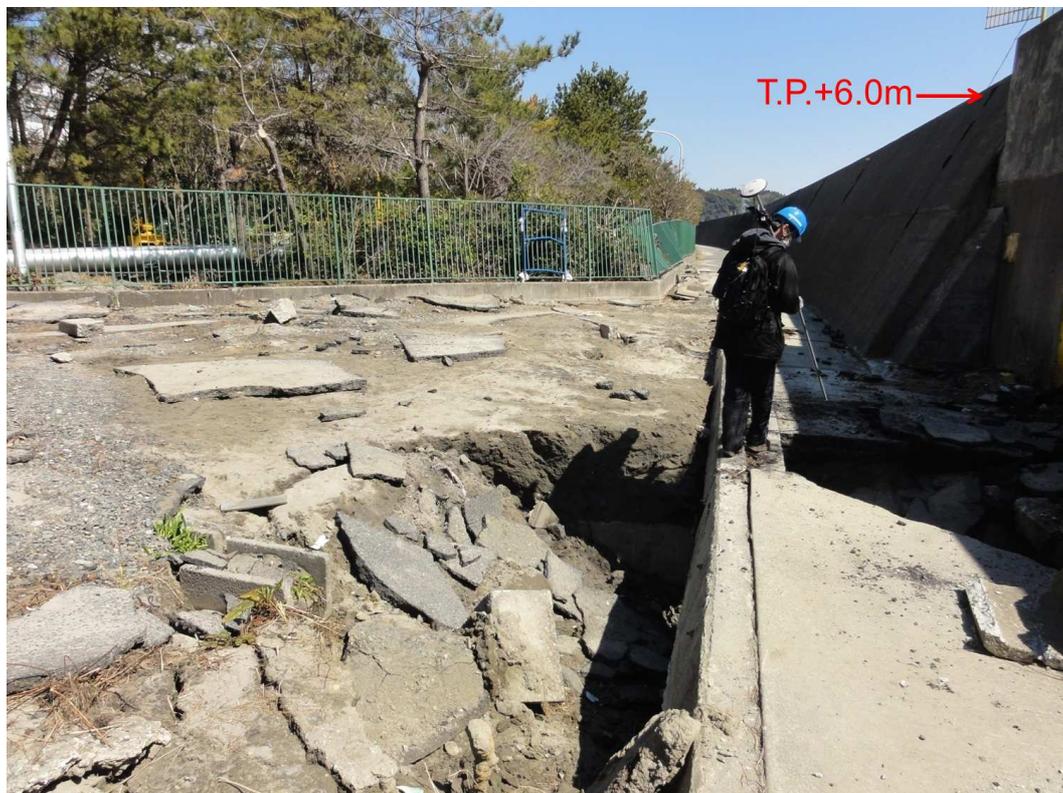
Figure 5. Intact parapet, apron concrete broken and land scoured by overflowed tsunami in Power Plant District. (March 25, 2011)

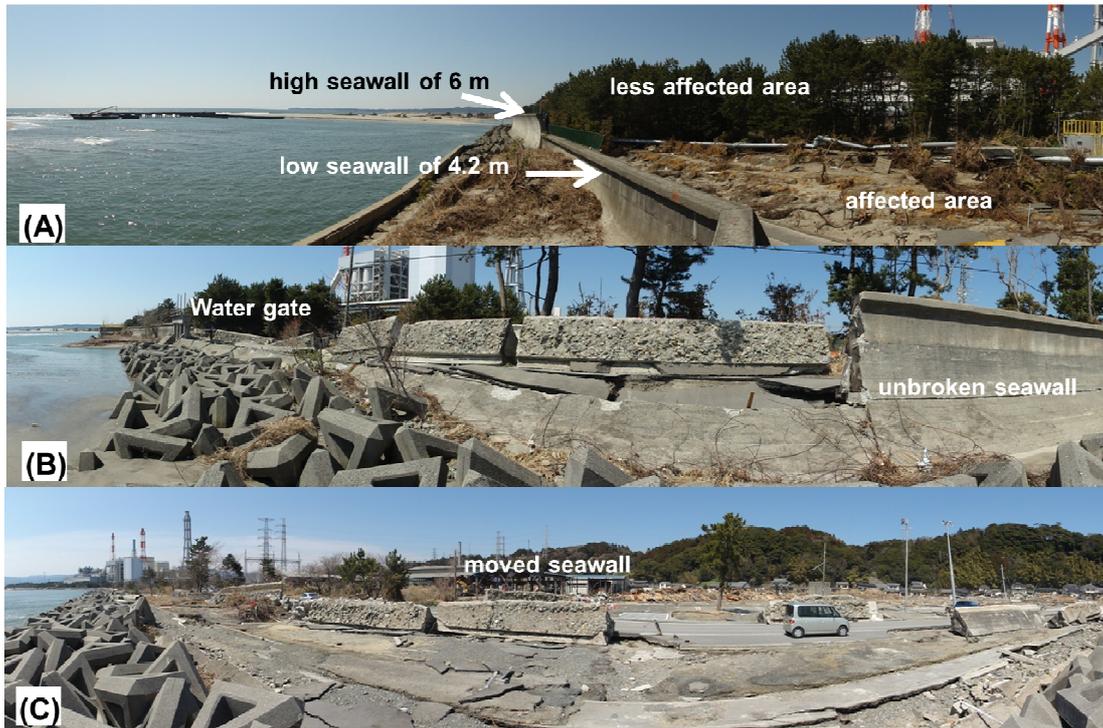
Figure 6. Panorama images taken at three specified locations (March 25, 2011, A, B and C indicated in Fig. 3)

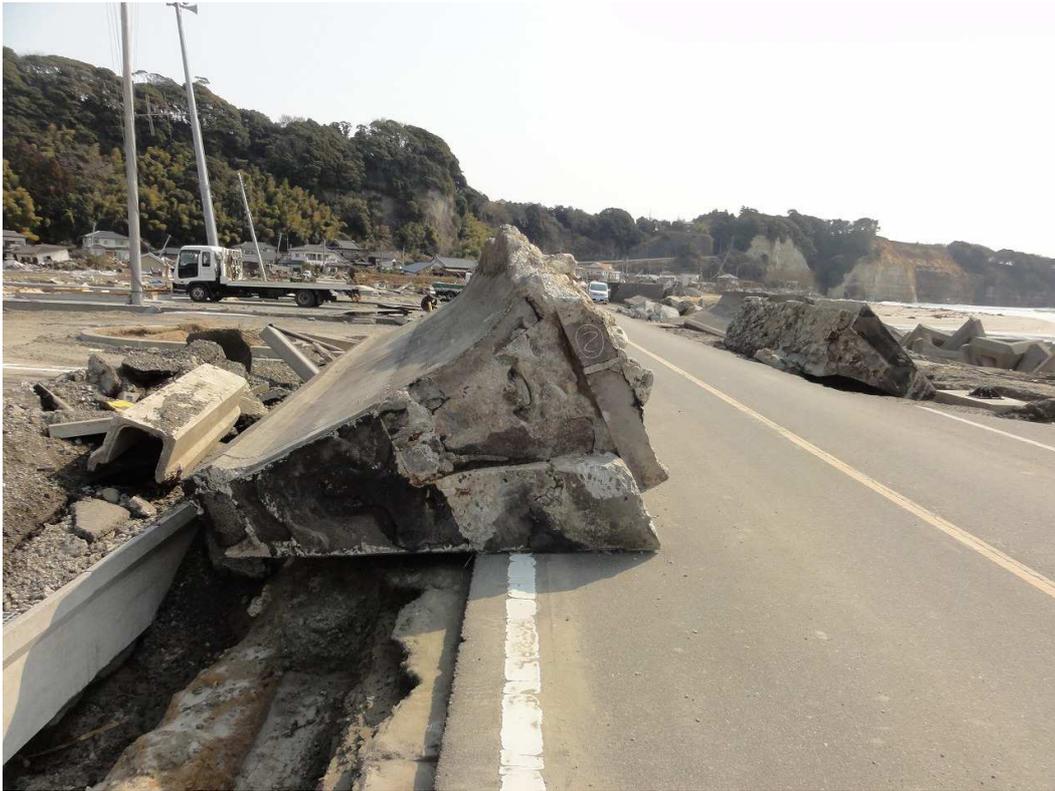
Figure 7. Broken and moved parapet of a seawall in Iwama District (March 25, 2011)

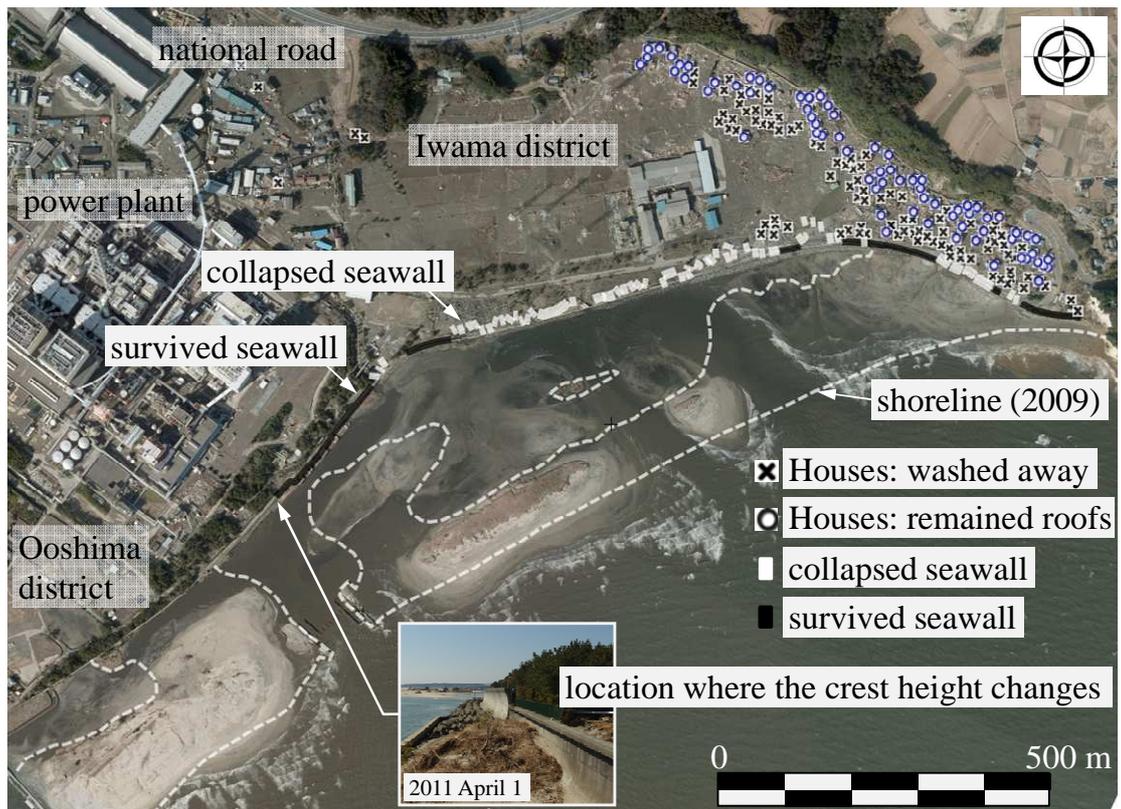
Figure 8 describes tsunami damages to houses and seawalls in the area north to the Samegawa River mouth. Damages were identified by the comparison of two aerial photos taken by Geographical Information Authority of Japan, on March 12, 2011 and in 2009. Houses were marked as ‘washed away’ when the roof disappeared after tsunami at the original location found in the 2009 photo. The concrete blocks of the seawalls are denoted by white rectangles where they are found broken. The change in the shape of barrier sand bar located seaside of the seawall was also illustrated in the figure. The change in the shape of the barrier sand bar indicates that the barrier sand bar was deformed in the region where seawalls were broken severely. The barrier sand bar in front of the Ooshima District remained un-deformed. This is considered to be due to the concentration of tsunami return flow. Due to the difference in the spatial slope of the water surface, tsunami up-rush would overflow the seawall almost uniform in a relatively short time, on the other hand, receding tsunami would tend to concentrate to the area with low elevation or to the river mouth in relatively long durations. The monitoring of the recovery of the barrier sand bar is important since the presence of the barrier sand bar is essential to the run-up of storm waves and thus influential to the height of seawall .

Figure 8. Tsunami damage in Iwama District, presenting disappeared houses, collapsed seawall and deformed barrier sand bar; Most of the houses were washed away in the Iwama District. Broken seawall block was transported inland.

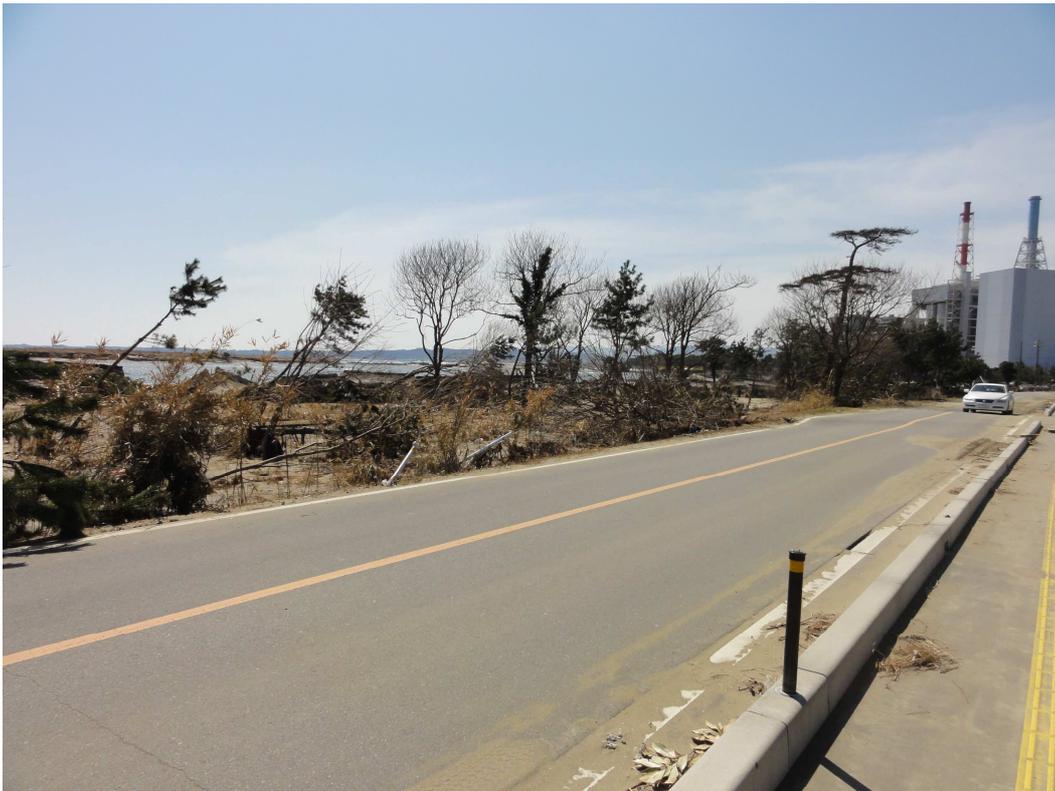
According to the testimony of local residents in the Iwama District who observed tsunami during their evacuation, the first and the second tsunami overflowed the seawall and flowed to the south, that is, to the direction of the Power Plant. The third tsunami, however, came from the south and washed away the northern residential area. This is consistent with our survey in which we found road signs and electricity poles were mostly bent to the south as shown in Figure 9. This is also consistent with the video clip taken from the top of a building in the Power Plant.

Figure 9. Fallen trees and road signs, representing the southward flow of the tsunami (March 25, 2011)

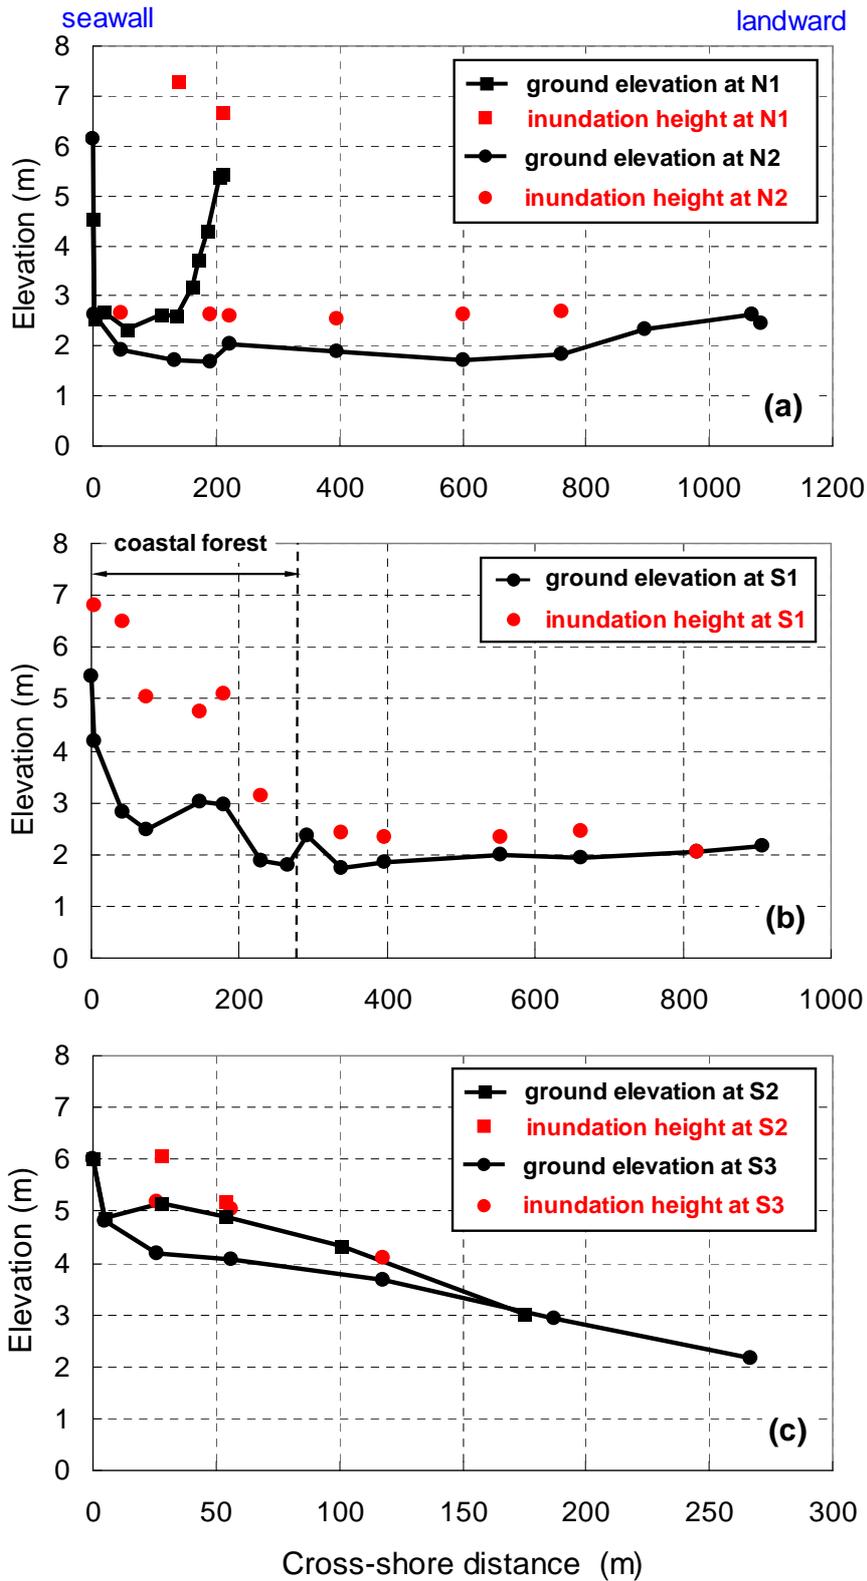
Figure 10(a) presents the cross-shore distribution of the ground elevation and tsunami inundation height at survey lines N1 and N2. Along the line N1, the seawall has a height of 4.5 m and the nearby ground elevation is 2.5 m. Moving to the landward direction, the ground elevation gradually increases. At location 210 m, the ground elevation is 5.4 m, about 3 m higher than the ground level at the seawall. The measured inundation height is 7.3 m (4.7 m above the local ground level) at location 137 m. In the vicinity of broken seawall, the inundation height is only about 6.3 m as is confirmed in Figure 2. At the same time, tsunami inundation height is 6.7 m at location 210 m. Therefore, the following scenario can be drawn from Fig. 10(a) with respect to line N1: After tsunami passed through the seawall, the tsunami height increases by 1 m within a cross-shore distance of 150 m owing to the run-up motion on the sloping topography (high tsunami velocity can be estimated since over here, most of the houses were washed away). Subsequently, inundation height decreases by 0.6 m from 150 m to 210 m. This is ascribed to the fact that tsunami wave may have lost its energy due to the significant bottom friction by the presence of dense houses.

Along line N2, the local seawall has a height of 6.2 m and the nearby ground elevation is 2.6 m. Moving to the landward, there is no significant change on the ground elevation with a certain decrease by 1 m just after the seawall. Considering the inundation height, it is around 2.6 m for all measured points (the inundation depth is approximate 0.6 m). Confirmed from the local residents, although the overflowed tsunami inundated the residential area, the tsunami intensity/velocity was significantly mitigated/reduced because of the protection of the high seawall. Therefore, the damage to the local houses is fairly mild. Increase of the water level in this district is assumed to be inch by inch and spatially uniform. However, the inundated area is large here, which covers more than 1 km landward of the seawall, whereas due to the steep slope of the land topography, the final tsunami run-up at line N1 is only about 330 m away from the seawall.

Figure 10. Cross-shore distribution of ground elevation and tsunami inundation height at survey lines N1 & N2 (a), S1 (b) and S2 & S3 (c).

Figure 10(b) illustrates the cross-shore distribution of the ground elevation and tsunami inundation height at the survey line S1, which crosses the coastal forest zone as demonstrated in Fig. 13. The local seawall has a height of 5.5 m whereas the nearby ground elevation is 4.2 m (the relative seawall height is 1.3 m). Moving landward up to the 260 m location, the ground elevation decreases to 1.8 m. At the same time, the tsunami inundation height also drops significantly in this region, *i.e.*, from 6.8 m near the seawall to 3 m at the 230 m location. The function of coastal forest as a buffer zone against the tsunami attack, which increases the friction, is obviously demonstrated in this figure. Further beyond, the ground level keeps around 2 m and the corresponding inundation depth is 0.5 m. During the field survey, we confirmed that the damage in this area was minor which indicates the tsunami velocity in this area is also small due to the reduction of tsunami intensity from the coastal forest. The most inland run-up location was found at location 820 m from the seawall.

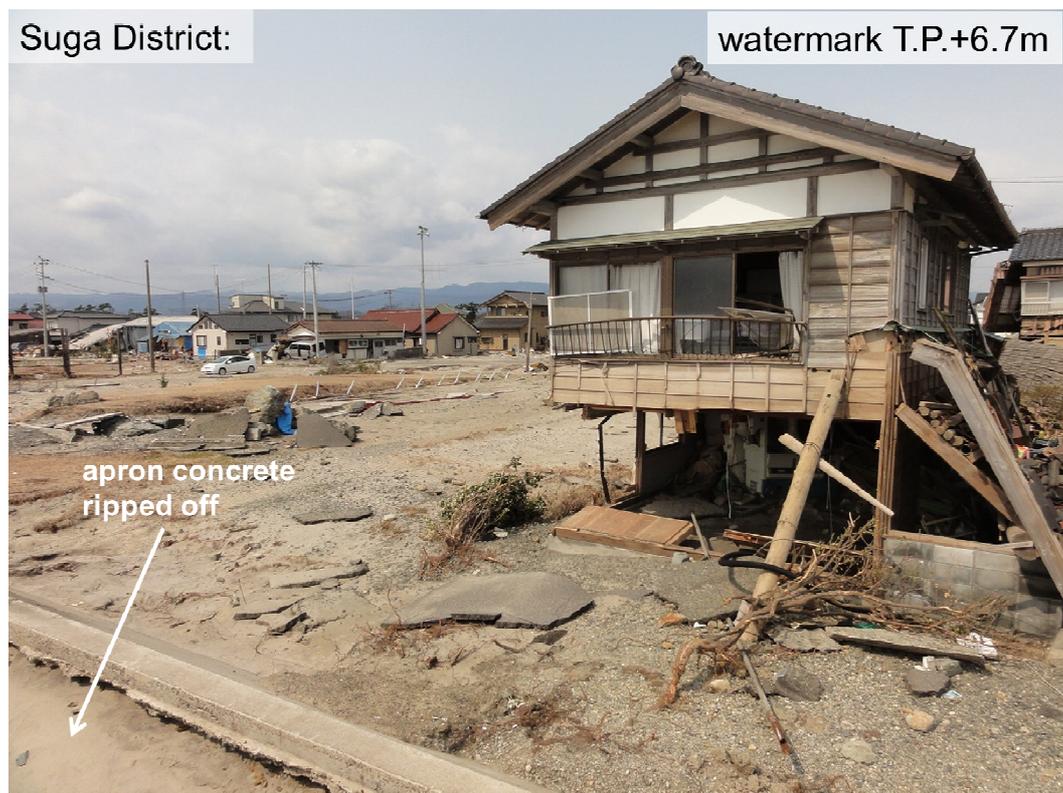
In this coastal region, only the north part is covered by the human community and the remaining is the coastal forest zone as shown by the shadow area in Fig. 1. As for this area, the whole seawall, *i.e.*, Seawall II with a height of 5.5 m, survived from the tsunami attack although certain overflow occurred. Figure 11 shows damage to a house in Suga District, where watermark was found at the ceiling of the first floor, at the height of 6.7m T.P.

Figure 11. Broken seawall and a house in Suga District. (March 25, 2011)

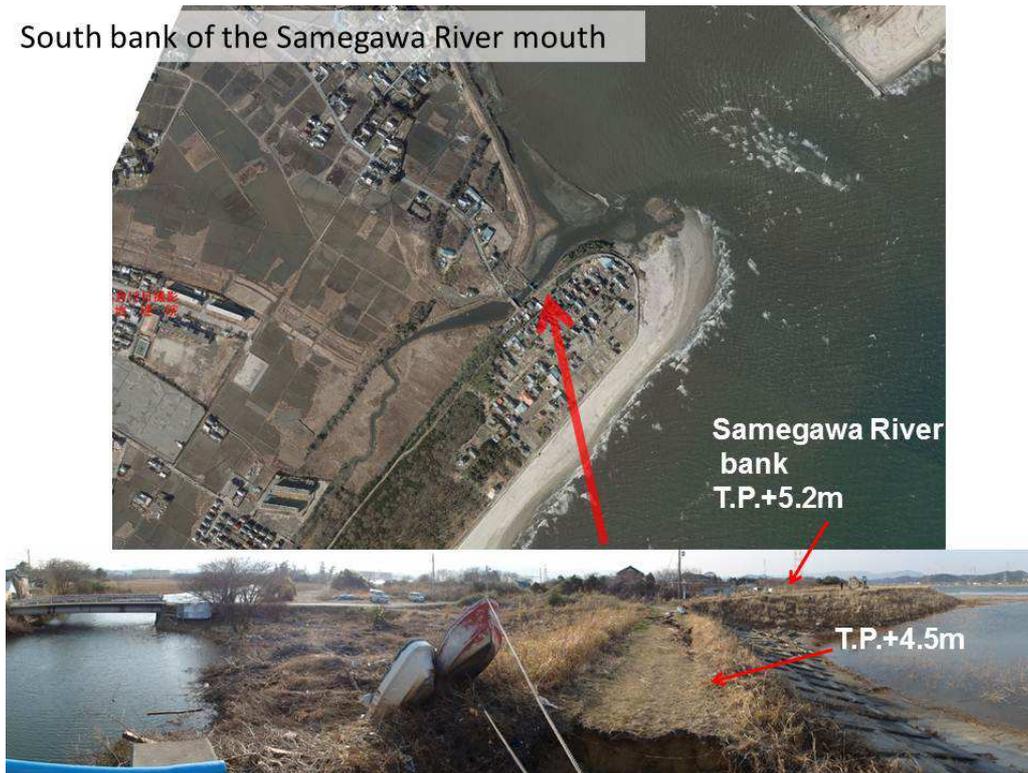
In the field survey, we found that the tsunami flooding was developed at the junction between the river bank and the seawall. Figure 12 shows a typical location where tsunami overflowed the river bank. The reason appeared to be due to the difference in structural type, that is, river bank is basically soil embankment partly covered with concrete plates on the riverside while seawall is covered with concrete plates on the three sides, *i.e.*, seaside, landside and top.

Figure 12. Inundation from broken river bank connected to intact seawall. (April 1, 2011)

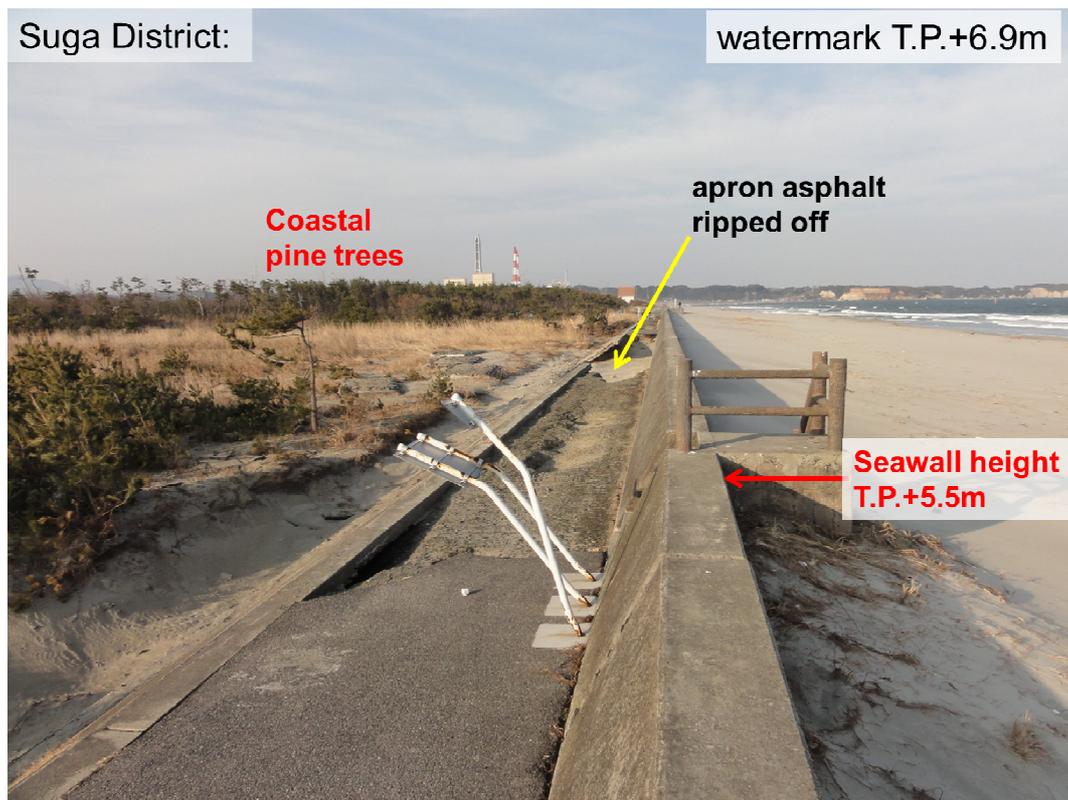
Figure 13. Partially broken seawall and coastal pine trees in Suga District. (April 1, 2011)

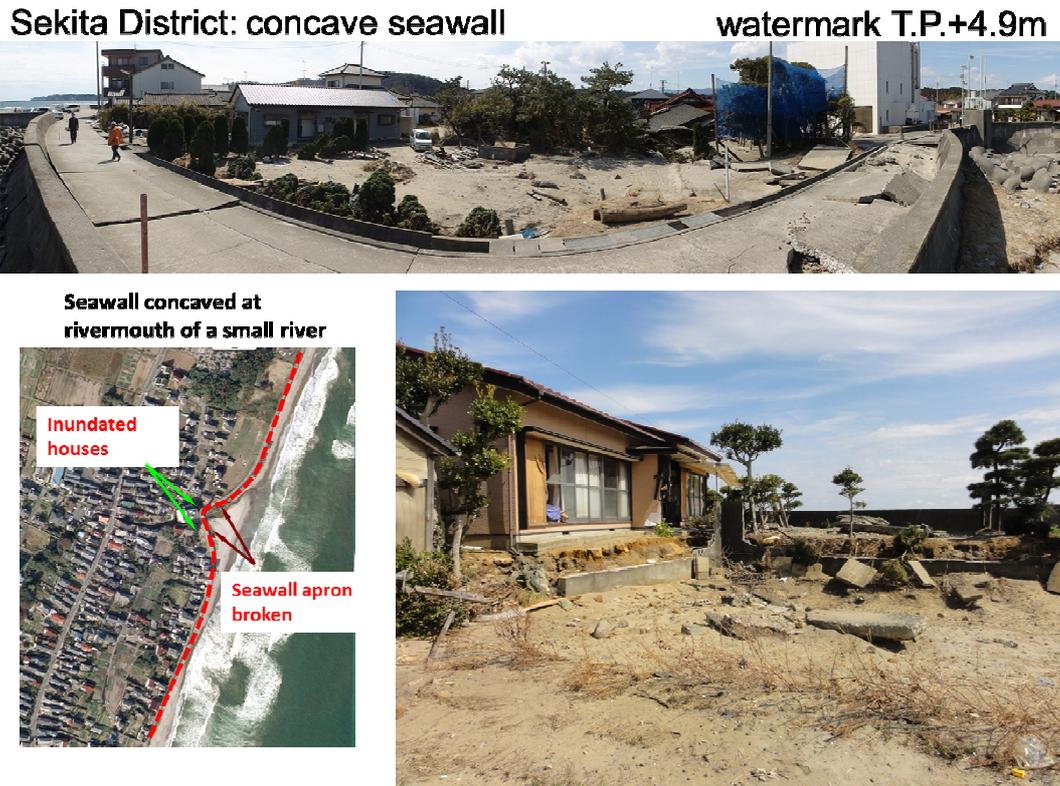
Figure 14 illustrates a location where exceptional tsunami damage was observed in this region. It is a location where the seawall was curved concave to the sea, at the river mouth of a small river. The concaved seawall appeared to concentrate the tsunami energy at the river mouth, where the apron concrete of the seawall was broken and houses located behind the seawall were affected by overflowed tsunami. The watermark was measured at 4.9m T.P.

Figure 14. Damage concentrated to a concave seawall in Sekita District. (March 24, 2011)
