MECHANISMS OF COASTAL DIKE FAILURE INDUCED BY THE GREAT EAST JAPAN EARTHQUAKE TSUNAMI

Fuminori Kato¹, Yoshio Suwa¹, Kunihiro Watanabe¹ and Satoshi Hatogai¹

Based on the results of field surveys, coastal dike failures caused by the Great East Japan Earthquake were classified into eight patterns. The results of hydraulic model experiments related to major failure patterns reinforced the proposed failure processes. In addition, the aggregated length of each failure pattern showed that failure from scouring at the landward toe is the dominant failure pattern.

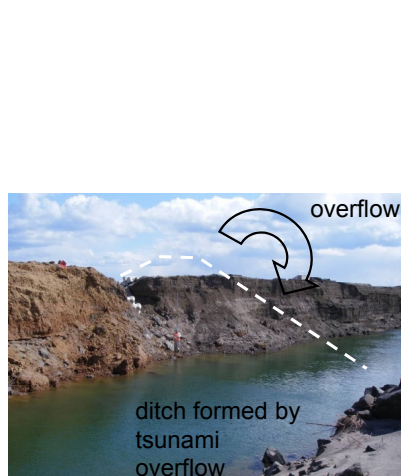
The landward toe of the coastal dike was scoured in many areas where the dike or seawall was not completely washed away. For example, as shown in Fig. 3, a ditch had formed on the landward side of the coastal dike, stretching in the longshore direction on Kabasaki Coast, Miyagi Prefecture. Kato et al. (2012) also showed some examples in Iwate Prefecture where tsunami runup induced scouring at the landward toe, resulting in the destruction of landward armor and the dike body.

Figure 3. Ditch formed by tsunami overflow (Kabasaki Coast, Miyagi Prefecture).

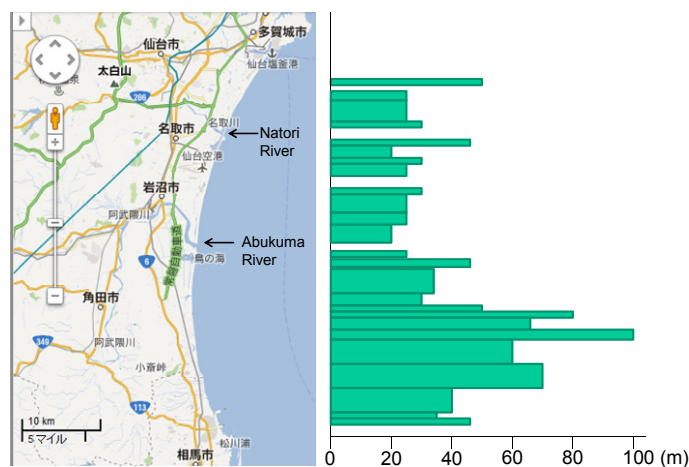
Figure 4 shows the average scour width on the landward side of coastal dikes in the southern part of the Sendai Plain, Miyagi Prefecture. Scour width was measured based on data obtained by airborne laser scanner after the earthquake. Along the sandy coast of about 40 km long, the scour width was about 30 m on average. A relatively large scour width was observed in the southern part where the proportion of completely failed coastal dikes was higher.

Figure 4. Longshore distribution of average scour width in the southern part of the Sendai Plain.

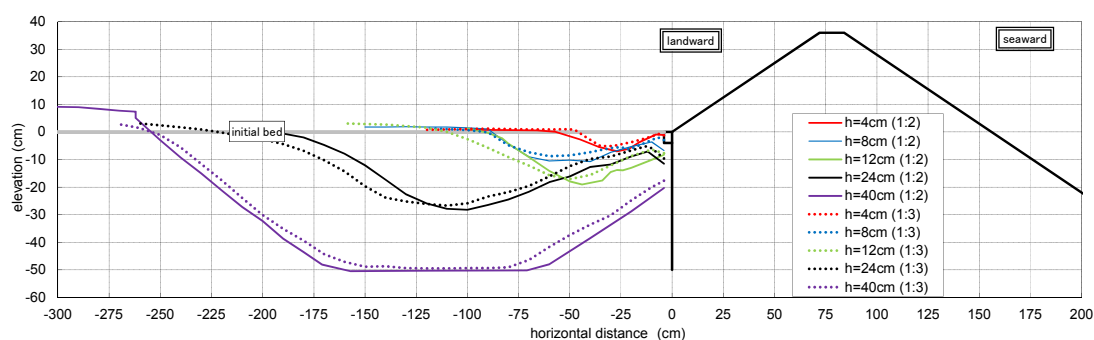
The results of the hydraulic model experiments helped us to understand the scouring process at the landward toe of the coastal dikes. Figure 5 shows the cross-sectional shape of the sandy bed landward of the coastal dike after two minutes of overflow in the experimental channel. The discharge was controlled in the upstream to obtain the targeted overflow depth. The height of the model dike was 36 cm, corresponding to a prototype height of 9 m. The grain size of the movable bed landward of the coastal dike was 0.25 mm. The landward slope was 1/2 or 1/3, and the overflow depth h was 4, 8, 12, 24, or 40 cm. The scour depth and scour width tended to increase with overflow depth. Although the

height of the model dike in prototype scale is higher than the coastal dike in the southern part of the Sendai Plain (T.P. 3.6–7.2 m), the scour width of the experiment in the case of $h = 24$ cm (6 m in prototype scale) is roughly the same as the scour width as shown in Fig. 3.

Figure 5. Scouring at the landward toe in hydraulic model experiments.

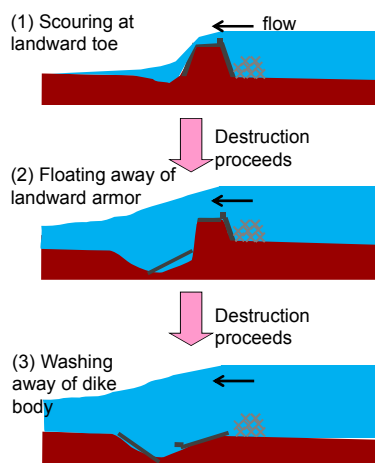
Based on the results of field surveys and physical experiments, the process of failure from scouring at the landward toe can be summarized as shown in Fig. 6. Landward armor of the coastal dike floated away after scouring at the landward toe. With no landward armor, the dike body was easily washed away.

Figure 6. Failure process originating from scouring at landward toe.

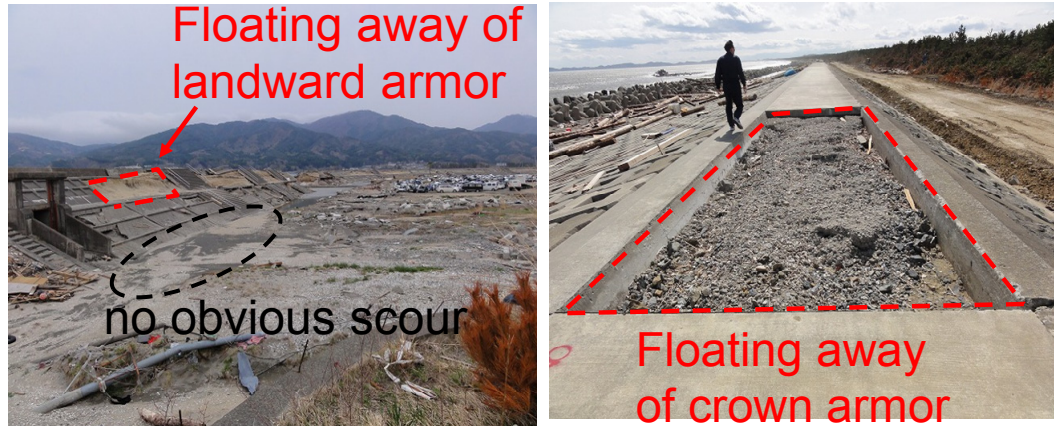
The second pattern is failure from the crown or the top of the landward armor. Failure of the landward slope or crown armor was observed even where the landward toe was not scoured, as shown in Fig. 7. On the Kanahama Coast (left photo in Fig. 7), the upper part of the landward armor floated away, while no obvious scouring was seen on the landward side of the coastal dike. On the Omagari Coast (right photo in Fig. 7), the crown armor was washed away, but there was no damage to the seaward and landward armor.

Figure 7. Examples of failure originating from scouring at landward toe (left: Kanahama Coast, Iwate prefecture; right: Omagari Coast, Miyagi Prefecture).

One of the main factors related to this pattern is negative force acting on the landward armor during tsunami runup. This negative force might be caused by fast flow at the top of the landward slope. Figure 8 shows the cross-shore distribution of water levels and piezometric heads in the physical experiments. The height of the model dike was 24 cm. Overflow depth was 40 cm in the upper figure and 4 cm in the lower figure. At the top of the landward slope, the piezometric head was below the height of the dike surface in both cases, indicating the occurrence of negative pressure.

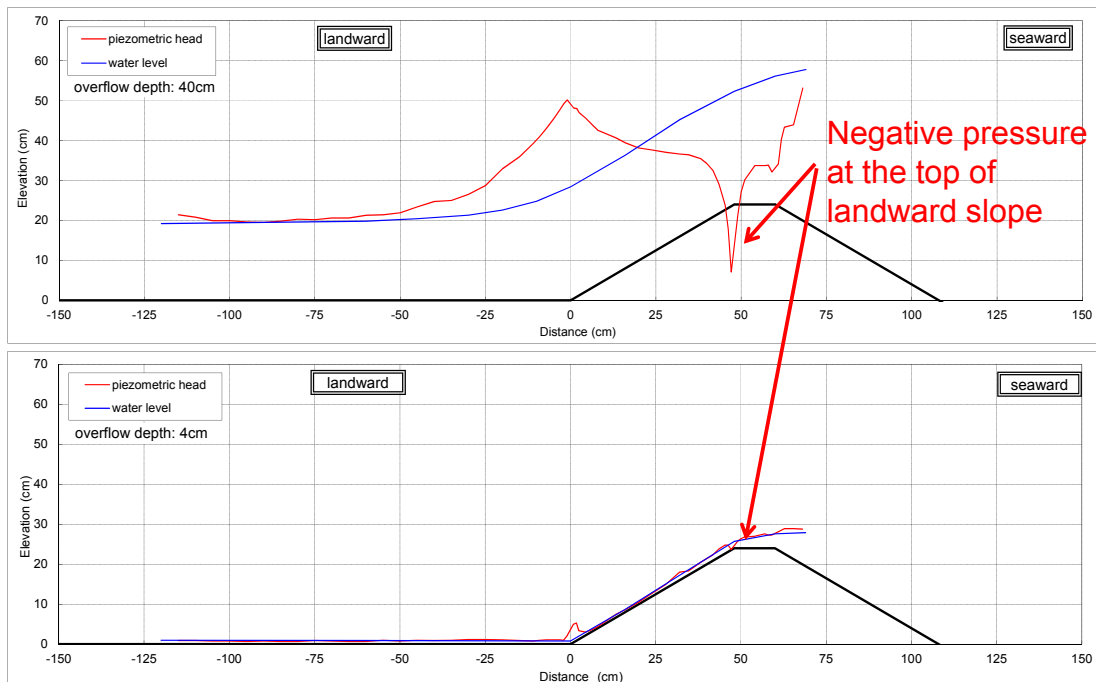
Figure 8. Cross-shore distribution of water levels and piezometric heads at the peak of overflow (left: overflow depth 40 cm; right: overflow depth 4 cm).

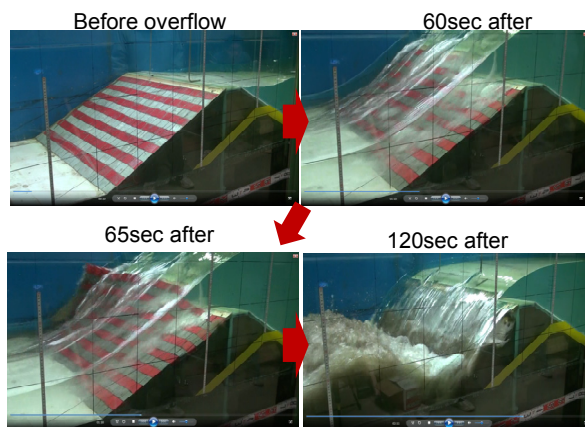
Another experiment also provided useful insight on this failure pattern. Figure 9 shows video images of the physical experiments on landward armor failure. The height of the model dike was 24 cm, and the overflow depth was 40 cm. Landward armor of 2 cm thick was installed on the dike body. At 65 s after the start of the overflow, the landward armor was turned over from the top. The negative pressure at the top of the landward armor affected this failure.

Figure 9. Example of failure from the top of the landward slope (dike height: 36 cm, overflow depth: 40 cm).

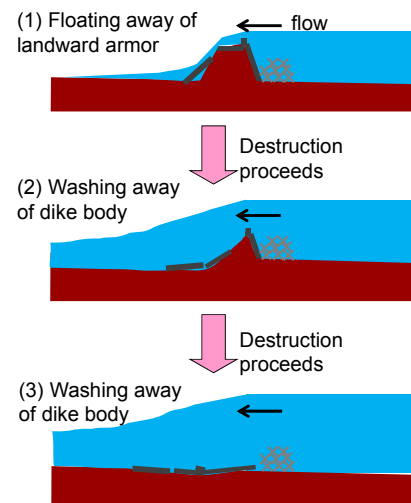
The failure process from the crown or the top of the landward armor can be summarized as shown in Fig. 10. The landward armor or crown armor floated away, which caused the dike body to wash away.

Figure 10. Process of failure from the crown or the top of the landward armor.

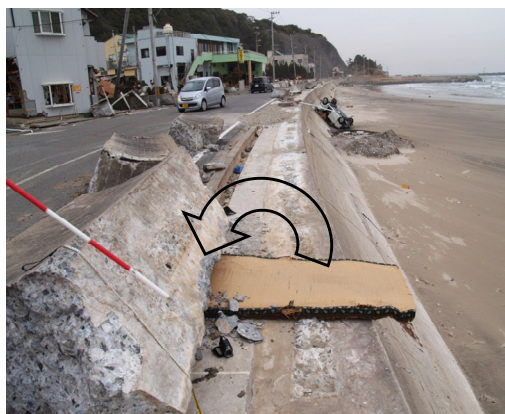
Concrete parapets were installed along the shoreline to mitigate wind-wave overtopping, but some of the parapets were broken by tsunami runup. As shown in Fig. 11, a broken parapet lies landward on the Toyoma Coast where tsunami inundation height was about 11 m, and the parapet height was 5.4 m.

This pattern may occur if shear stress induced by the wave force acting on the parapet during tsunami overtopping is larger than the shear strength of the parapet joints, as shown in Fig. 12.

Figure 11. Parapet failure on Toyoma Coast, Fukushima Prefecture.

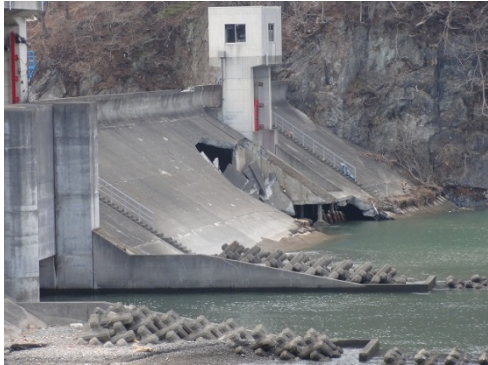
Seaward flow over the coastal dike may cause scouring at the seaward toe of the dike. Although this pattern has already been pointed out in previous studies (e.g., Noguchi et al. 1997), it was also observed in the Great East Japan Earthquake. On the Mizuumi Coast, Iwate Prefecture, the seaward

armor of the coastal dike was broken and the dike body was washed away, as shown in Fig. 13. The failure process can be summarized as shown in Fig. 14. Seaward flow during tsunami drawdown caused scouring at the seaward toe of the coastal dike and revetment. Scouring at the landward toe affected the stability of the seaward armor, resulting in floating away of seaward armor and breaching of the dike.

Figure 13. Failure of seaward armor on Mizuumi Coast, Iwate Prefecture.

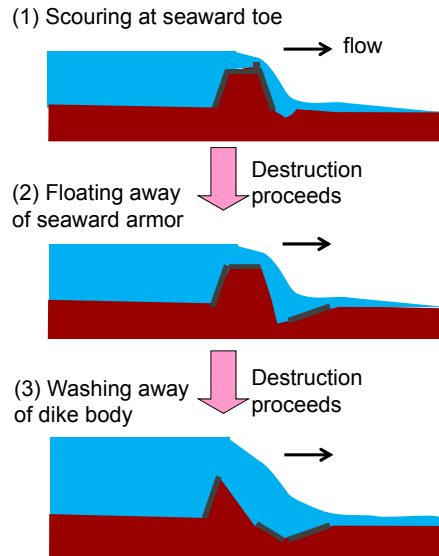
Figure 14. Process of failure from scouring at seaward toe.

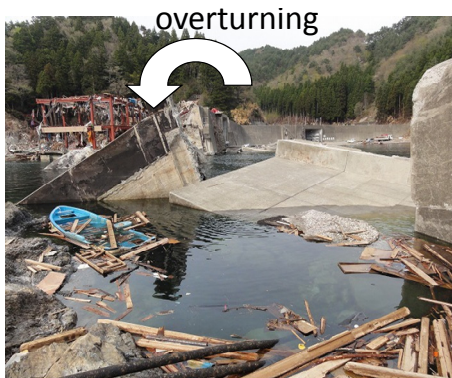
Figure 15 shows overturning of the seawall on the Ryoishi Coast, Iwate Prefecture, where tsunami inundation height was 21 m and the height of the seawall was 9.2 m. This pattern may occur if the overturning moment induced by the wave force on the seawall during tsunami runup or drawdown is larger than the resistance moment due to the weight of the seawall, as shown in Fig. 16.

Figure 15. Overturning of seawall on Ryoishi Coast, Iwate Prefecture.

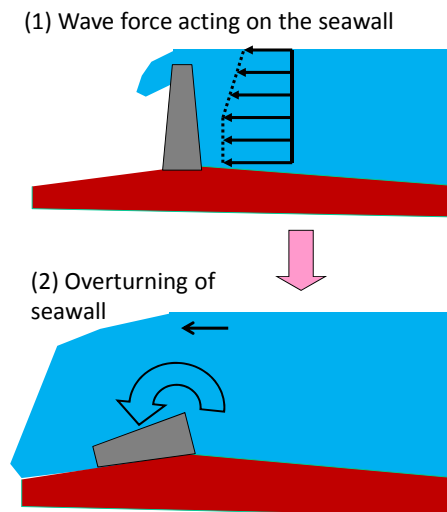
Figure 16. Process of seawall overturning.

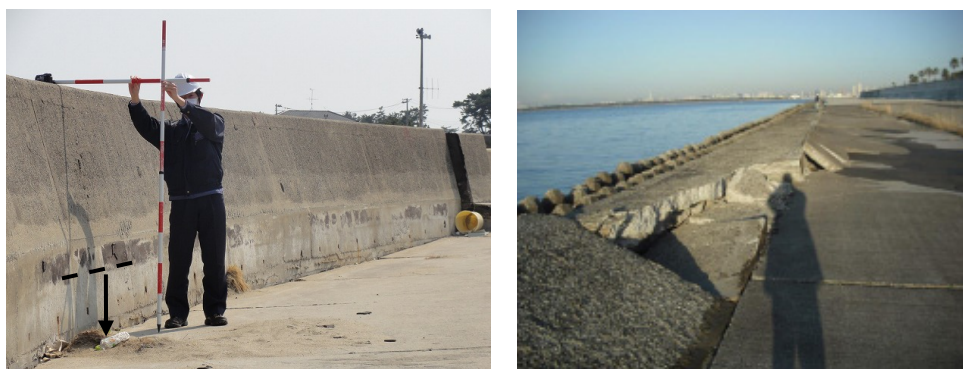
Tsunami was the dominant force for coastal dike failure in the earthquake; however, some coastal dikes and revetments were damaged mainly by seismic motion and ground liquefaction. For example, crown armor on the Yotsukura Coast sank about 40 cm, and a coastal revetment on the Ichikawa Coast was cracked, as shown in Fig. 17. The same type of failure was suspected on the coast along Iwate and Miyagi Prefectures. However, on the coasts where tsunami waves were relatively high, the damage caused by seismic motion would likely be hidden by tsunami damage after the earthquake.

Figure 17. Examples of damage mainly caused by seismic motion (left: Yotsukura Coast, Fukushima Prefecture; right: Ichikawa Coast, Chiba Prefecture).

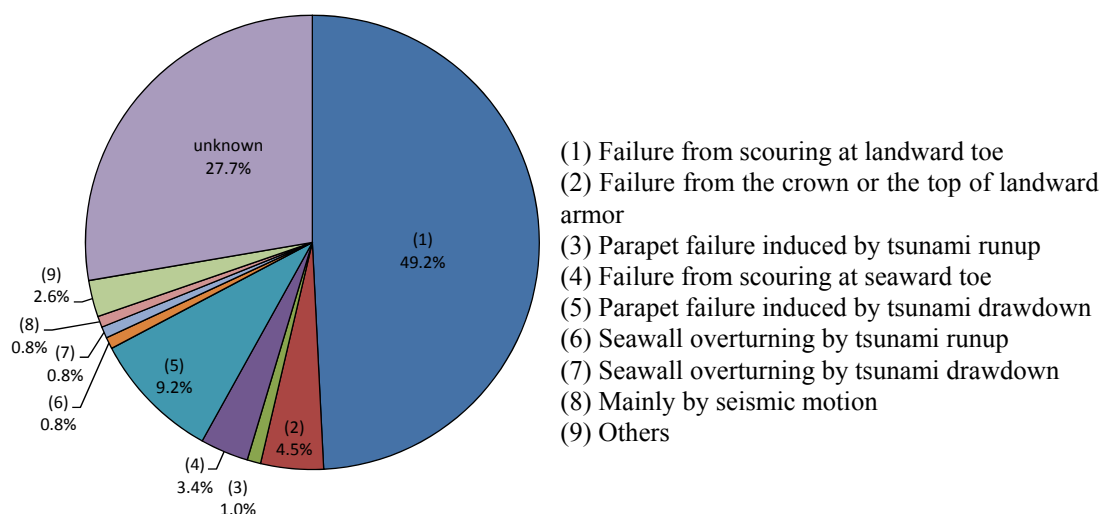
As shown in Fig. 18, failure from scouring at the landward toe is the dominant failure pattern at 49.2%. The proportion of parapet failure induced by tsunami drawdown is relatively large at 9.2%. Failure from the crown or the top of the landward slope and failure from scouring at the seaward slope each accounts for about 4%.

Figure 18. Proportion of each failure pattern along the length of damaged coastal dike.

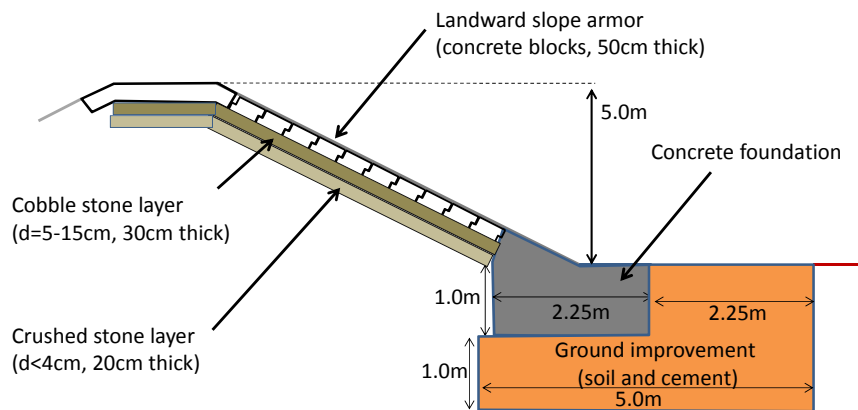
Figure 19. Proposed resilient structures for coastal dike.

Since the height of the coastal dike will be lower than that of the highest-class tsunami, resilience to tsunami overflow is important. Therefore, based on the report, resilient structures for coastal dikes are being studied by research institutes in Japan. We recently released preliminary reports on resilient structures for coastal dikes (River Research Department, National Institute for Land and Infrastructure Management, 2012). As shown in Fig. 19, a large foundation at the landward slope toe and a sequence of blocks with notches on the top and the bottom as landward slope armor were proposed in the reports based on the results of hydraulic experiments and calculations. The proposed structures were examined through large-scale hydraulic model experiments, and have been adopted in restoration works in the southern part of the Sendai Plain.
