DESTRUCTIVE WAVE OVERTOPPING TESTS ON GRASS COVERED LANDWARD SLOPES OF DIKES AND TRANSITIONS TO BERMS

Gosse Jan Steendam¹, Jentsje W. van der Meer², Bianca Hardeman³, André van Hoven⁴

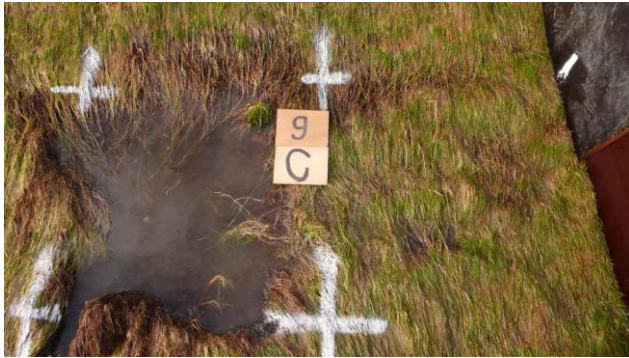
Results of test series 1. In the first session of two hours with 10 l/s per m initial damage occurred at a small irregularity at the toe of the dike. A small part of the grass cover was torn off creating a hole of about 0.75 m² with a depth of 0.1 m (Figure 9).

Figure 9. Initial damage at toe of section 1 (0.75 m^2 ; depth 0.1 m)

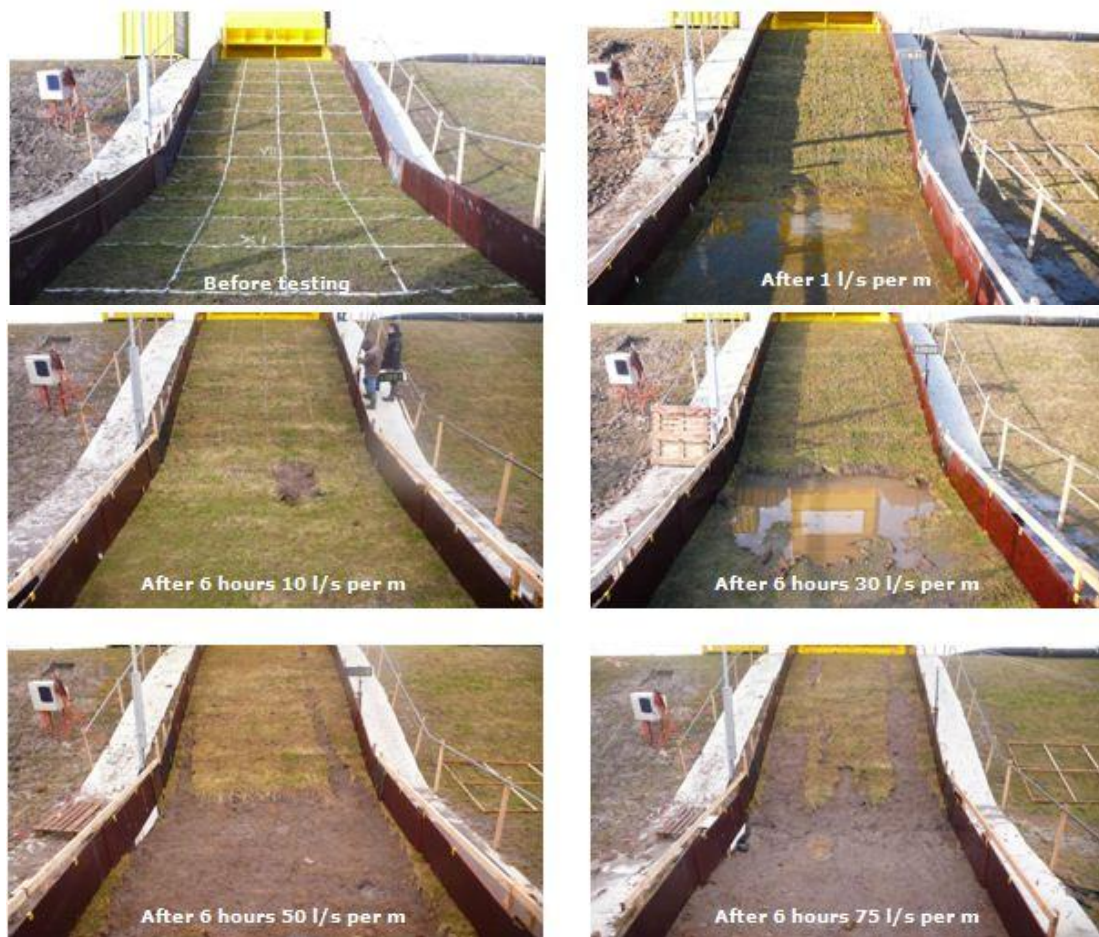
During 30 l/s per m the damage at the toe developed gradually to over 10 m^2 and at 50 l/s per m the complete grass cover at the toe had disappeared. However the depth of the damage did not change much.

During the last test (75 l/s per m) the damages developed further in length and width but did not lead to failure of the dike. Figure 10 gives an overall view of the development of the damages over the test series in test section A1.

It was concluded that the grass cover failed easily, but the remaining top layer of rooted clay was remarkably erosion

Figure 10. Development of damages in test section 1

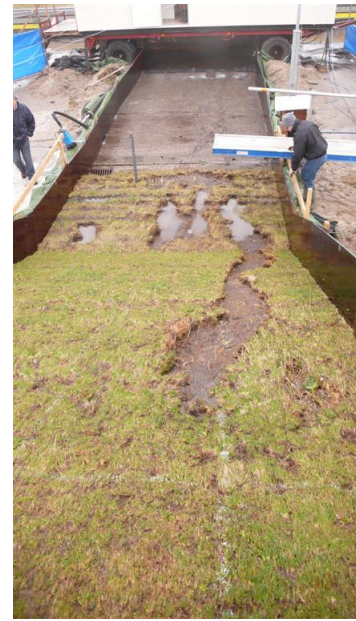
Results of test series A2. At 1 l/s per m small initial damage occurred at the tire track. In the following 10 l/s per m test at the location of the removed fence showed first damage. At the end of the 10 l/s per test the damage on the slope developed downward to the berm, ripping off a 0.05 to 0.1 m thick layer of the grass cover (Figure 11). The damage at the berm evolved in the same way.

Figure 11. Damage section A2 after 6 hours 10 l/s per m

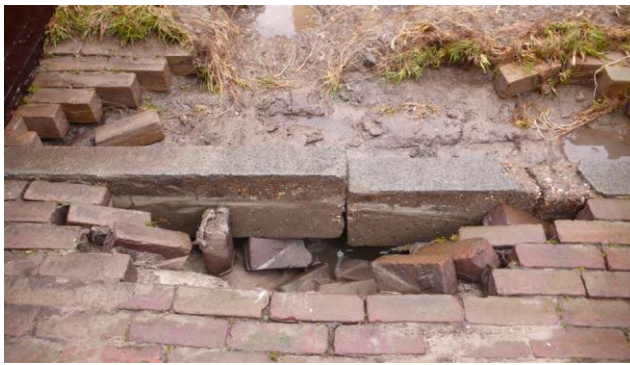
At 4 hours after the start of the test with 30 l/s per m, with a high overtopping wave some bricks were displaced (Figure 12). The rate increased rapidly. In 1 hour a total of 54 bricks were washed out. At the same time the erosion hole just in front of the curb expanded and deepened. At each following wave water was pressed underneath the concrete band causing upward forces on the bricks of the parking lot. Together with the uplift forces during over wash of the overtopping waves a first brick of the parking lot came out. This damage expanded fast. After 4 hours and 20 minutes the test was stopped because of the large damages (figure 13).

Figure 12. After 4 hours 30 l/s per some bricks of the parking lot were removed

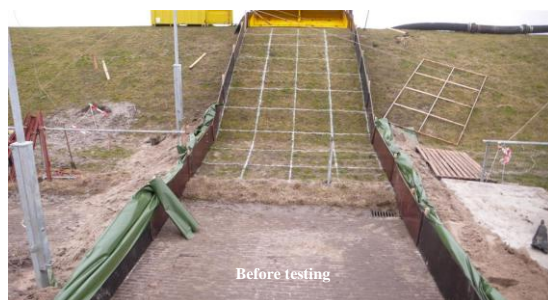
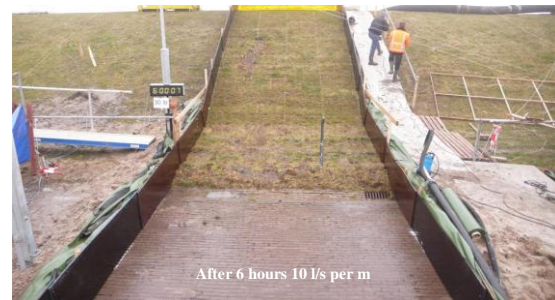
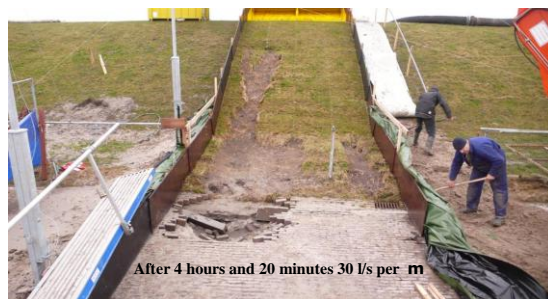
Figure 13. Damage development test section A2

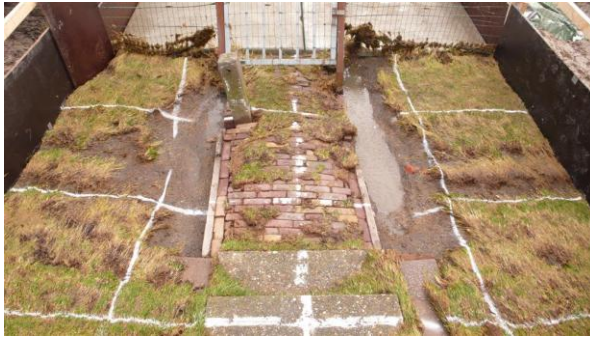
Figure 14. Result after 6 hours of 10 l/s per m.

In the 10 l/s per m test erosion started at the low end of the tiles on both sides of the staircase (Figure 14).

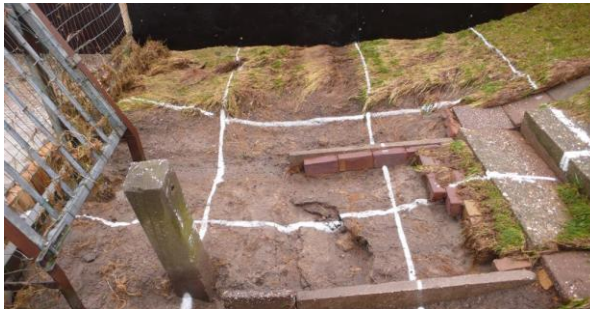
Figure 15. Result after 4 hours of 30 l/s per m.

In the 30 l/s per m test more damage occurred at the path. After 4 hours most of the path had disintegrated (Figure 15). The erosion holes at the toe deepened and a initial damage on the slope developed to the toe.

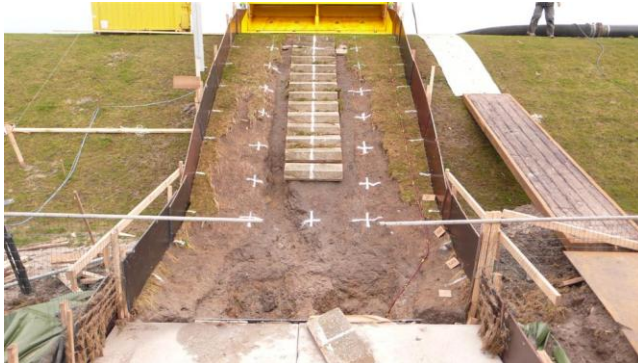
Figure 16. End result test section A3 after 2 hours 75 l/s per m

At 75 l/s per the lower 4 steps of the staircase came down. The test was stopped because of this. Very deep holes (over 1 m) had developed beneath the staircase (Figure 16). As there was a 1.5 m thick layer of clay present, the core of the dike was not reached yet and therefore the dike did not fail yet.

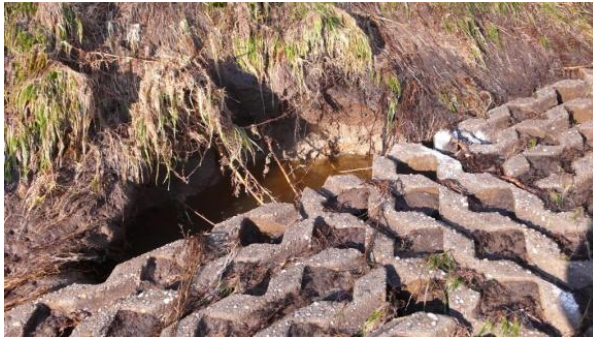
Results of test series V1. During the 1 l/s per m test initial damage developed at the vertical ridge just above the maintenance road. These damages evolved slowly at 10 l/s per m (Figure 18) and at 30 l/s per m these damages developed to two substantial holes undermining the road. (Figure 19).

Figure 19. One of the holes undermining the maintenance road

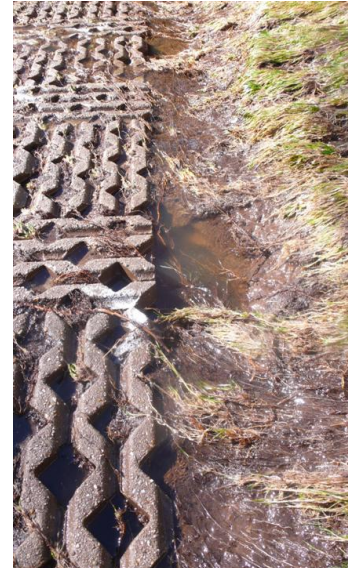
Figure 18. First damage at upper edge of maintenance road

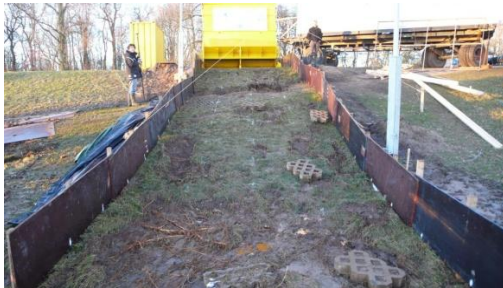
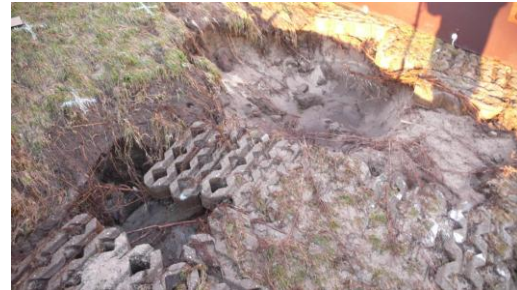
At the start of the 50 l/s per m test, with a large wave, bricks came out. The end result is shown in Figure 20. At this time also large surfaces (several square meters) of the grass cover at the toe and the berm were eroded as well.

Figure 20. End result test V1

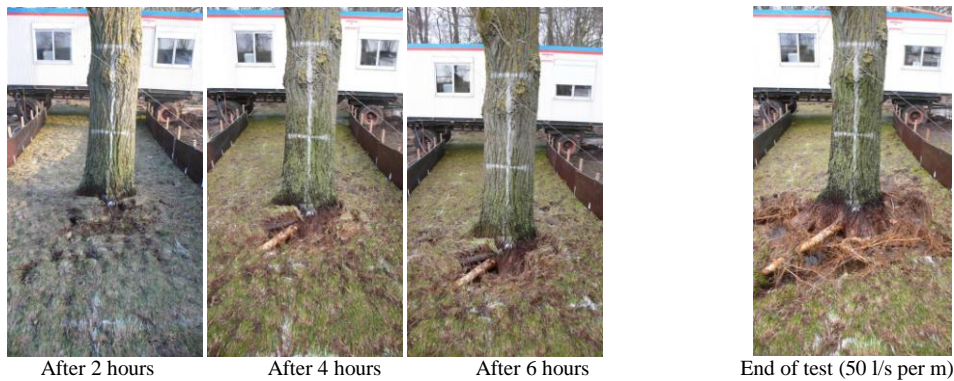
Results of test series V2. At the 5 l/s per m test the grass cover around the tree disintegrated showing a lot of near surface roots from the tree. The damage developed fast at the 10 l/s per m test (Figure 23).

Figure 23. Damage development section V2 at 10 l/s per m and end result after 5½ hours 50 l/s per m

In the 30 l/s per m test the surface of the slope did not change much. The damage at the tree increased. In the next test (50 l/s per m) the damage at the tree expanded to over 4 m² and sand was washed out. The test was stopped after 5½ hours; the dike at the tree was considered to have failed (Figure 23 on the right).

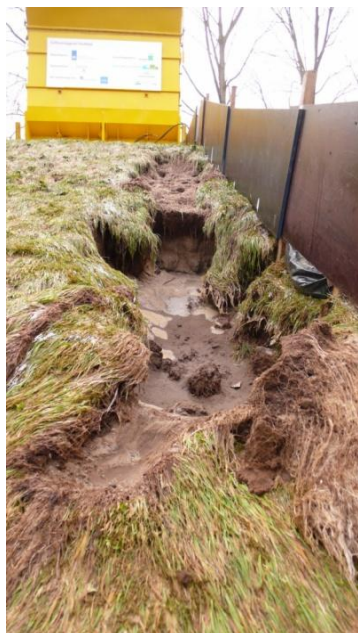
Results of test series V3. The behaviour of the slope was similar to the previous test at section V2. At 30 l/s per m things started to happen. The small holes on the surface eroded at large waves. All of the damages started where signs of activities of moles were found. In Figure 24 the damages after 30 l/s per m are shown.

Figure 24. Damage section V3 after test session 30 l/s per m

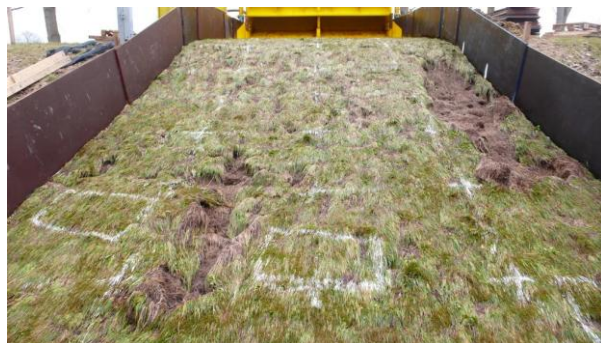
In the next test with 50 l/s per m the damages increased fast. At a mole hole which penetrated the top layer to the sand core of the dike the damage was ongoing in depth, first undermining the grass cover and top layer and next resulting in collapse of the top layer. The magnitude of the damages is shown in Figure 25.

Figure 25. End result section V3 after test session 50 l/s per m

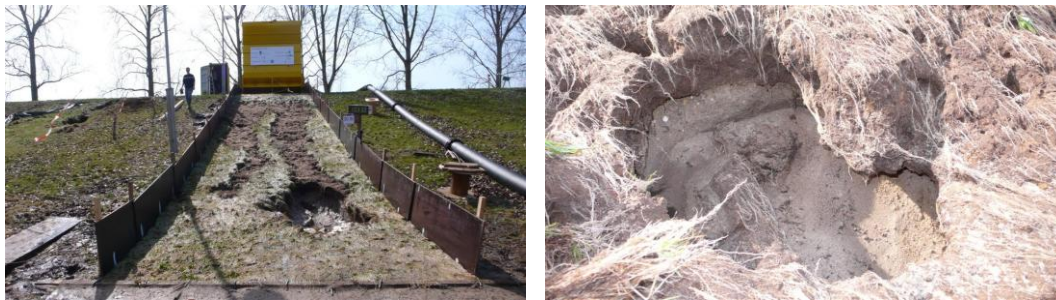
Results of test series V4. From the start of the test series it was observed that the larger overtopping wave volumes had an immediate impact on initiation and development of damage at the slope. This damage development appeared to be the same as with test series V2 (on the slope) and V3, but much faster. Already at 5 l/s per m several initial damages on the slope developed to gullies. To the end of this test some of the gullies merged but did not change much in depth. At 10 l/s per m, locally the depth increased to 35 cm revealing the sand of the core. All of these local deep marks were mole tunnel induced holes. The 30 l/s per m test was stopped after one hour (Figure 26). The core material was washed out, leading to head cut erosion. Also higher on the slope a hole was found which would have led to dike failure if the test had not been stopped.

Figure 26. End result section V4 after 1 hour 30 l/s per m
