# CORROSION STUDIES OF STEEL PILING IN SEA WATER IN BOSTON HARBOR

George L. Wey  
Chief Engineer, Port of Boston Authority  
Commonwealth Pier No. 5, South Boston, Mass.

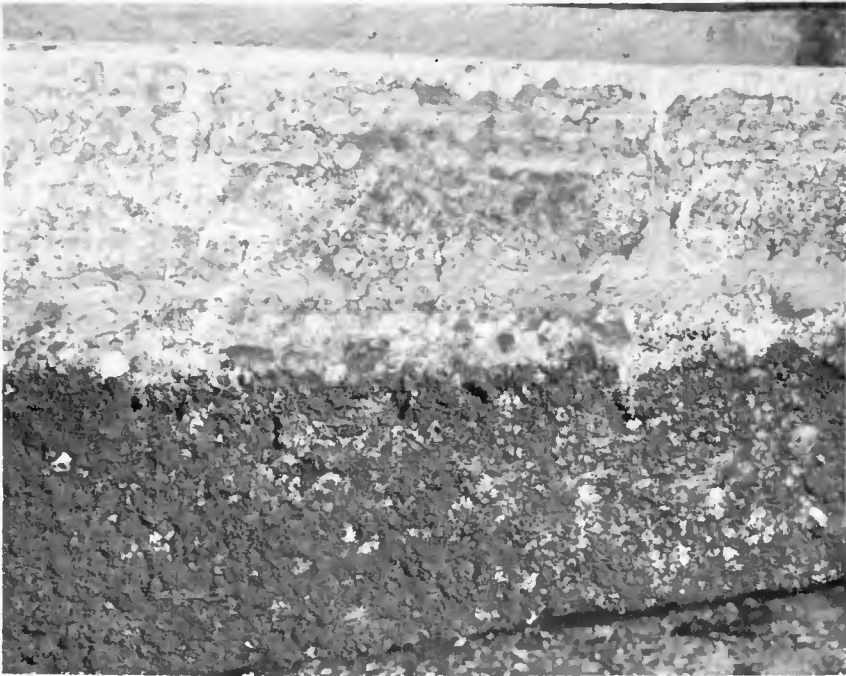
Fig. 1. Corrosion pattern on unencased pile.

At one location two steel "H" bearing piles were removed from sea water after 11 years of service. These two were about 12 feet apart. One had concrete encasement to low water, and the other no protection of any kind. The corrosion pattern was entirely different in each case. The encased pile had a more or less uniform corrosion rate consisting mainly of grooves as shown on Figure 1. The plain pile had a severe attack at low water with a pattern consisting of pits as shown on Figure 2. The maximum loss of metal in the cross-section of the encased pile was about 3 per cent, whereas the other had a loss of 10.4 per cent occurring at approximately the extreme low water line, with an insignificant loss for the remainder of the length. The loss of 10.4 per cent of the plain pile does not appear alarming until you analyze it from a structural standpoint. The loss occurred at the edges of the flanges, which would normally be expected in galvanic action resulting from the differential of oxygen concentration. Structurally the loss takes place in the worst part of the member, the weak axis.

As an example of the seriousness of this loss, take a 14 inch 73# bearing pile with an unsupported length of 48 feet. A reduction in the radius of gyration from a 10 per cent loss of metal at the ends of the flanges results in a 44 per cent decrease in the allowable load on the pile. Under this degree of corrosion attack it would be impractical and uneconomical to provide a sufficient cross-section of metal to sustain such a loss over a great period of time.

Since this accelerated attack took place below the normal water level and the pile was covered with a thick growth of marine organisms, discovery of the accelerated attack is not likely by visual observation. Unless periodic examinations by a competent diver are made to discover such critical conditions, collapse of the structure would be imminent.

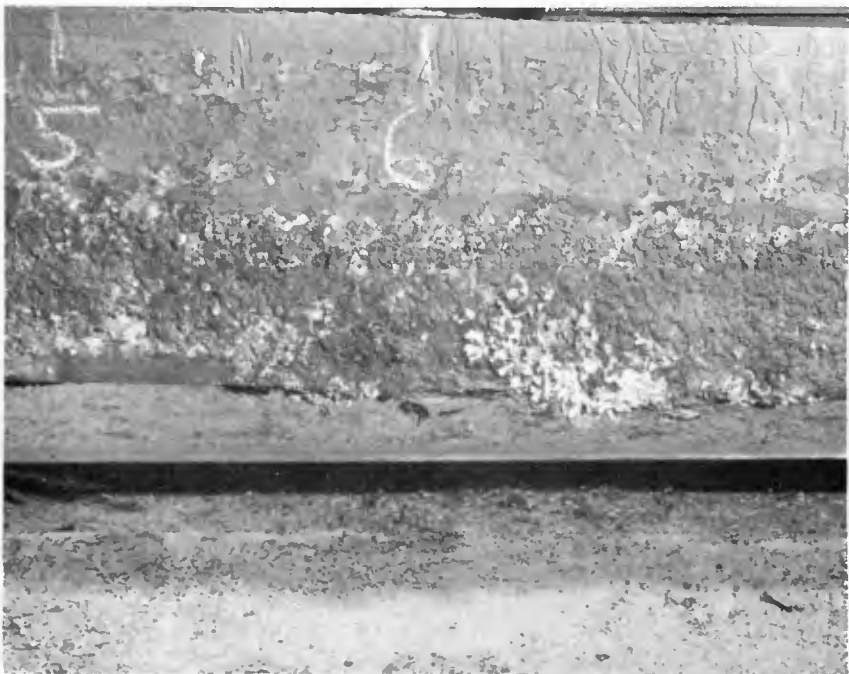
Fig. 2. Corrosion pattern on encased pile.

Low water accelerated attack does not occur on the encased piles, and grooving with a more or less uniform corrosion loss is also a characteristic of the encased piles.
