CHAPTER 67

SHORE PROTECTION ON THE COAST OF "YAIZU"

Goichi Seo and Tatsuma Fukuchi
Director of Fishing Port Division, Fisheries Agency, Tokyo,
Japan and Deputy Chief of Fishing Port Planning Section, Ditto

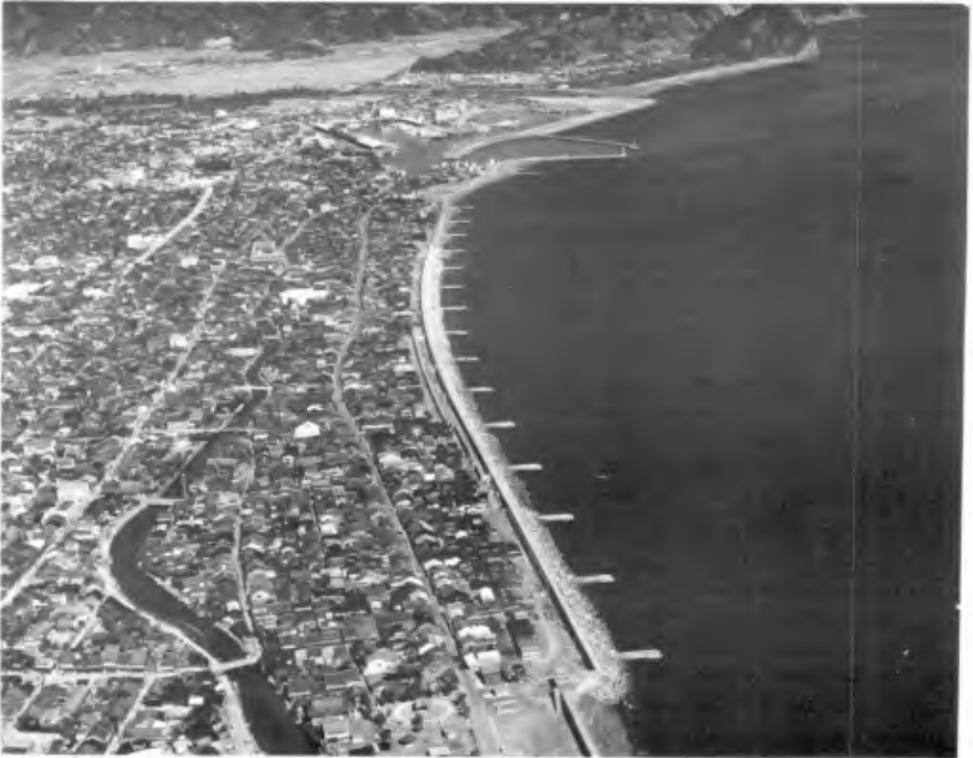
"YAIZU" is one of the greatest fishing ports in Japan. It has been developed by fishing from the ancient days and today it has grown into an important base of pelagic fishing in our country. The area stretching out long and narrow along the coast line is concentrated by many residences, fish-processing plants, shipyards and other essential facilities. The dyke, length of 1,600 m running along the coast line, protects these facilities from natural sea disasters. This dyke, however, since the beginning of its construction, was subjected to damages many times, through severe waves and beach erosion, and human lives, assets and properties were often be endangered. The residents have paid great attention and made large efforts to maintain the dyke. Before 1939 when "YAIZU" Fishing Port was provided with the existing dock for large-size vessels, there was a wide beach in front of the dyke and the daily catch was sold on this shore. But today we can see only tidal water washing directly on to the foot of the dyke. (See Fig-1)

Fig. 1. Aerial view of the coast.

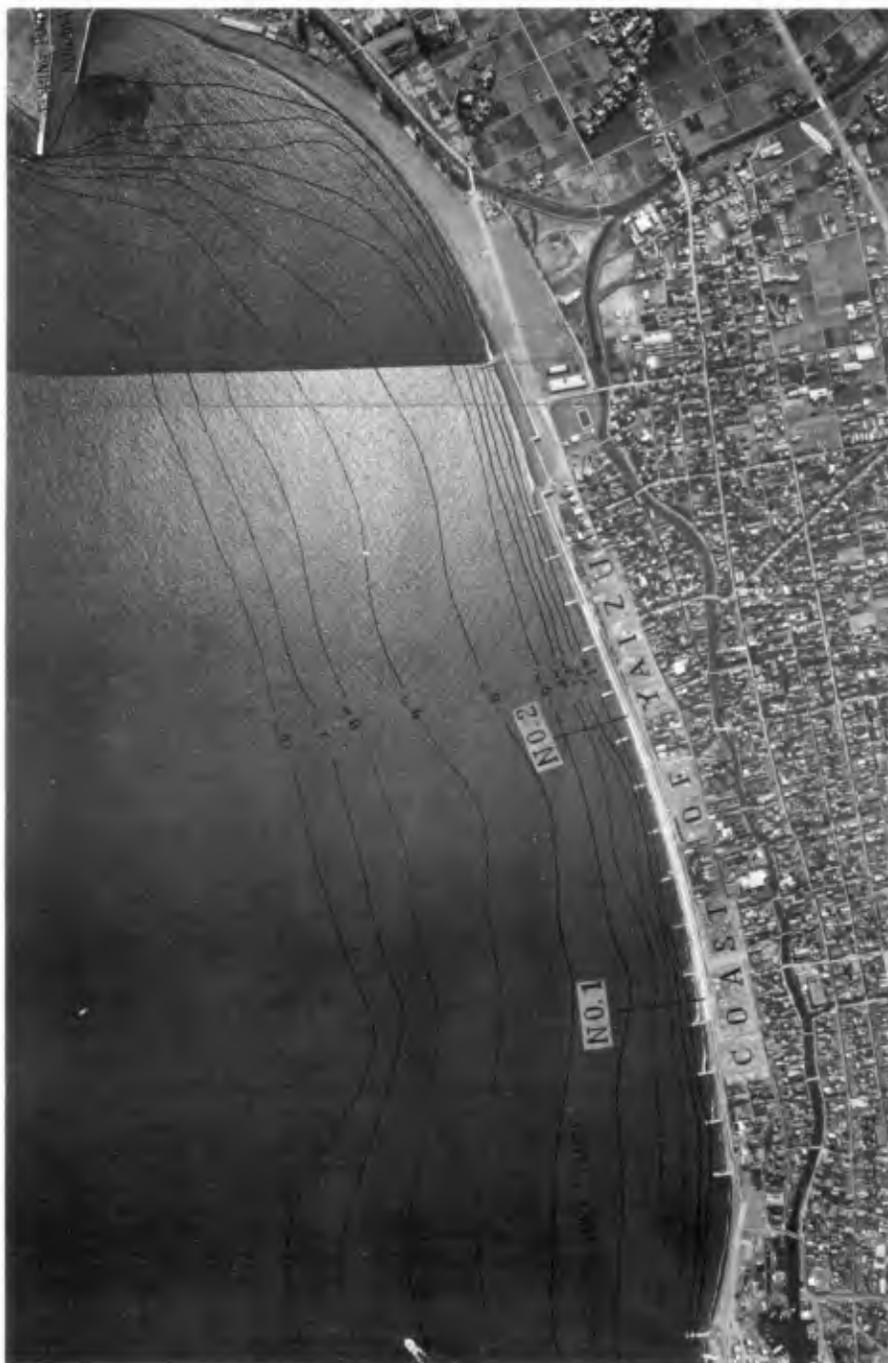
Sand-groins are arranged along the whole coast of "YALZU" and protect the dyke from scouring. At the south end of the dyke, groins do not carry out their sand depositing function. Thus, there is no beach in front of the dyke. On the northern part of the dyke, some sand and gravel deposits can be seen. They are the southern side of each groin but little on the opposite side.

It is observed, on the other hand, that the sand depositing function of the groins makes a beach of 10-20 m wide and 300 m long on the coast, adjacent to the southern part of the south breakwater at "YALZU" Fishing Port. The average sea-bottom gradient up to the -5 m depth point is, 1:10 at the south end, 1:15 at the central part of "YALZU" coast and about 1:30 at the south of the southern breakwater. While the -10 m depth contour projects seaward in front of the entrance of "YALZU" Fishing Port, though it runs parallel with the shore alongside the dyke. The -100 m contour lies 3 km off-shore of "YALZU" and that characterizes its marked entry near the coast in comparison with other sections. No shoal or bar is found along this coast. (See Fig.-4)

Fig. 4. General view of the coast.

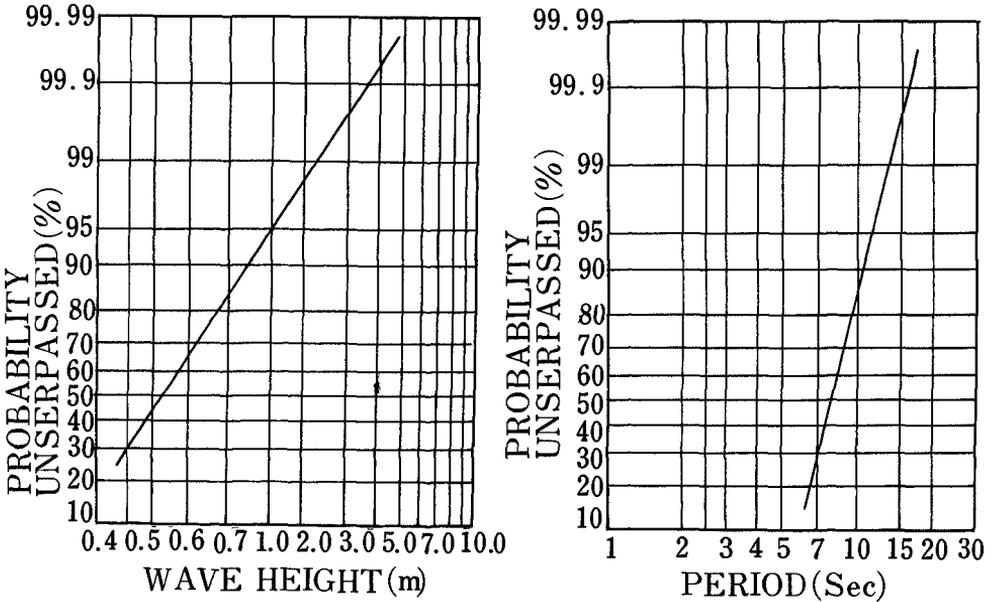
Waves - As the coast of "YAIZU" is located on the side away from the direction of waves entering the mouth of the bay, its waves are less than those at the bottom of the bay owing to refraction. According to the refraction diagrams, the refraction coefficient at "TAGONOURA" (vs. the mouth of the bay) is 1, while it is 0.5 at "YAIZU". From Sept. 1960 to Nov. 1962, "wave recording" by an automatic wave meter was carried out at a place (-9 m deep), 420 m off-shore at "YAIZU". Frequency of appearing waves is as per Fig.-6 and their probability of surpassing 1 m in height is 15 %. As for the direction of the waves, they are mainly between S-SE. The largest train during this period was observed as H max. 6.9 and H 1/3 was 4.5 m, period was 8.4 sec. The sea bottom gradient of the "YAIZU" coast is so steep that wave-breaking point is limited to within 60 m from the beach line. The waves, even after breaking, dash against the dyke sending up sprays of about 20 m which fall behind it. (See Fig.-6)

Fig. 6. Result of wave recording.

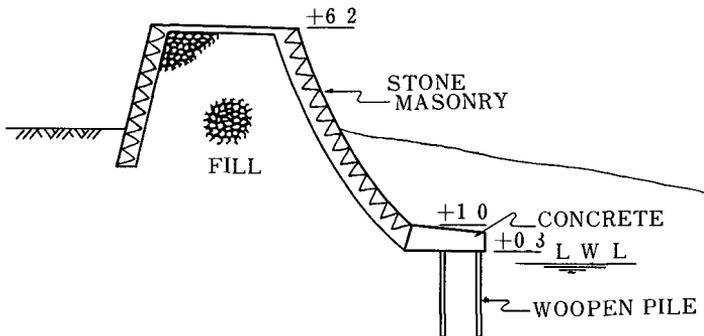
Every time, the position of the sea wall to be reconstructed, was obliged to retreat gradually owing to erosion of the shore line. The details of these structures are unknown, but the vicissitudes of the coast can briefly be conjectured from the above-mentioned records. As the documents for the end of the 19th century exist, we can trace the story of construction, destruction and reconstruction. The oldest documents are of a sea wall that was constructed around 1890. It was executed by the structures shown in Fig.-9, extending over 1,090 meters out and was destroyed and washed away by a disaster in 1898. The next year, a substitute sea wall was constructed on trial under the specifications of stone masonry (as shown in Fig.-10) on a site 9 meters behind the former wall.

Fig. 10. Original section of the present dyke.

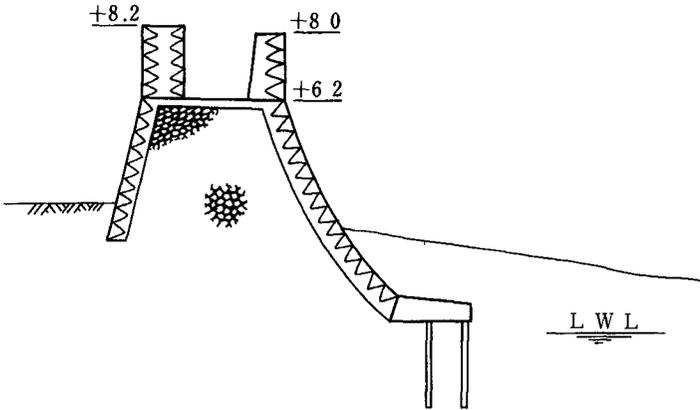
As this structure was certified to be durable against fairly high waves, a following extension of 1,050 meters was executed from 1900 to 1907, protecting an urgent and dangerous part of the hinterland. This is the origin of the existing dyke. The sea wall, over 6 meters high, was uncomparable in Japan at that time. But during its construction, it was found that the dyke could not prevent backyard flooding because of the lack of crown height. So it was made higher, from 6.20 m to 8.50 meter, by construction of an annex wall with stone masonry at the front and back edges of the crown (as shown in Fig.-11). The open central part of the crown was intended to be a splash basin for draining, but this function was not fulfilled effectively because the interim drainage was filled in with

gravel, and later the annex wall collapsed under the impact of the high waves. The interim vacancy was filled with concrete and then this structure was finally completed in 1910.

Fig. 11. Raising-up of wall.

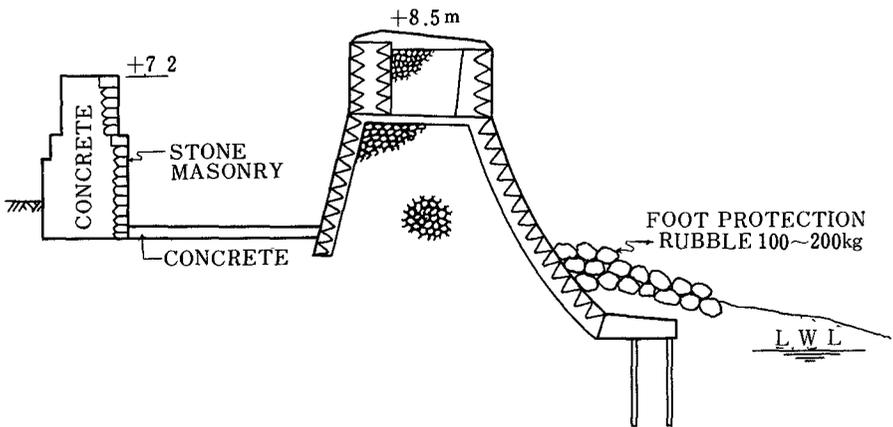
In 1911, immediately after completion, it was broken at several places by unexpectedly severe waves which flooded many houses nearby. On its restoration, subsidiary walls were built at the weaker points (as shown in Fig.-12) in addition to the reconstruction of the main dyke. At the same time, the length of the the dyke was increased to 1,320 meters, and boulders (approximately 100 kg a unit) were placed in front of the dyke to spend the wave dash and to protect the toe of the dyke. Also, an apron was constructed behind the existing sea wall, where a large quantity of tidal water splashed over.

Fig. 12. Subsidiary wall.

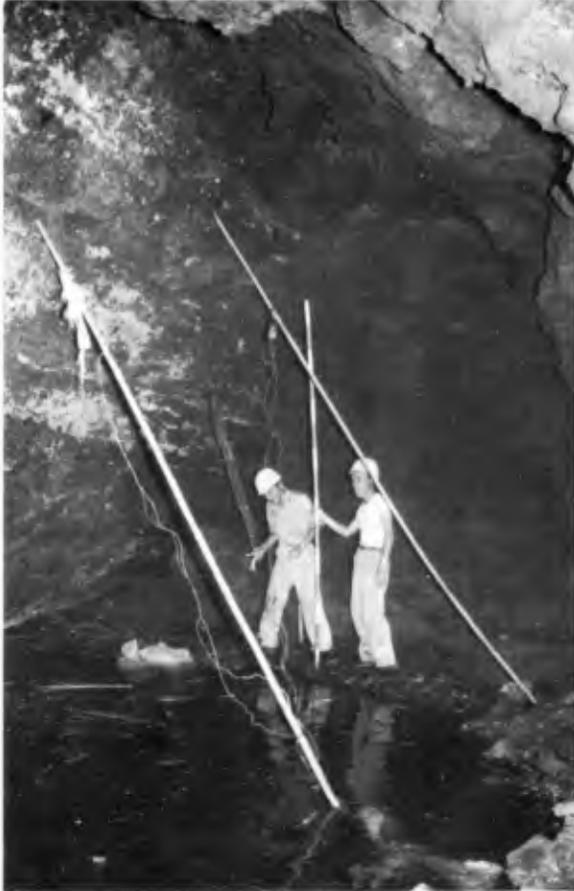
During World War II, the maintenance of the dyke could not be done satisfactorily. In addition to these circumstances, gigantic typhoon passed every year from 1947 to 1949 and greatly damaged the dyke. Many cracks and hollows were generated and most of the foot protection blocks were washed away. Among them, during the calamity of 1948, about 20 meters length of the dyke was completely broken and fierce waves destroyed more than a hundred residential houses, and also caused the damage to a wide area by tidal deluge in the surrounding district. Thus, more than 2,500 of the residential houses and a total of several billion yen of industrial facilities stood in a serious situation. In 1954 and 1959 serious calamities reoccured.

The process of these disasters is as follows: Firstly, sand in front of dyke is washed away, secondly, the toe of the dyke is secured by stronger waves, thirdly, scouring causes the leaking out of the filling and the wall becomes weak by losing its filling, and stone masonry then loosens due to the shock of waves and finally the dyke is destroyed. To prevent this, the groins, 25 meters long and 4 meters wide, were constructed every 75 meter. The construction work was executed between 1949-1953. Considerable amount of sand was deposited immediately after the completion of the groins and the coastline was advanced. A few years later, however, the coastline commenced again to recede and at present, it seems that the groins do not entirely fulfil their purpose.

Fig. 14. Damaged state.

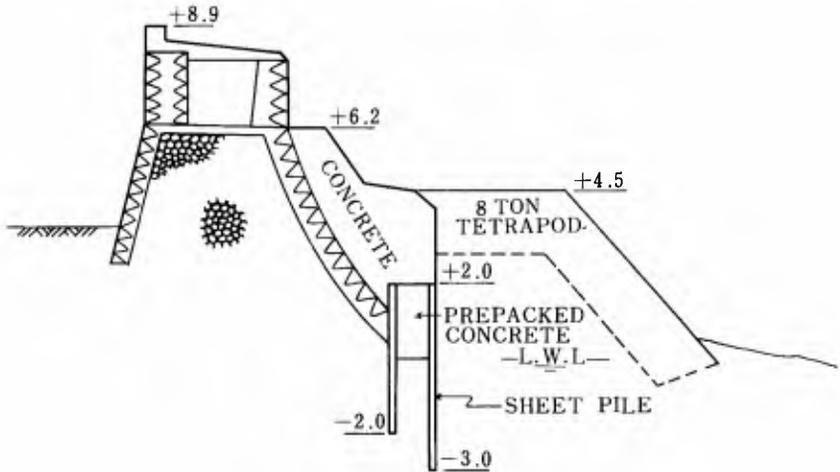
Fig. 15. Cross section of improvement work.

Recently, improvement work on the whole dyke and sand groins was planned in order to make sure of the coastal protection. The following items were taken into consideration in this plan and its standard cross section is shown in Fig.-15.

- 1) 8 ton armour blocks were placed at the foot of the dyke to decrease the scouring and wave power against the body,
- 2) Double steel sheet piles were driven -3.5 meters deep into the toe of the dyke to prevent the leaking out of the filling,
- 3) Concrete was cast inside the body,
- 4) The front face of the masonry wall was covered with concrete reinforcement.

This improvement scheme of the dyke was started in 1959 and is still progressing now. The armour blocks have been remarkably effective in the prevention of erosion. There has been no damage to the dyke, though, it has been attacked several times in the past by severe waves. At the same time, it has had a good effect on maintaining the beach sand, but the study of this takes much more time. The entire operation mentioned above will be completed by the spring in 1967.
