## CHAPTER 43

### CASE HISTORY OF MISSION BAY INLET SAN DIEGO, CALIFORNIA

by  
William J. Herron, Jr.  
Moffatt & Nichol, Engineers  
Long Beach, California

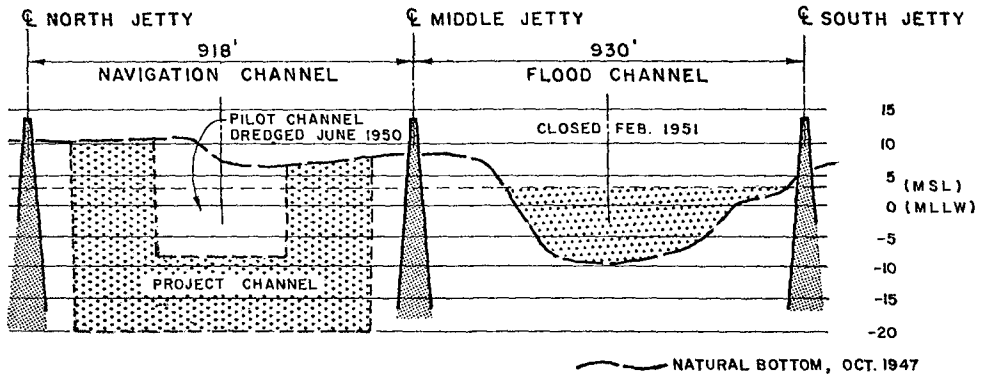
FIGURE 2a

2. Mission Bay in its natural state reportedly had a tidal prism of about 10,400 acre feet (Photo 1). The minimal cross-sectional area of the entrance channel as surveyed in 1947 was 6000 square feet (Fig.2a). Compared to this field data, the Robins' equation shows a computed equilibrium entrance area of 10,400 sq.ft. while the O'Brien equation shows an area of 9,100 sq. ft. The reported 10,400 acre-feet of tidal prism may be in error or, if correct, the very flat slopes of the marshlands and the constructions of tidal flow at the two Ingraham Boulevard bridges may have reduced the resultant required channel cross-section from the O'Brien derivation of 9100 sq. ft. to the actual 6000 sq. ft.

The shutdown of this project as a result of the Korean War had a most adverse effect. While the flood channel was completed, only a minimum effort was made to open the bay to the sea by dredging a pilot channel through the barrier beach. The pilot channel was to be 300 feet wide to the -8 foot depth (Fig. 2a). In other words, looking at O'Brien's equilibrium equation the cross-sectional area of less than 4000 feet was completely inadequate and the channel shoaled and spread the full width between jetties to form a very dangerous bar. (Figs. 2c and 2d). From an engineering point of view this was a very successful maneuver because in accord with the equilibrium relationship and because of the west coast tidal character of getting maximum tidal run from MHHW to MLLW, the minimal cross-sectional area of the entrance channel increased to about 11,000 ft.<sup>2</sup> by July 1954, and over 250,000 cubic yards of sand were scoured from the channel and apparently carried out to sea. However, the boatmen were not adequately informed as to the hazards of this partial channel, and before its closure by City Ordinance in 1953, several boats were capsized and 11 lives lost.

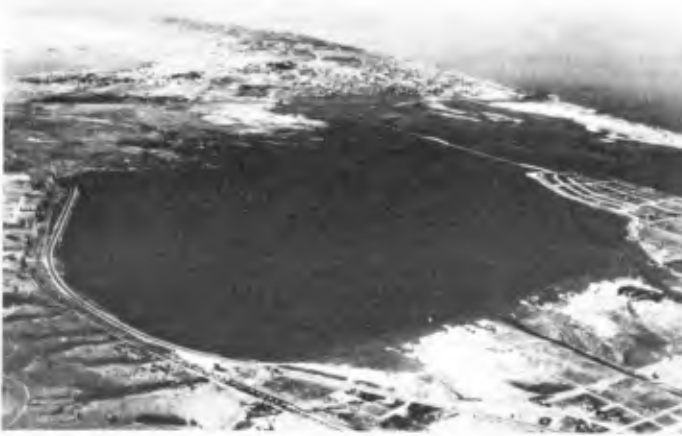
**BEFORE CONSTRUCTION**  
GENERAL CONFIGURATION OF BAY AT HIGH TIDE  
**1947** **NO. 1**

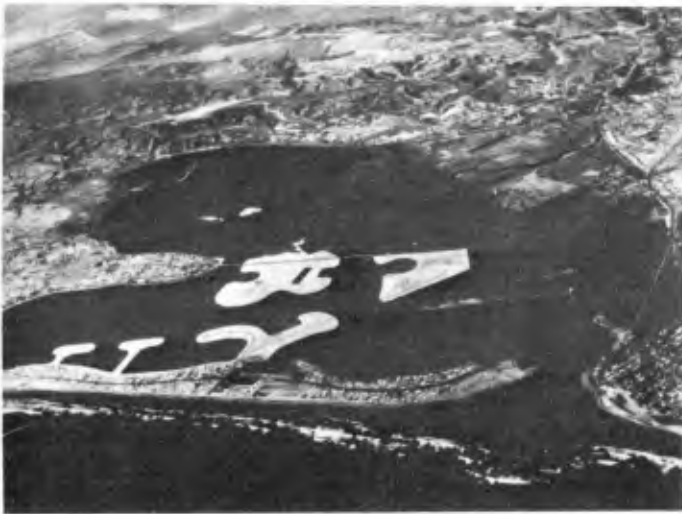
**START INTERIOR CONSTRUCTION**  
NOTE CONFIGURATION OF NATURAL INLET  
**FEB. 1948** **NO. 2**

1946: Dredging and filling of interior portions of the bay were initiated by the City. (Photo 2, 1948).

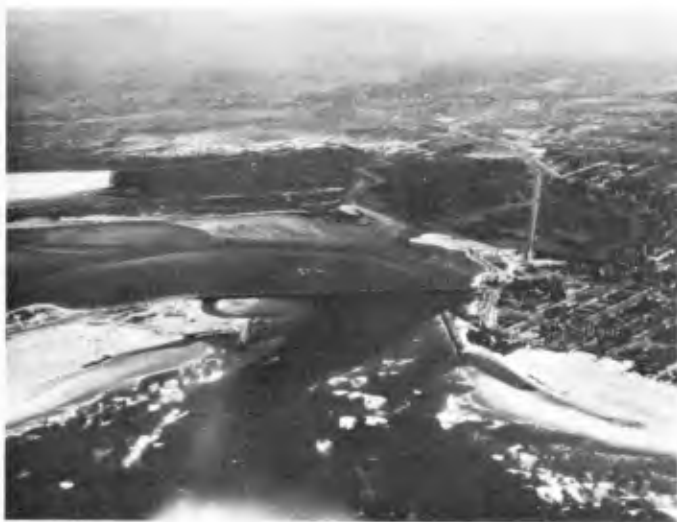
**START ENTRANCE CONSTRUCTION**  
MIDDLE AND SOUTH JETTIES  
JULY, 1948 NO. 3

May 1948: The Corps of Engineers initiated construction of the south (flood control) jetty and the middle (combined flood control and navigation) jetty. (Photo 3, 1948); Photo 4, 1949).

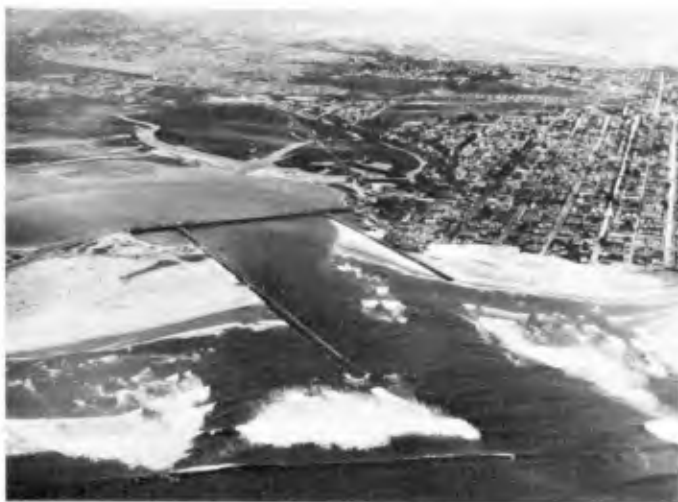
**COMPLETION OF FLOOD CONTROL CHANNEL OUTLET**  
MIDDLE AND SOUTH JETTIES  
FEB. 1949 NO. 4

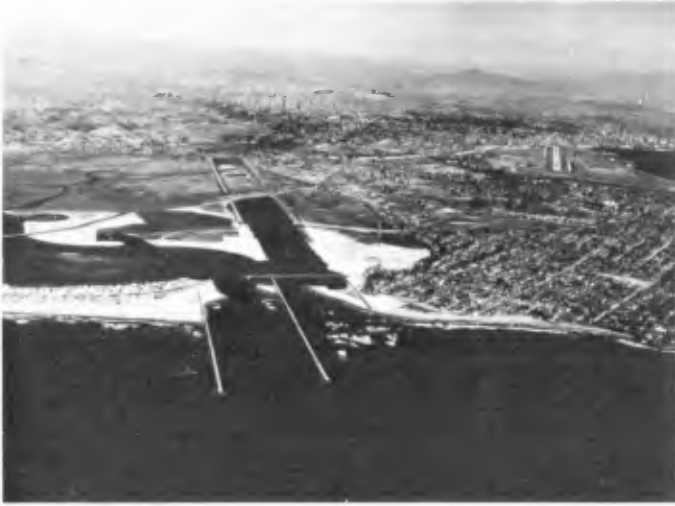
**NAVIGATION AND FLOOD CONTROL CHANNEL JETTIES  
COMPLETION OF NORTH JETTY**

September 1950: The north jetty was completed (Photo 5, 1950).

June 1950: A pilot channel (300 feet wide) was dredged to the -8 foot MLLW depth to divert tidal flow of the bay to between the navigation jetties. (Photo 5, 1950).

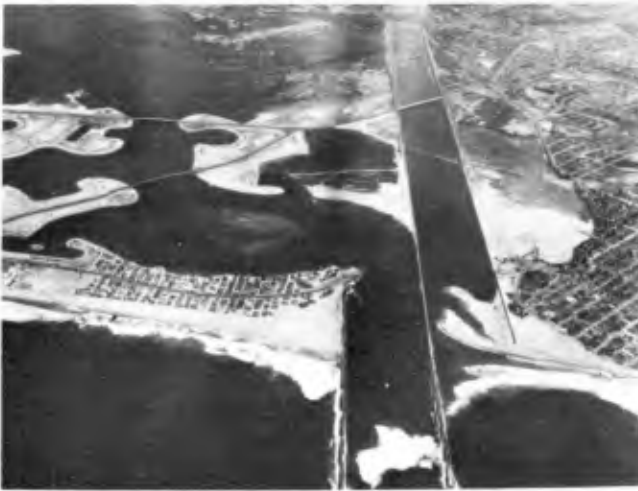
**NAVIGATION AND FLOOD CONTROL CHANNELS  
MIDDLE JETTY CLOSED, CREATING TWO CHANNELS  
SEPT. 1951**

February 1951: The flood control channel was completed and the final section of the middle jetty was closed, separating the Flood Control Channel from Mission Bay. (Photo 6, 1951).

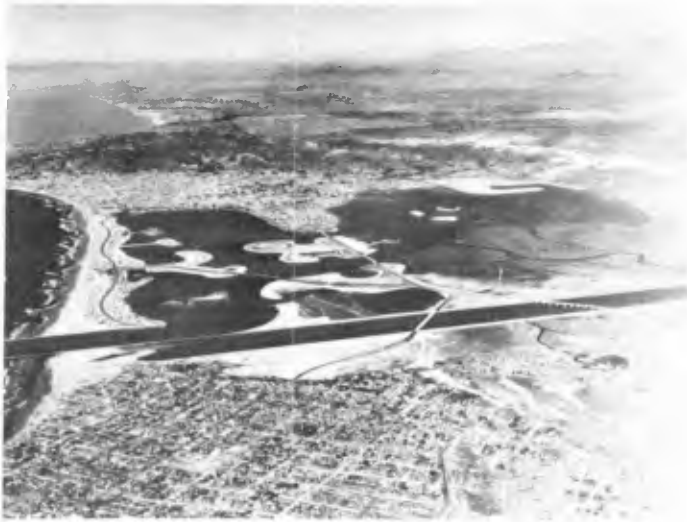
**DEVELOPMENT OF WEST MISSION BAY**

NOTE CLOSURE OF FLOOD CHANNEL

March 1951 to Nov. 1954: The Corps of Engineers project was shut down because of the Korean War. During this time period, the City essentially completed their dredge and fill program for the bay westerly of Ingraham Street (Photo 7, 1953).

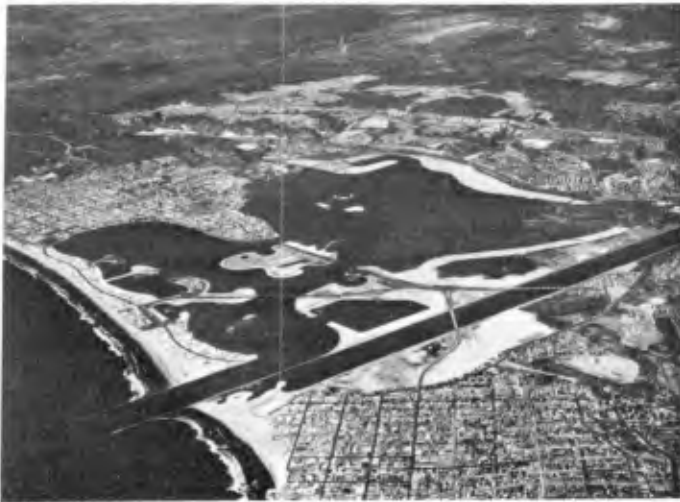
**START OF DEVELOPMENT OF EAST MISSION BAY**

NOTE COMPLETED DREDGING OF ENTRANCE CHANNEL

January 1957 to December 1957: The Corps of Engineers dredged a portion of the main channel and Quivera Basin to a depth of -20 feet MLLW. This relatively coarse sand was pumped to the eastern perimeter of the bay to stabilize the mud deposits along U. S. 101 Highway. This dredging essentially permitted full and unimpeded tidal flow through the West Bay, the main channel and the entrance channel. (Photo 8, 1958).

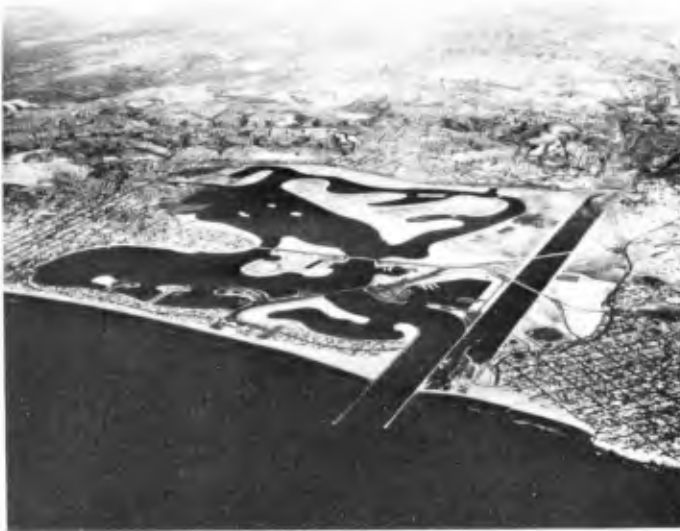
COMPLETION OF MISSION BAY - SAN DIEGO RIVER PROJECT  
1963 NO. 9

July 1958: The Corps of Engineers dredged the main channel and the west anchorage basin (Mariner's Basin) to a depth of -15 feet, MLLW. At the same time, the City initiated a 12 million cubic yard dredging contract to complete the development of the east bay. This project, completed in 1963, essentially completed the City's dredge and fill program, and while the natural tidal prism was reduced by about 10%, flow characteristics were greatly improved by elimination of the large marshy areas with flat slopes between high and low tide. (Photo 9, 1963).

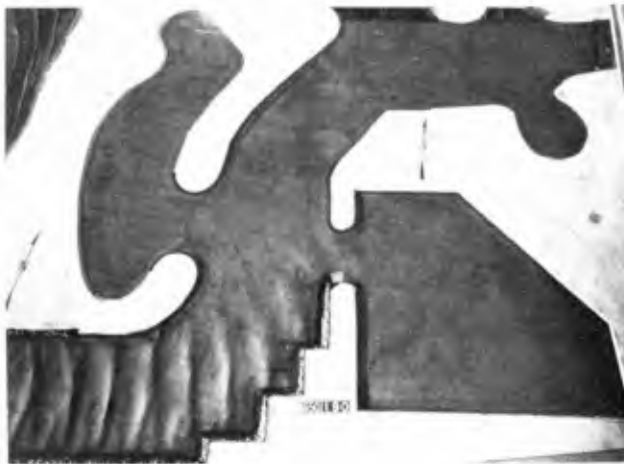
HYDRAULIC MODEL STUDY - MISSION BAY ENTRANCE  
1969 NO. 10

October 1966 to June 1969: Field studies, resulting in a hydraulic model study were made by the Corps of Engineers to develop a solution for occasional undesirable wave action in the two deepwater anchorage basins (Photo 10, Hydraulic Model Study).

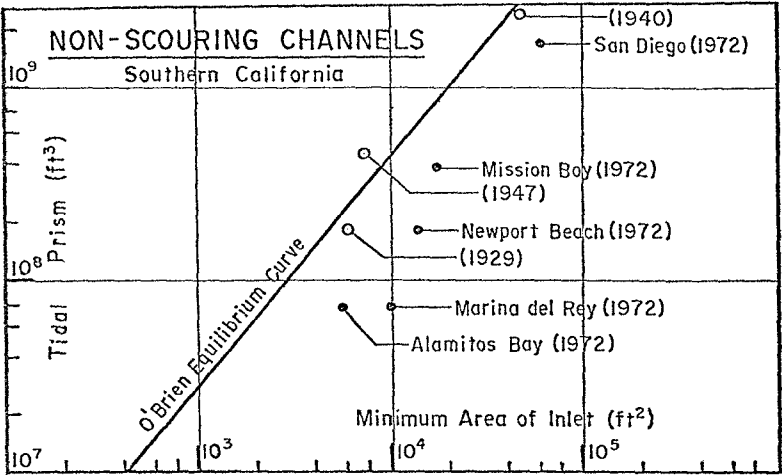
FIGURE 3

The various relationships between the tidal prism and the area of the inlet since start of construction in 1946 are shown in Figure 3 and Table 1. It is apparent that there has been a very major change in the relationship of tidal prism to inlet area with a resultant reduction in tidal velocities, yet no significant entrance shoaling has occurred as the equilibrium formula would have predicted.
