## CHAPTER 77

### FIELD TESTS ON TWO PERMEABLE GROYNES

#### ABSTRACT

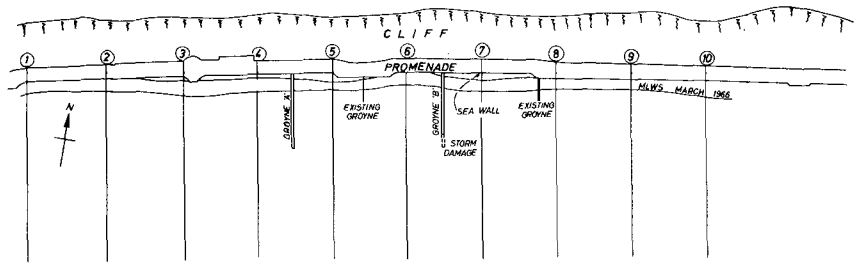
FIG 3 SITE PLAN

On each of the 10 sections shown on this figure, beach profiles were measured at 3 monthly intervals, beginning in March 1966. In July 1968, groyne construction began. The surveys were continued until March 1971.

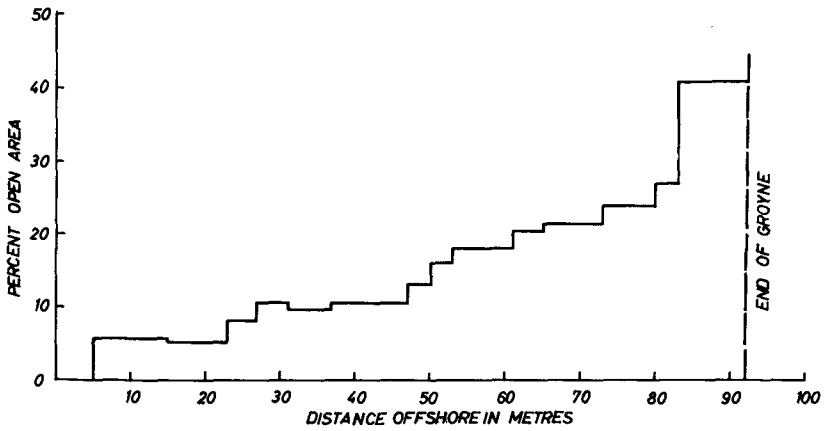
FIG 4 VARIATION OF OPEN AREA WITH DISTANCE ALONG GROINE

The longitudinal precast concrete units are castellated so that the groynes are permeable. The percentage of open area increases seaward as shown in Figure 4. The groynes were 190 m apart and designed to be 90 m long, although shortly after construction approximately 16 m of the seaward end of one collapsed. During the discussion of this paper at the 13th Coastal Engineering Conference a delegate reported the collapse of the seaward ends of a number of Makepeace Wood groynes in Jamaica.

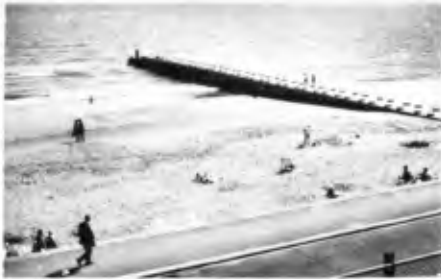
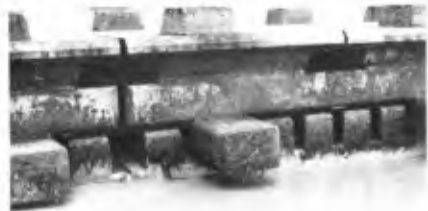
Plate 1. General view of groyne  
 Plate 2. Detail of groyne construction

The groynes were built to a design by Sidney Makepeace Wood, see Ref 1. Each consisted of a double row of piles, interlaced with precast concrete units, and capped by a flat deck which provided a working platform during construction and added to its structural stability, see Plates 1 and 2.

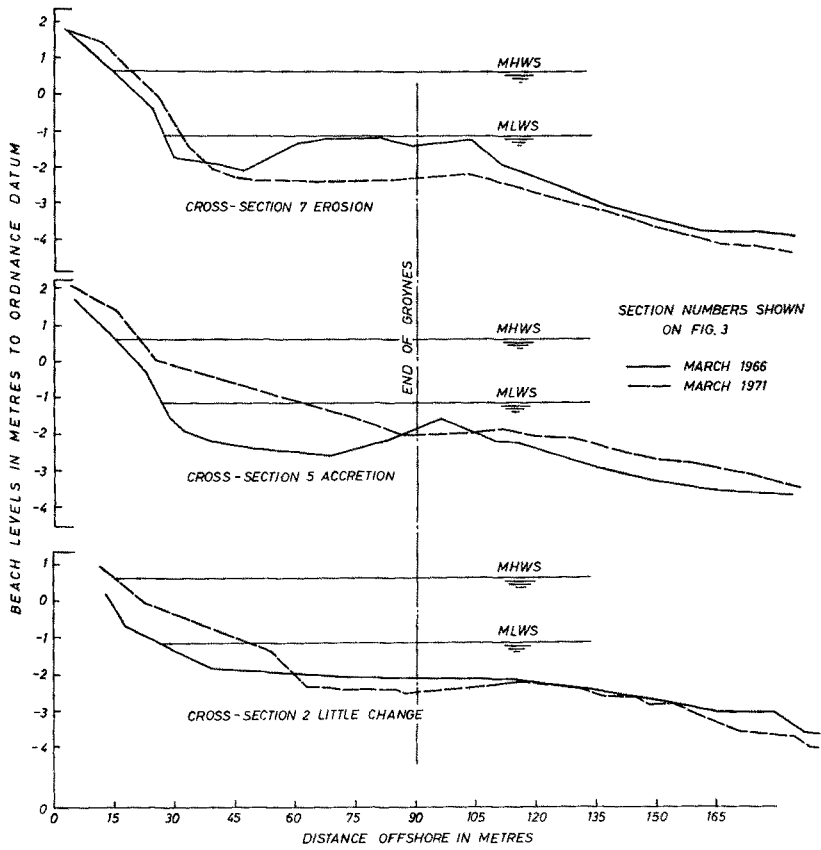
FIG 6 BEACH CROSS-SECTIONS

Of the 20 regression lines, it is significant that 14 showed an increase in slope following groyne construction. These increases were most marked landward of the groynes and updrift, Sections 3, 4 and 5. Although erosion downdrift was expected, Sections 6 through 10 showed some improvement as well, and it is possible that the beach as a whole would have accreted, but at a slower rate, if the groynes had not been constructed. Plate 3 shows the beach as it was before groyne construction, and Plate 4 shows it in the spring of 1971. The build-up in beach levels in the immediate vicinity of the groynes is marked; there appears to be little downdrift erosion. Figure 6 shows the changes in some typical cross-sections between March 1966 and March 1971.

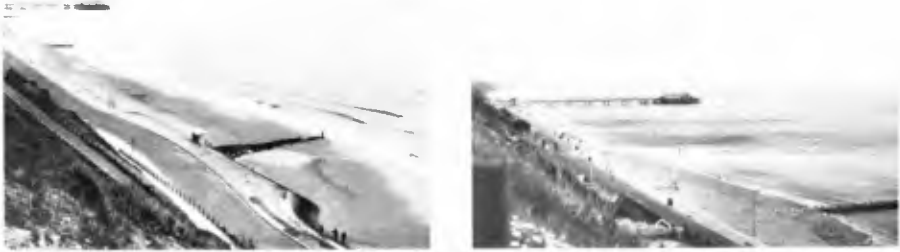
Plate 3. The beach before groyne construction  
Plate 4. The beach in 1971

There seems little doubt that the two Makepeace Wood groynes constructed at Bournemouth have resulted in a build-up of the beach in their immediate vicinity. Although erosion would be expected downdrift, it is not immediately obvious. Beach surveys are to be resumed.
