CHAPTER 3

STORM SURGE EFFECTS AT LEIXÕES

by C. Campos Morais, research officer

Laboratório Nacional de Engenharia Civil, Lisboa, Portugal

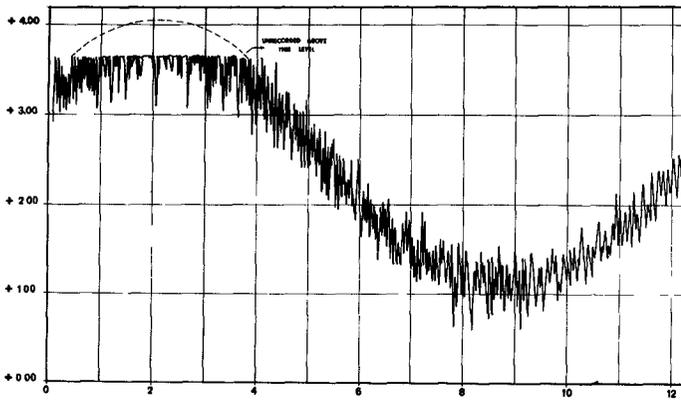
Fig. 9 - Tide record (close-up)

If the tide record is searched (fig. 8) for long period waves and the part of the record that corresponds to the occurrence of the storm surge (fig. 9) is more carefully inspected, it is possible to observe that waves with periods of about 4, 8, 16, 20 and 40 minutes were present, with rather significant amplitude. The more persistent wave is the 4 minutes one, more precisely 220 s.

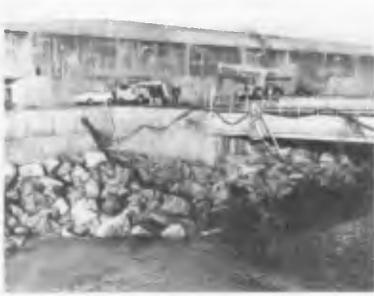
During the storm the outer breakwater was severely overtopped. As a consequence of this overtopping the structures of the oil terminal itself, mainly the steel ones, and the oil leading pipes were bent (fig. 10).

Fig. 10 - Damages caused by overtopping

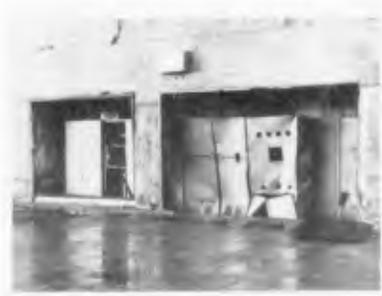
The looking landwards steel doors of a transformer station located inside the concrete superstructure of the breakwater were carried away, apparently by suction action (fig. 11). Some tetrapods of the cover layer of the breakwater were broken. But the most severe damages occurred in the head of the breakwater that was practically destroyed: many tetrapods were broken or carried away; the end concrete block of the superstructure supporting the lighthouse and the neighbouring one fell down by undermining action of the waves, that carried away the small rock blocks of the underlayer over which they were placed, and the following concrete block was slightly displaced laterally (fig.s 12, 13, 14, 15). To this effect strongly contributed the presence of the cylindrical concrete monolith

Fig. 11 - Damages caused by overtopping (cont.)

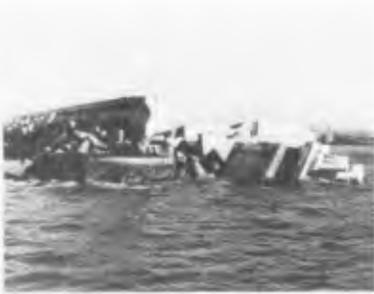
that supported the lighthouse of the submerged breakwater before the raising operation, though the upper part of this cylindrical block was mechanically destroyed during the raising works, as this block originated a concentration of strong currents from the breaking waves on the damaged zone.

Fig. 12 - Damages at the head

Model test were run after the accident in order to obtain a better knowledge of the destruction process and the best solution for the repairing works, to be carried out during the summer 1973.

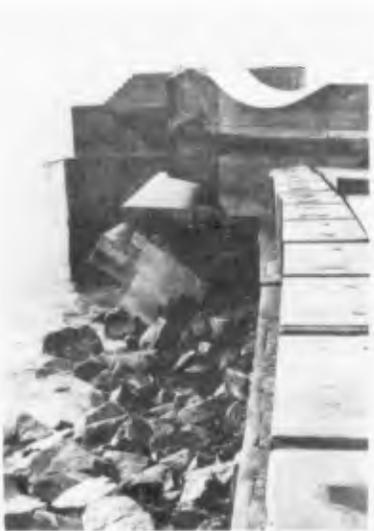
Fig. 13 - Damages at the head (cont.)

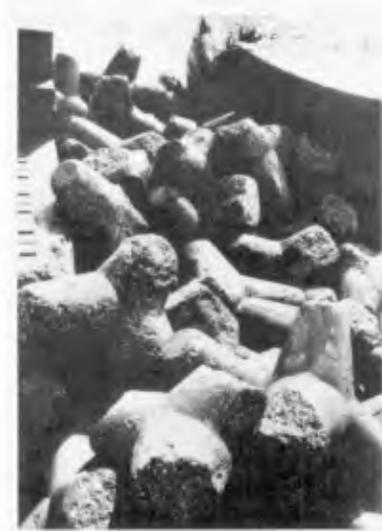
Fig. 14 - Damages at the head (cont.)

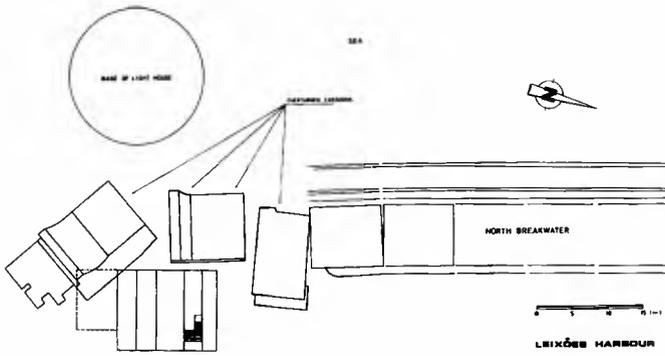
Fig. 15 - Damages at the head (cont.)

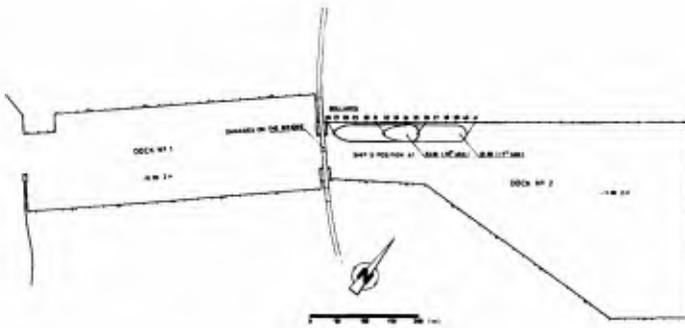
A 160 m long freighter with general cargo berthed between bollards nº 26 and 36 of the north quay (nº 2 dock) broke the ropes at 23:00 on Jan. 16, 1973. Thrown adrift she then hit at 23:30 the abutment of the Leixões cantilever bridge and broke bollards nº 26 and 33. The bridge was damaged. At 10:30 of Jan. 17/1/1973 bad weather conditions persisted and the same ship, though secured by two tugs, was lurching so heavily that springs and a bollard (nº38), were broken (fig. 16).

If the two docks are considered as a sole rectangular dock 1220 m long it is seen that a half wave length resonance may occur with a nodal zone on the ship's position, with a fundamental resonant period of 212 to 225 s, embracing that of about 220 s whose presence was noted at the tide record.

Thus the disturbances caused by the ship which damaged the bridge and the bollards at about 23:00 of the 16th and 10:30 of the following day are explained. The nodal zone positioned in the berthing zone of the ship has horizontal movements which in turn are aggravated by the constriction between the two docks. Horizontal movements and corresponding velocities can be easily calculated, for selected values of d, T and H (d=12 m, T=225 s, and for instance, H=0.5 m)

Fig. 16 - Damages on the bridge

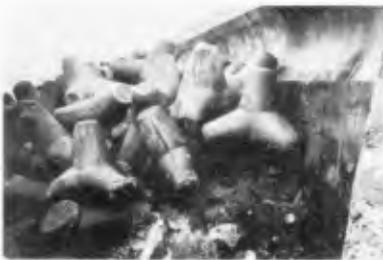
A storm occurred in February 1974, after the head of the outer breakwater had been reconstructed. During this storm no major damages happened. However several tetrapods of the zone near the head were broken or carried away (fig. 17, 18).

Fig. 17 - New damages at North breakwater

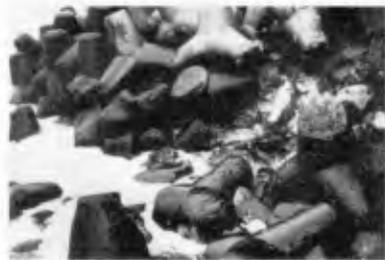
Fig. 18 - New damages at North breakwater

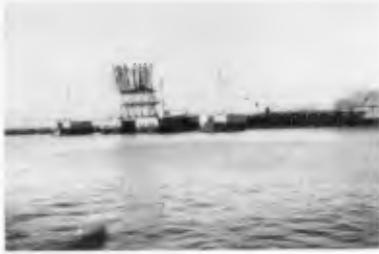
Fig. 19 - Berth n° 1 (view)

Frequent problems have occurred after ships are berthed in n^o 1 berth of the oil terminal, caused by long period waves (fig.19 shows berth n^o 1 inside view).

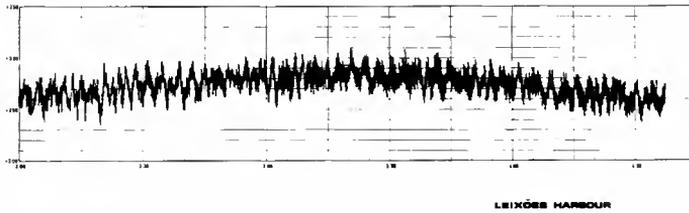
Fig. 21 - Rapid rotation tidal gauge record (22/1/74)

An analysis of the rapid rotation tide records of those days shows that there were waves with periods of 2 to 4 minutes with amplitudes up to 50 cm, probably amplified (fig. 21).

It is expected that the situation will be worse for periods near 2 min (for instance the 133 s period above mentioned) as it was admitted that this could be a resonant situation. As the triangular wedge is quite wide it is expected that the response curve will be smooth, corresponds to a poorly selective situation.
