CHAPTER 86

PERFORMANCE OF A JETTY-WEIR INLET IMPROVEMENT PLAN

PONCE DE LEON INLET
FLORIDA

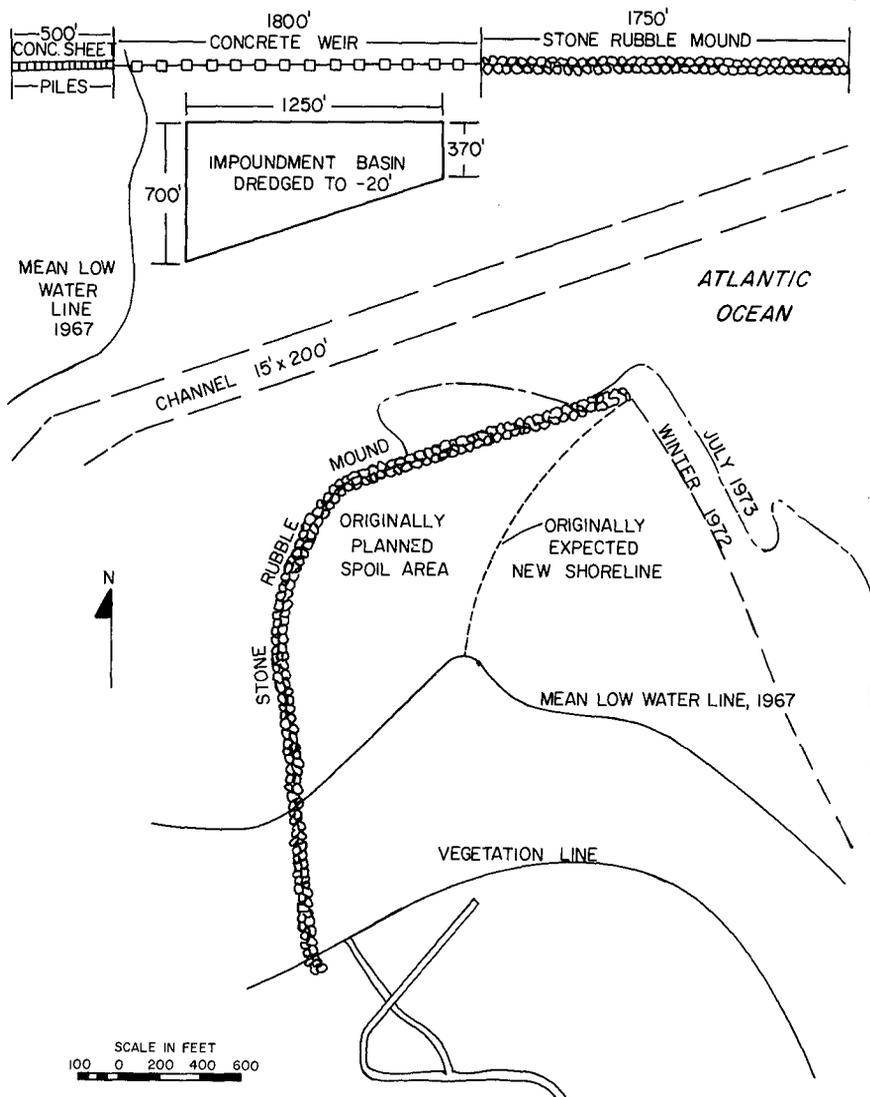
FIGURE 2 Outline of the Ponce de Leon Stabilization System

Figure 2 shows an outline of the July 1973 shoreline and M.L.W. and of the originally expected new shoreline after the dredge disposal.

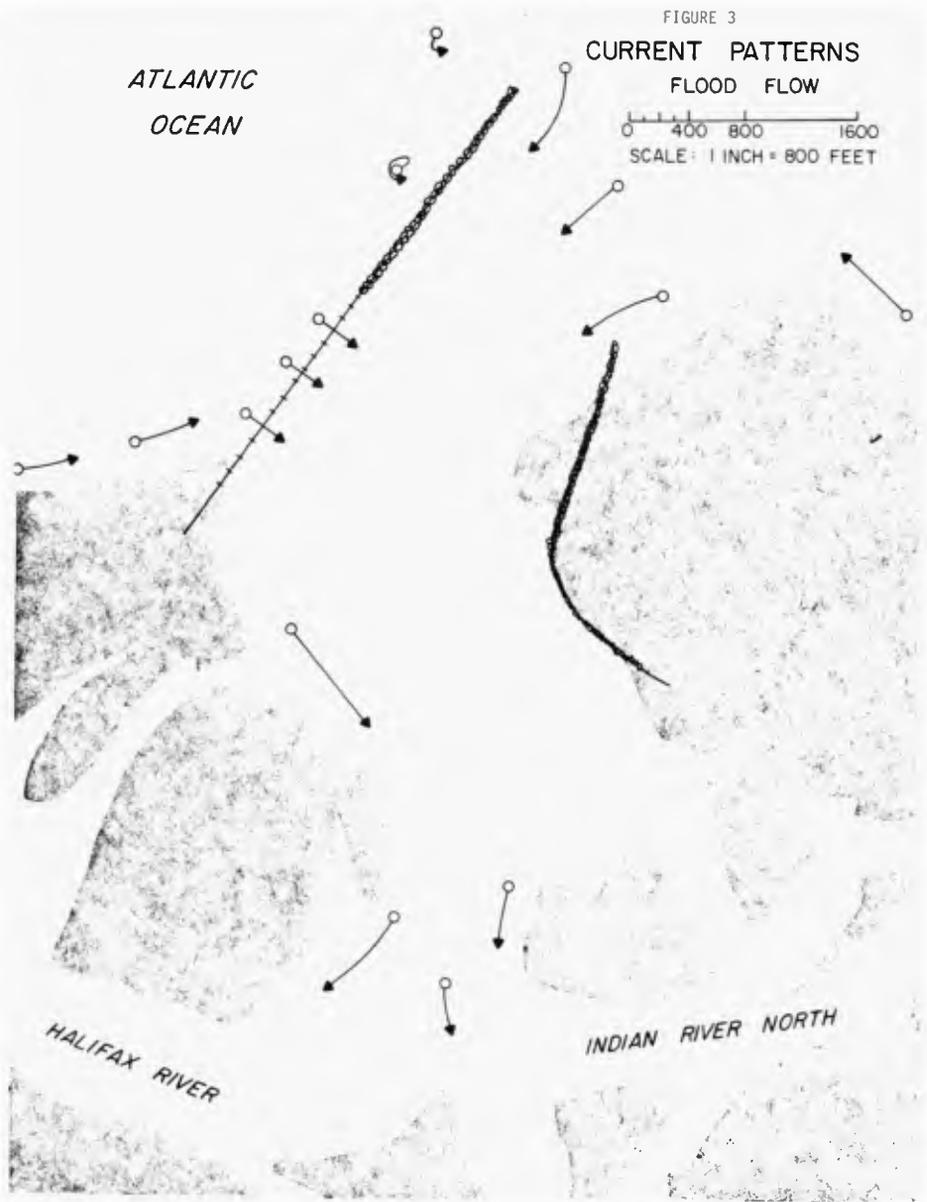
Figure 3 denotes a strong current overtopping the weir section during flood flow. There is also a very strong southerly flow evident along and parallel to the beach just north of the weir. It should be noted that this strong current is independent of any visible wave induced current

since the dye tests were made on a day with very minimal wave activity while later, at slack water, there was a negligible longshore current. On ebb flow, at a time when the tide level is approaching the level of the weir section, a strong flow is observed both across the weir and along the north jetty. Divers have observed that the current across the weir section to the northeast is quite strong during the ebb cycle. The weir section effects the inlet hydraulics by increasing the flow area during the flood cycle, while somewhat constricting the flow to within the two jetties during the extreme ebb flows. Another interesting phenomena may be observed in Figure 4 where the dye released to the north of the weir and just seaward of the breakers progresses shoreward during the ebb cycle.

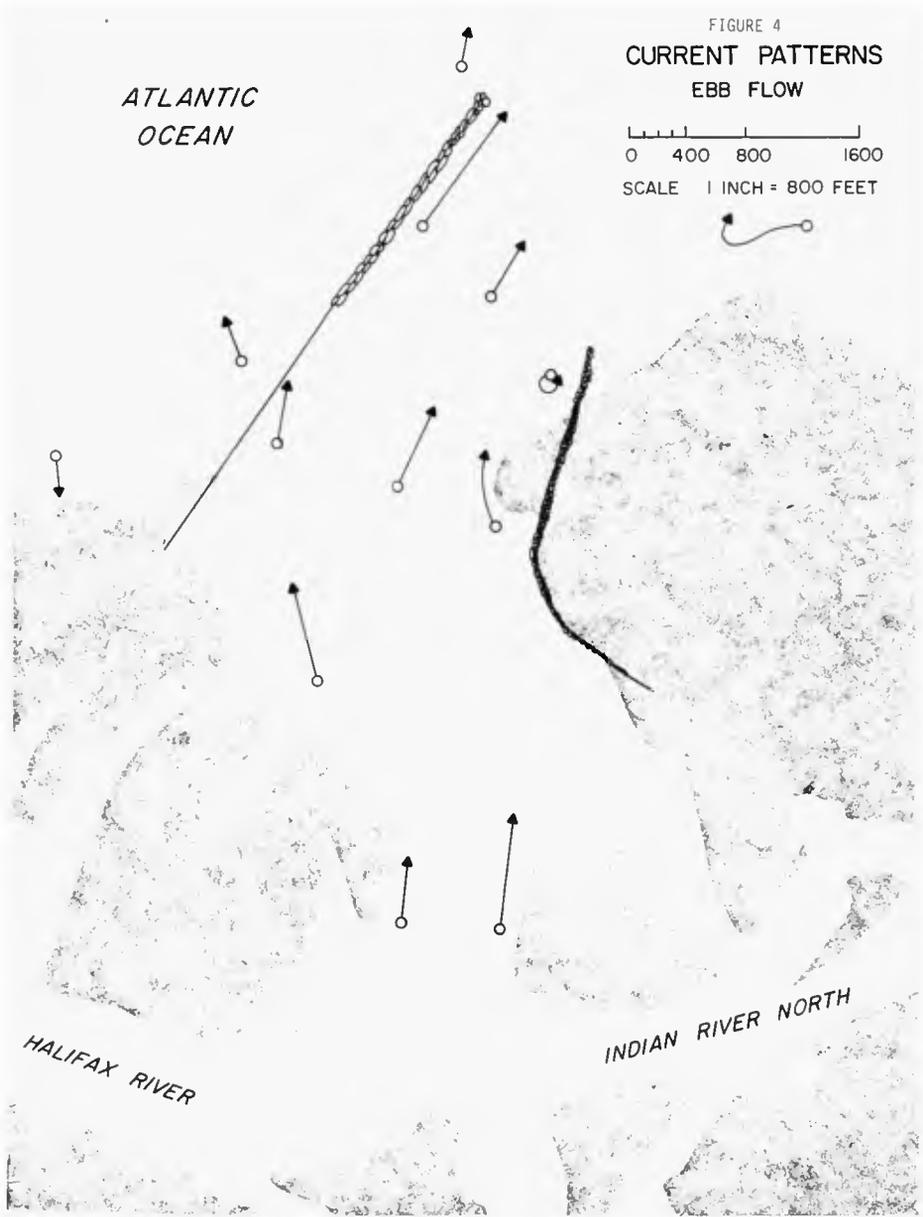
In Figure 4 a large eddy is observed during ebb current which tends to circulate clockwise moving water and sediment back into the inlet. This is a classical example of an inlet performing as a sediment sink on ebb flow as well as during flood. Sediment is rounding the south jetty and contributing to the large shoal extending from the south jetty. As this shoal progrades further into the channel, a more constricted channel flow results. Hydrographic surveys reveal this shoal to be migrating westward toward the large inner shoal area south of the throat. It is interesting that this shoal has aligned itself directly opposite the north jetty.

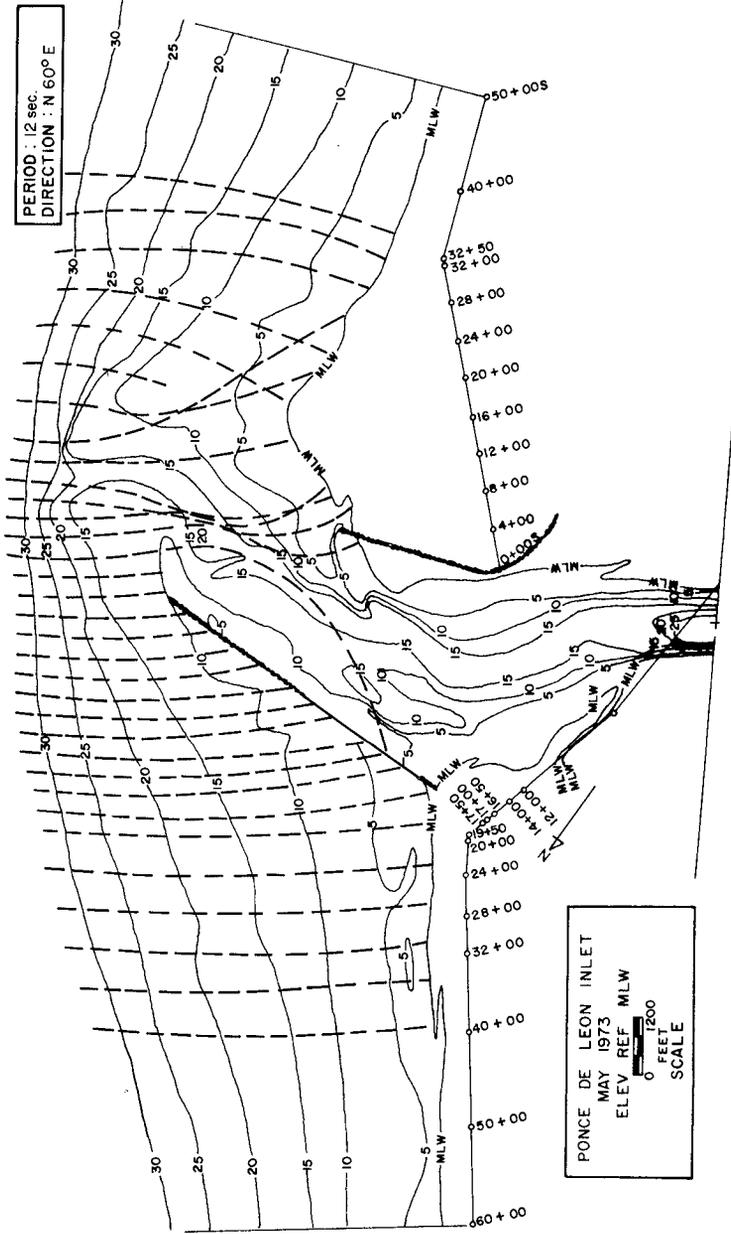
FIGURE 6

The wave rays generated in deepwater and converging on the inlet were then superimposed on a smaller grid encompassing the immediate inlet area, and refracted shoreward. Figure 6 shows a typical nearshore wave refraction pattern which was developed. From these diagrams, distinct locations of energy concentration and tendencies toward physical shoreline changes were determined. It appears that the existence and growth of the large promontory located just to the south of the south jetty is a result of a localized reversal of drift to the north associated with the refraction wave energy. Also, waves entering the entrance of the inlet tend to be refracted toward the north jetty and shoreline to which it is attached, thence enhancing the significant erosion which is being experienced in this area. Lastly, it was noted that, with respect to the region just north of the inlet, regardless of the wave characteristics, the rays are everywhere bent toward the inlet. It was therefore concluded that along the shoreline to the north side of the inlet there exist a predominant tendency for drift toward the inlet.

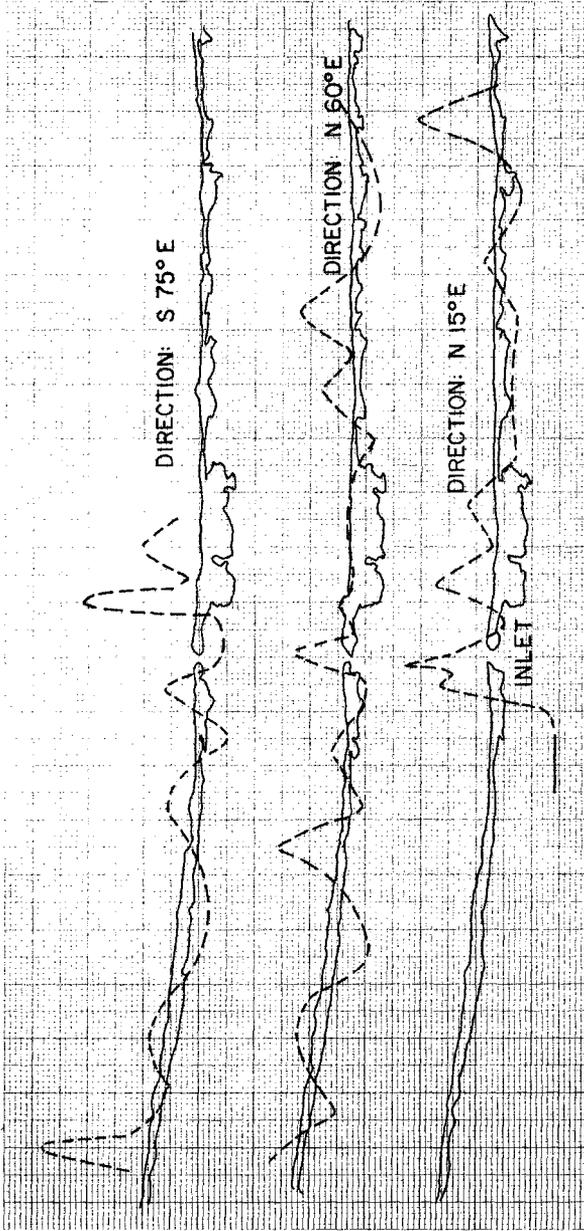
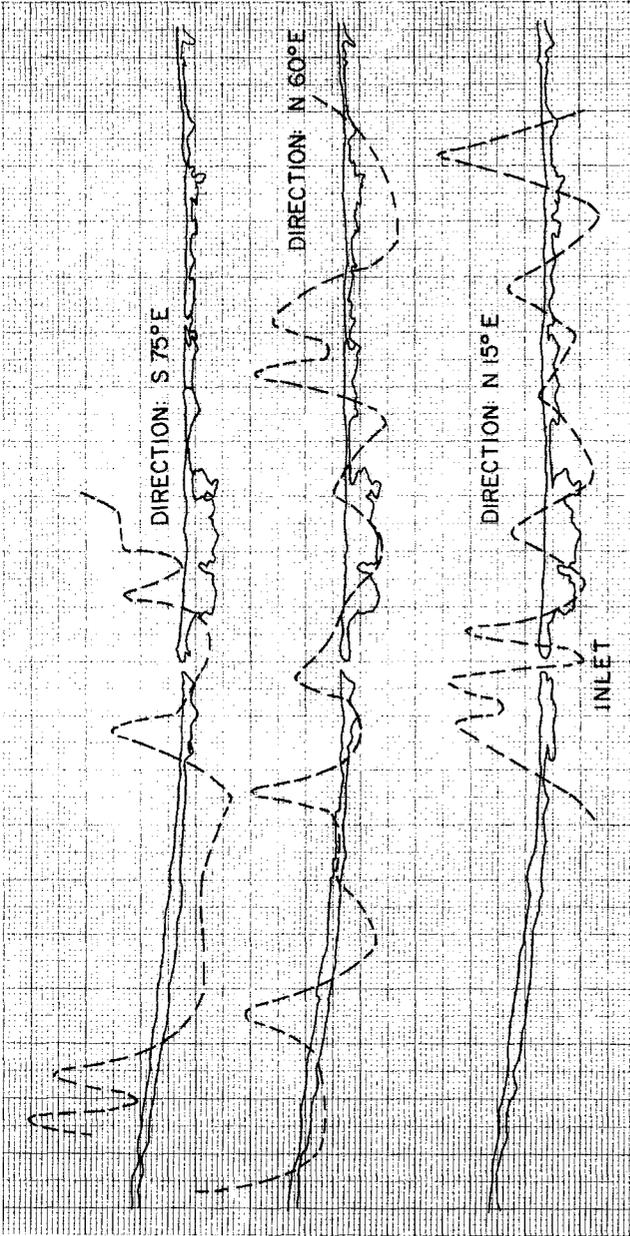
Wave energy distributions were also obtained from the refraction diagrams and plotted on a relative basis (Figure 7 and 8) from which could be determined the areas displaying a general tendency for energy concentration or reduction. It was noted that the larger storm waves caused greater concentrations of energy at certain points along the shoreline than the more normal waves. Also, by observing the resultant angle of wave approach at the shoreline, it was concluded that for an equal distribution of waves originating from different directions, a net southerly drift predominance would result to the north of the inlet and a varying drift predominance to the south.
