PART III
COASTAL STRUCTURES AND RELATED PROBLEMS,

CHAPTER 97

DAMAGES TO COASTAL STRUCTURES

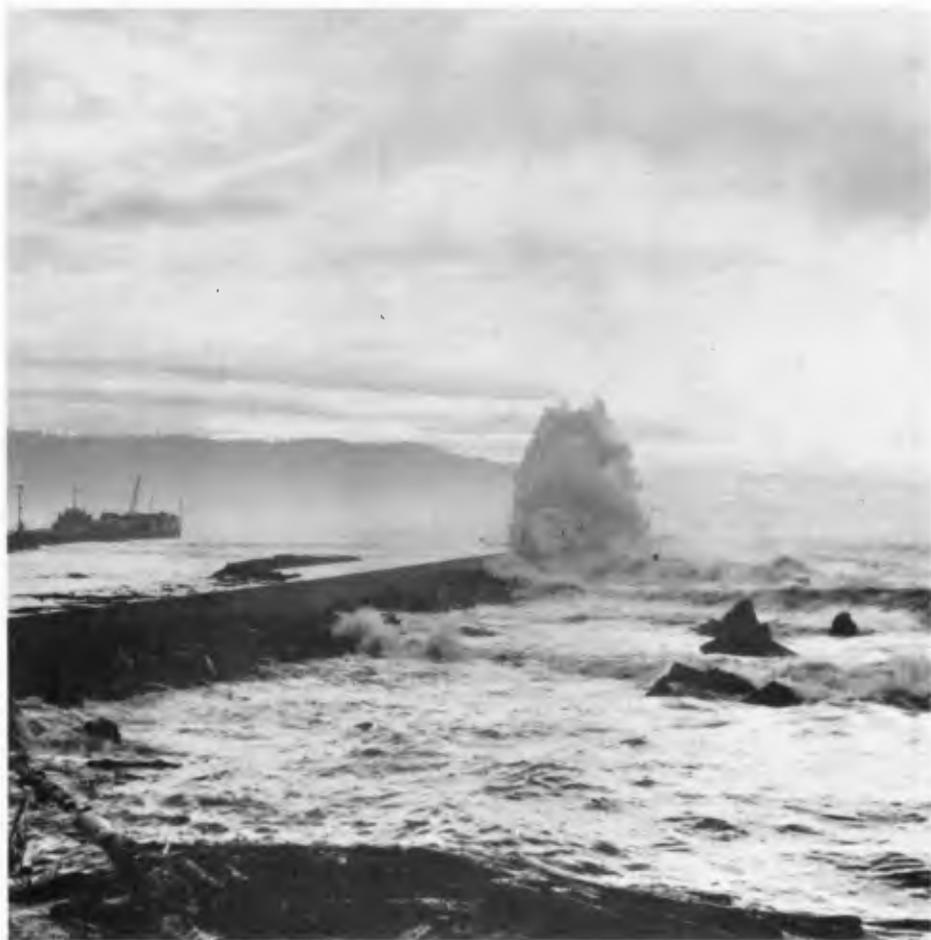
As shown on Figure 1, selected sections of coastal structures may experience concentrated wave action (even under relatively mild wave attack) due to local bathymetric effects. These areas of severe wave attack have probably produced points of initial failure. Designers of coastal structures should pay particular attention to localized effects where appropriate.

FIGURE 1. Wave attack on Crescent City
Outer Breakwater.

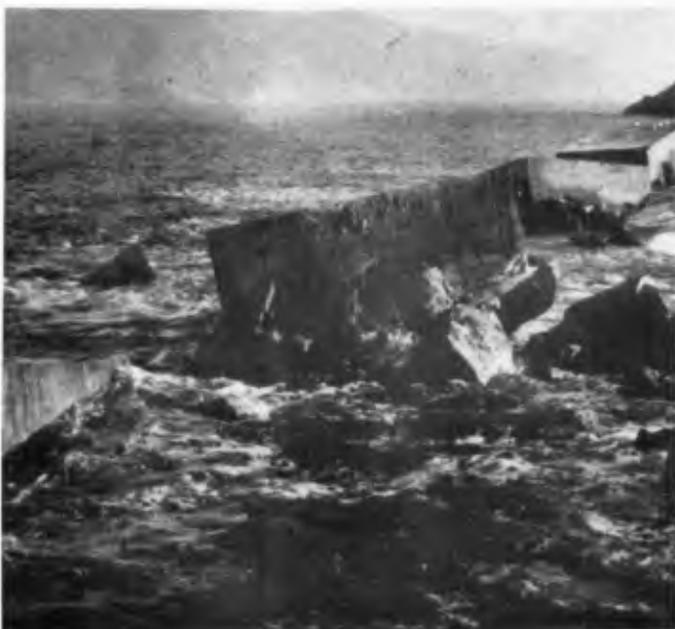
Originally, it had been planned to extend the structure along the S 27° E alignment toward Round Rock. However, as shown in Figure 4, about 500 feet of breakwater was extensively damaged during the winter of 1950 to 1951 and a realigned 1,000 foot extension was constructed during 1954 to 1957, as shown in Figure 5.

FIGURE 4. Damaged original extension of Crescent City Outer Breakwater-- viewed from Station 36+70 with Round Rock in distance (upper right).

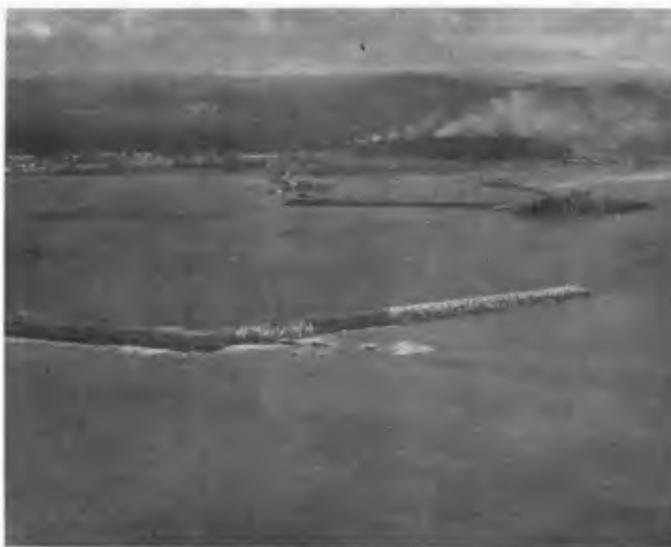
FIGURE 5. Realigned extension of Crescent City Outer Breakwater.

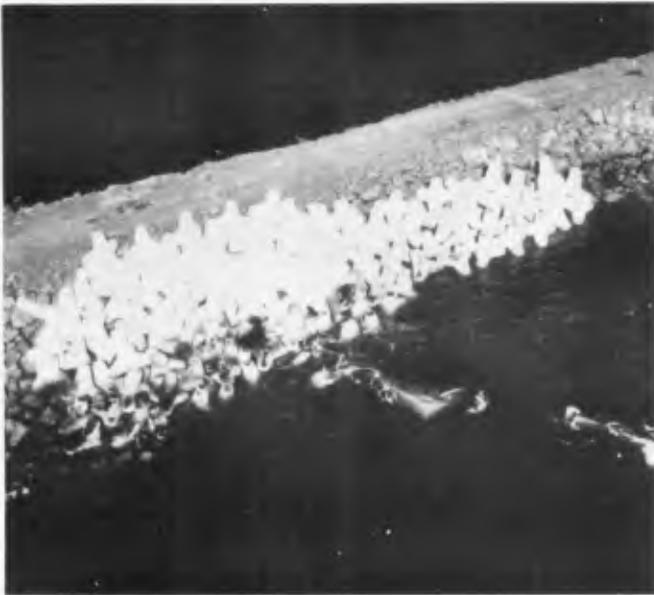
During the winter of 1956-1957, the stone section of the breakwater extension from Station 36+70 to 39+10 suffered a loss of armor stone and as sufficient stone could not be obtained from local quarries, one hundred and forty 25-ton tetrapods identical to the tetrapods placed in this section were placed in two layers from approximately Station 37+10 to 38+10 and were placed one layer from approximately Station 33+10 to 39+10 (see Figure 6). These repairs were completed in June 1957.

FIGURE 6. Tetrapod repairs to realigned extension of Crescent City Outer Breakwater.

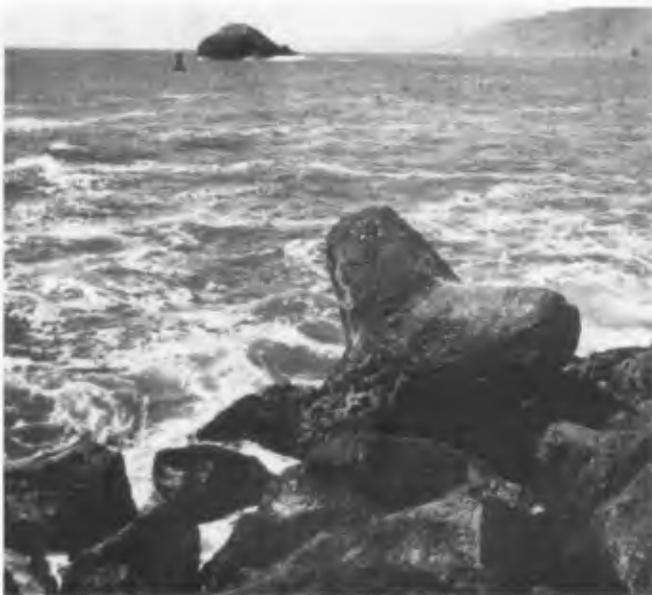
This section was extensively damaged during a severe storm in February, 1960, which resulted in the movement along the breakwater of 25-ton tetrapod units of distances of at least 100 feet (see Figure 7) and extensive breakage of tetrapods (see Figure 8). At the present time, approximately half of the tetrapods are damaged or broken, caused apparently either by movement or impact of large stone units or broken concrete fragments. The breakwater is also subject to severe overtopping (see Figure 9). This often results in a steepening in the back side of the breakwater and, in some instances, in the formation of a wave trench (see Figure 10). Two hundred and forty-six

FIGURE 7. Storm wave displacement of originally submerged tetrapod from repaired area shown on Fig.6.

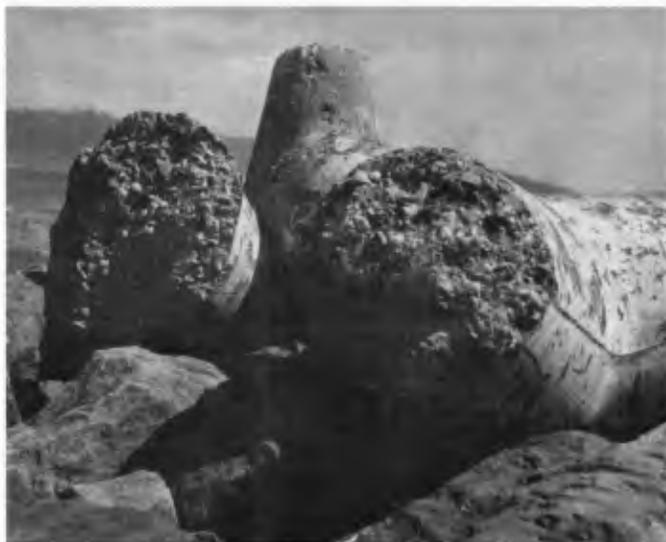
FIGURE 8. Tetrapod damaged by storm wave attack on repaired area shown on Fig.6.

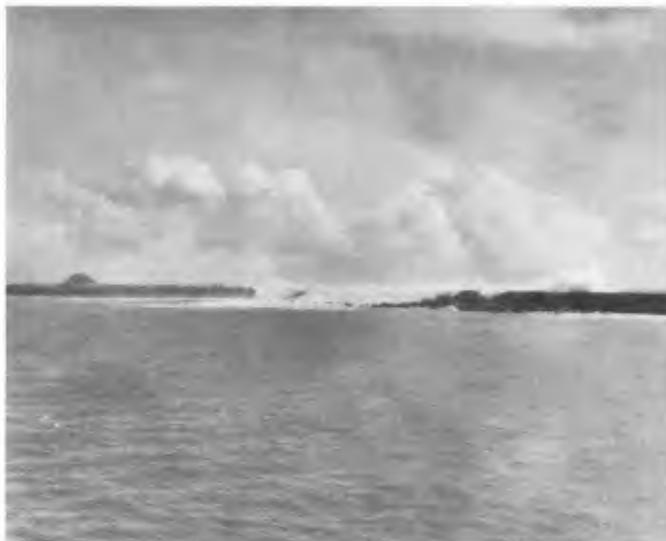
FIGURE 9. Wave overtopping--Crescent City Outer Breakwater.

40-ton dolosse were placed as repair between Stations 35/00 and 37/00 (area of maximum overtopping in Figure 9) in late 1973 (see Figure 22).

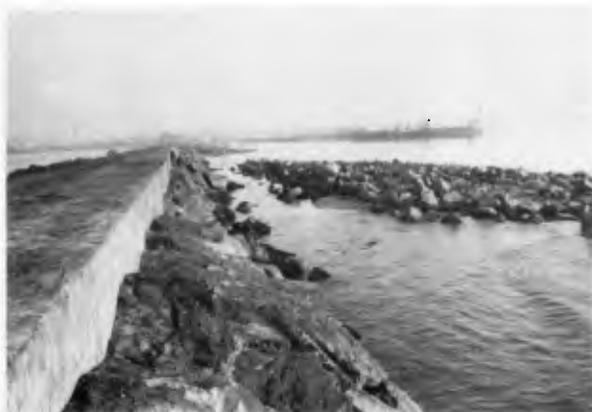
FIGURE 10. Wave trench resulting from the overtopping shown on Fig. 9-- Crescent City Outer Breakwater.

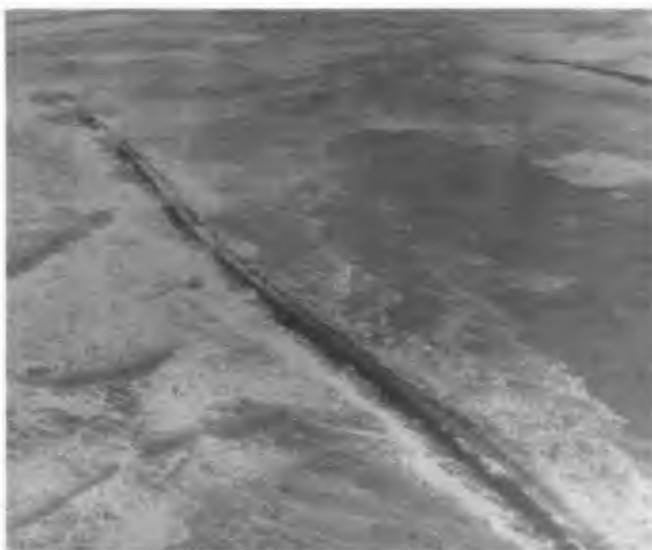
FIGURE 11. Jettied entrance to Humboldt Harbor and Bay during storm activity of February 1960.

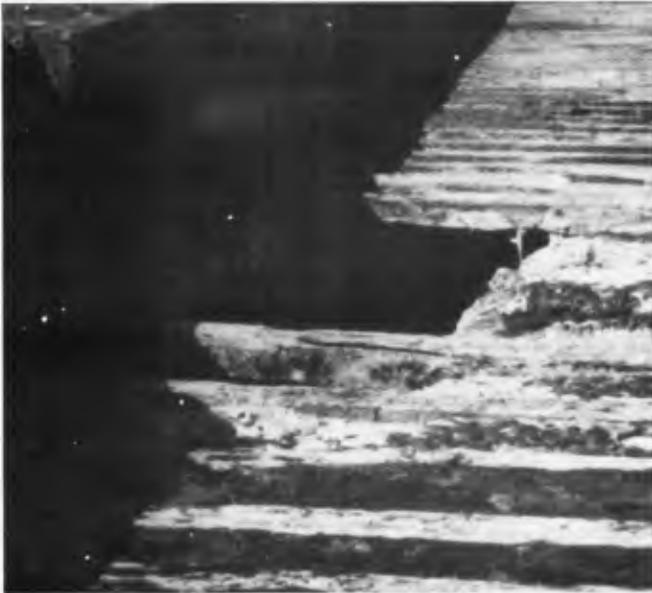
FIGURE 13. Uplift pressure failure--Humboldt Harbor and Bay North Jetty.

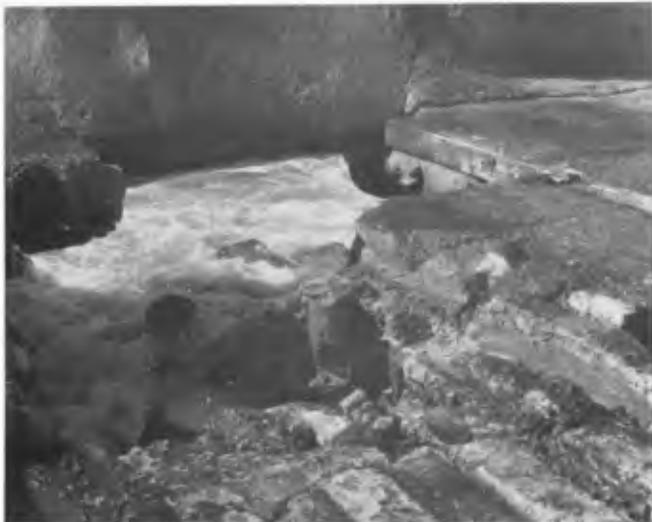
FIGURE 14. Advanced stages of uplift pressure failure--Humboldt Harbor and Bay North Jetty.

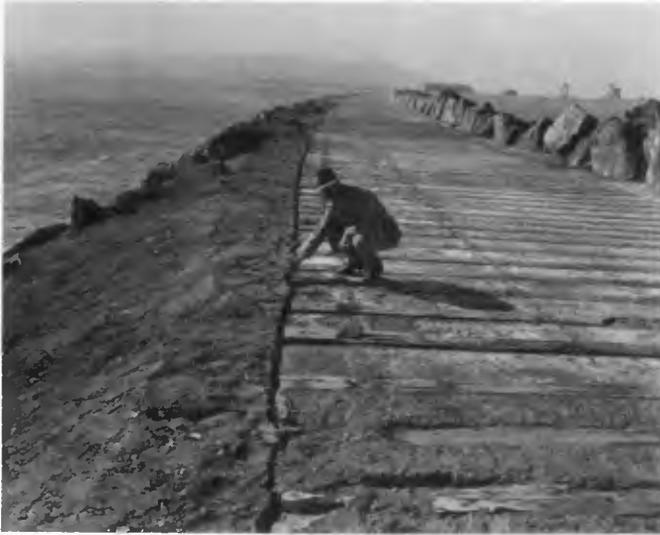
The Humboldt jetties (1), shown on Figure 12 have probably experienced the most severe wave attack and necessitated the greatest amount of maintenance of any structure studied. The structures were initiated in 1889, and, although the exact quantities of new construction and maintenance stone cannot be determined exactly, the quantity of stone placed for repair has been greater than the quantity placed in the initial construction (more than 1,000,000 tons). Documented storm attack on the structure (see Figure 11) has indicated that waves completely cover the seaward portions of the structure, with an average dock elevation of 26 feet MLLW. Several types of failure have been repeatedly experienced at the Humboldt jetties. Damage by uplift pressures is shown in Figures 13 and 14. In an effort to prevent slope failure by overtopping, portions of the back sides of the structure were covered with concrete. As shown in Figures 15 and 16, initial cracking of this concrete eventually breaks up completely.

FIGURE 15. Beginning of slope separation failure--Humboldt Harbor and Bay South Jetty.

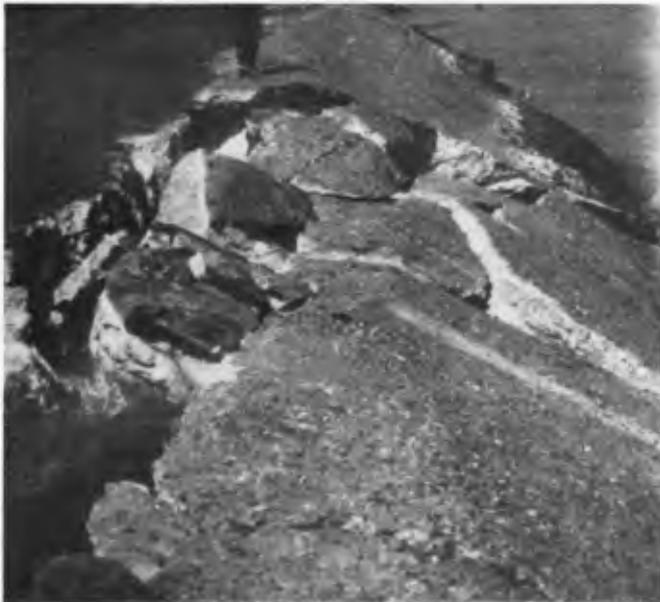
FIGURE 16. Advanced slope separation failure--Humboldt Harbor and Bay South Jetty.

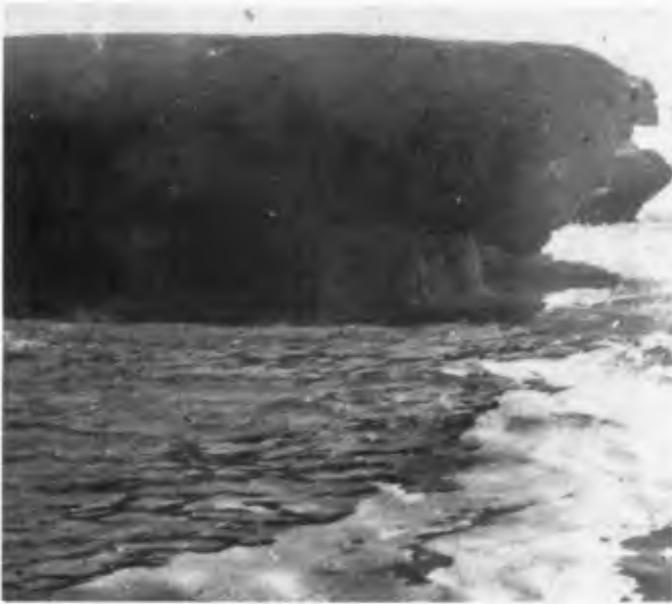
During the 1960s, a concrete monolith was constructed at the seaward head of the North Jetty. A ringing levee was placed around the head, with the intention of pouring mass concrete into the area surrounding the existing head. However, wave action through the ring levee resulted in washing away of the concrete as it was poured. Soon after construction, the ring levee was washed away resulting in an overhanging concrete mass shown in Figure 17. This subsequently collapsed, resulting in large broken pieces as shown in Figure 18. In efforts to stabilize the heads of these structures, a great number of concrete blocks (see Figure 19) with maximum weights of 100 tons have been placed along the sides of the jetties. Essentially all of these blocks have been dislodged. Many of the blocks and supporting stones have been displaced landward and moved landward (see Figure 20).

FIGURE 17. Displacement of ring dike and lack of concrete penetration--seaward head of Humboldt Harbor and Bay North Jetty.

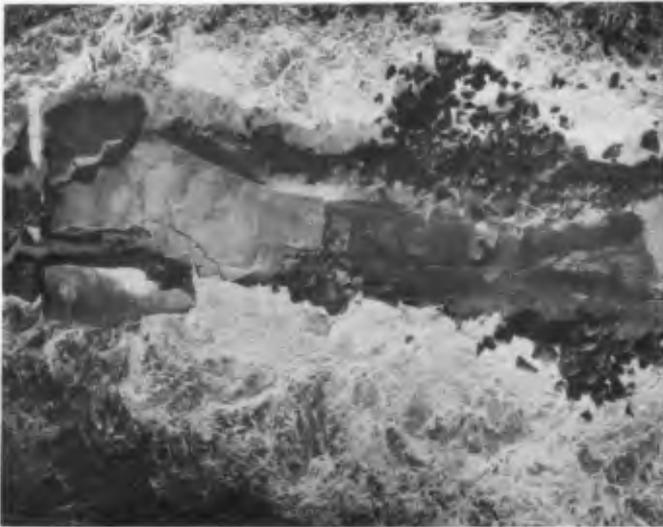
FIGURE 18. Monolithic breakup--Humboldt Harbor and Bay North Jetty.

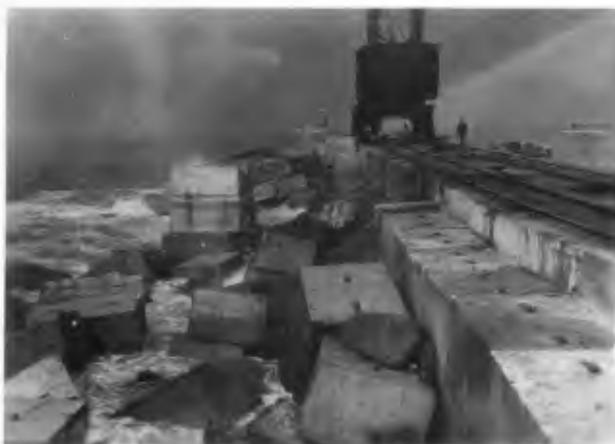
FIGURE 19. 20-ton pre-cast concrete blocks circa 1932--seaward face of Humboldt Harbor and Bay South Jetty.

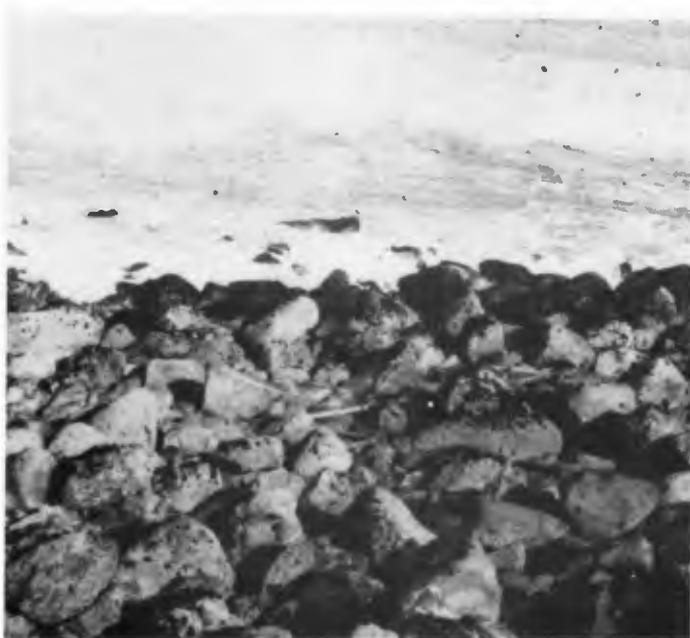
FIGURE 20. Stones displaced from seaward head of Humboldt Harbor and Bay North Jetty showing extensive rounding due to impact and abrasion.

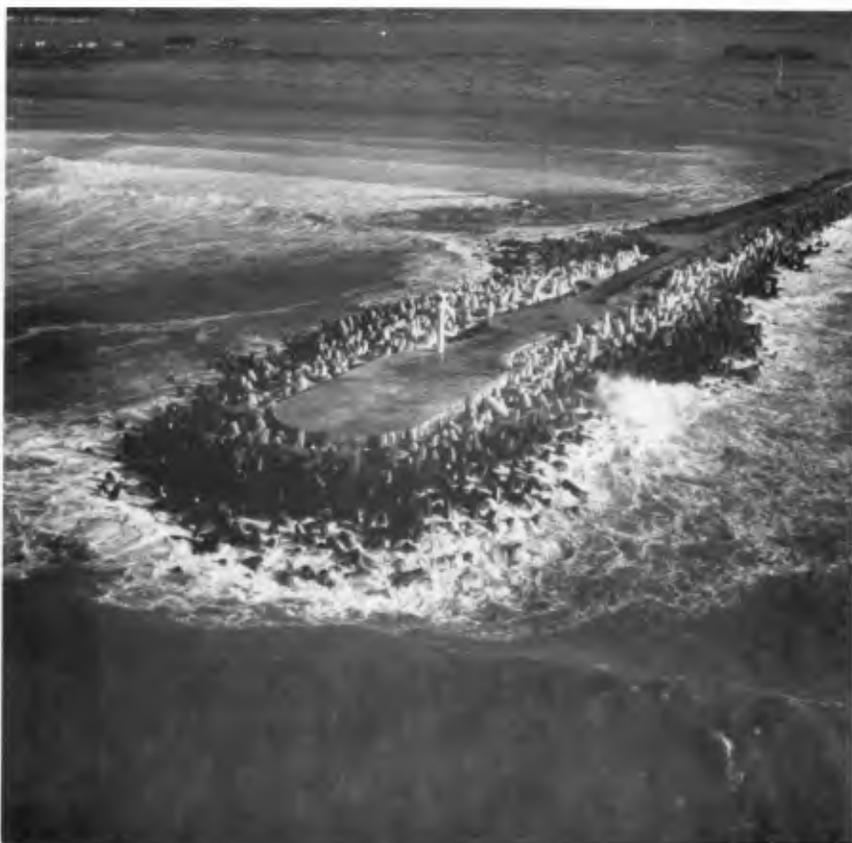
FIGURE 21. Wave dissipation in Dolos armor units--rehabilitated Humboldt Harbor and Bay North Jetty.

As described by Magoon and Shimizu (2), both the North and South Jetty heads have been repaired with 42 and 43-ton concrete dolosse armor units (see Figure 21). Most of these units are reinforced; however, as shown in Figure 22, unreinforced and fiber reinforced (3) units have been placed at both the Humboldt jetties and at the Crescent City outer breakwater (see Figure 22). Based on the available inspections which do not include those units placed under water, about 12% of the unreinforced units are broken, 0.4% of the conventionally reinforced units are broken and none of the fiber reinforced units are broken.

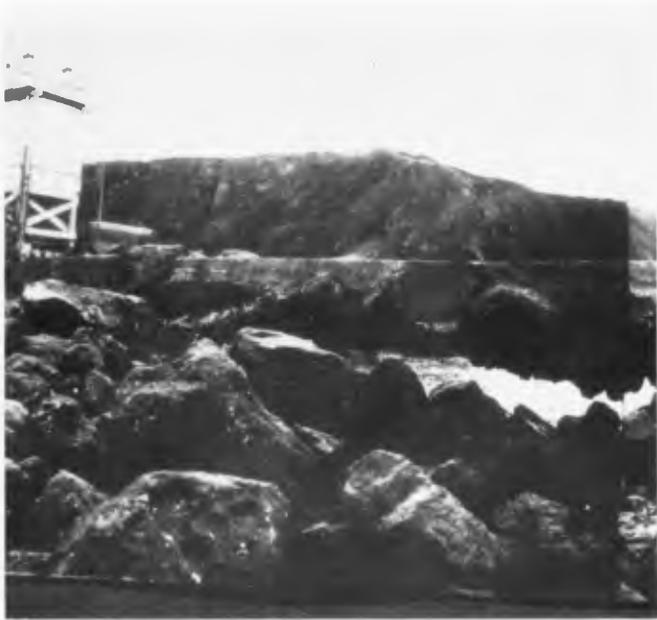
a classical failure of composite structures which results from consolidation of the rubble structure and subsequent removal of the material below the concrete cap, leaving the cap in the form of a bridge (see Figure 23). Rigid coastal structures often fail by loss of protective material at the toe and subsequently collapse or topple over. Photographs of Figures 7 and 27 are left to right reversed.

FIGURE 24. Failure of rigid structure due to undermining--Noyo River and Harbor North Wall and Jetty.

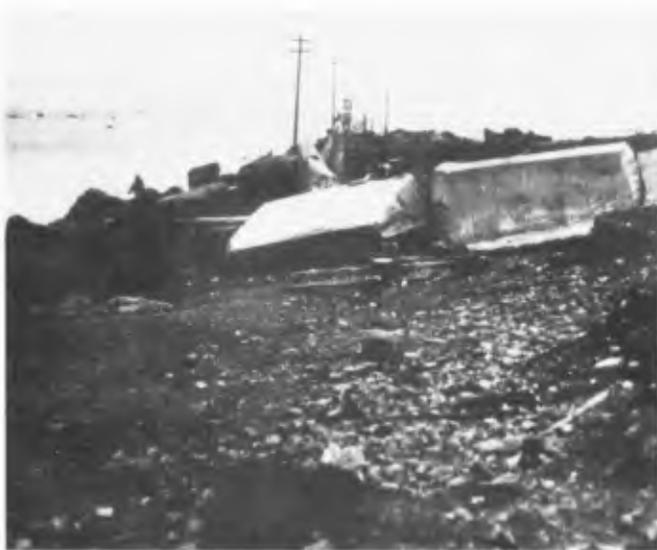
FIGURE 25. Advanced failure of rigid structure due to undermining--Noyo River and Harbor North Wall and Jetty.
