LOW-COST SHORE PROTECTION ON THE GREAT LAKES: A DEMONSTRATION/RESEARCH PROGRAM

Dr. John M. Armstrong

Associate Professor, Department of Civil Engineering
and
Director, Coastal Zone Laboratory
The University of Michigan
Ann Arbor, Michigan

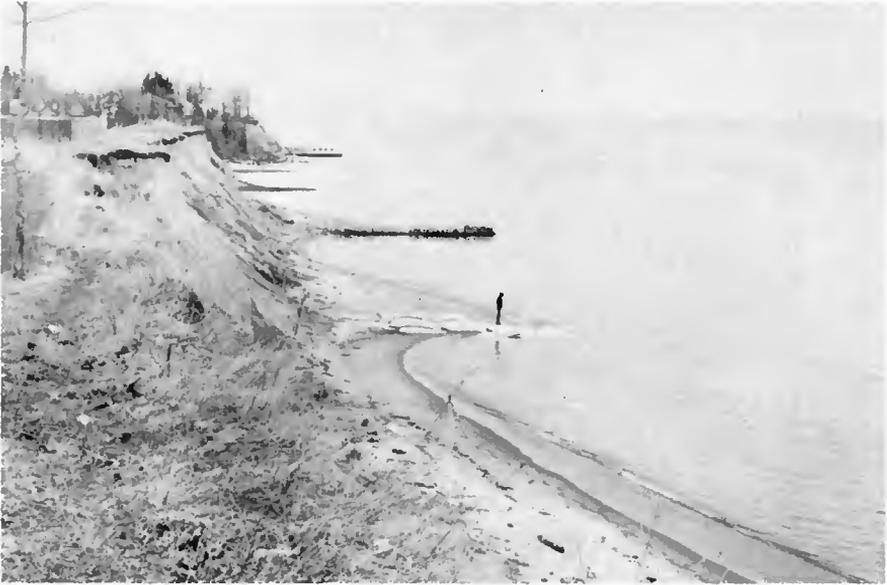
Figure 2 Sanilac 26 April 27, 1975

Giant Sandbag Groin. The giant sandbag groin was installed in the late fall of 1973 and suffered major damage in the first year. The length of the groin is 60 feet (18.3 meters) and costs \$30 per foot (\$98 per meter) to install. Nearly 15 feet (4.6 meters) of sandbags were lost at the lake end of the groin. Vandalism is probably not the cause since the lost bags are at the lakeward end of the structure. No further sandbag loss has been detected, but some bags have shifted since April 1975. The structure appears to be effectively trapping sand despite the damage. Preliminary conclusions as to its effectiveness and durability indicated that sandbag groins could only offer temporary protection. After further study under mild storm activity, it appears that the bags can offer more than just temporary protection. However, they are not as durable as other structures. With annual replacement of damaged bags and protection against tearing, sandbag groins could function effectively for several years.

In general, the wider spacing between the different groins has proven effective. Minor bank recession has been recorded for small stretches of the shoreline. However, as stated earlier, this could be completely due to terrestrial processes. Of the six groins studied at Sanilac 26, the asphalt-mastic groin has been the most stable. The sandbag groin has suffered the most damage. The Longard tube groins are performing adequately. Both the gabion and the timber crib groins are in excellent condition.

The sandbag groin can be seen in the foreground with the gabion, 69-inch (175.3 cm) diameter Longard tube and the two 40-inch (101.6 cm) diameter Longard tube groins in succession behind it. The group of structures in the far background are not part of this project.

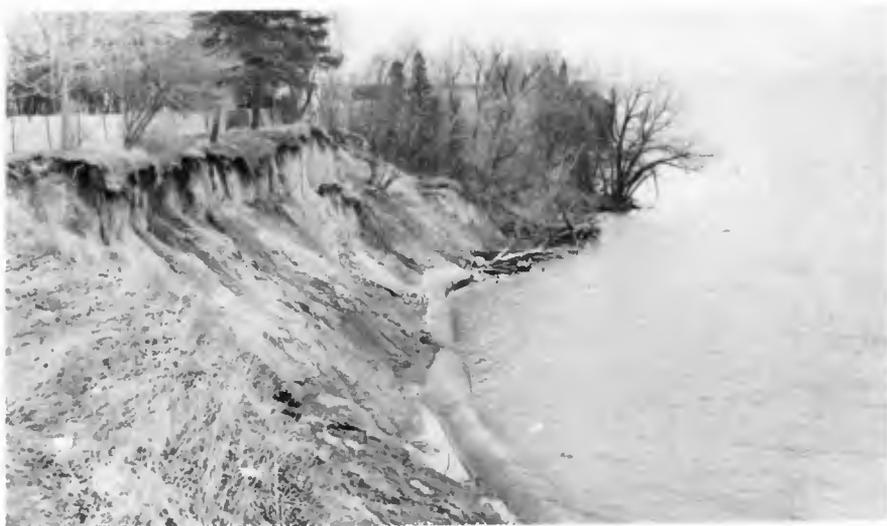
Figure 4 Sanilac 11 April 27, 1975

Site 7 is located about 1.5 miles (2.42 kilometers) north of Site 6 and has the same high clay bluff shoreline. Two 69-inch (175.3 cm) diameter Longard tubes were installed here as a seawall rather than as the groin system utilized at Site 6. The tubes were placed end-to-end at the toe of the bluff parallel to the shoreline, extending 400 feet (121.9 meters). Cost of construction was \$65 per foot (\$213 per meter) of shoreline at the time of installation in the early fall of 1974. Figure 4 shows the condition of the site in the spring of 1975. While the tubes appear to have performed well at this location, there has been minor shifting and damage. Some sand has been lost at the center of the structure where the tubes meet. The north end of the seawall has moved lakeward by more than 5 feet (1.5 meters), but the entire structure has, in general, resisted back pressure from the slumping bluff. Only slight vertical settlement of the tubes has been detected. The one major storm experienced at this site had no effect on the seawall's performance.

This view shows the 69-inch (175.3 cm) diameter Longard tube used as a seawall at Sanilac 11. The very active and slumping clay bluff is evident in the photograph.

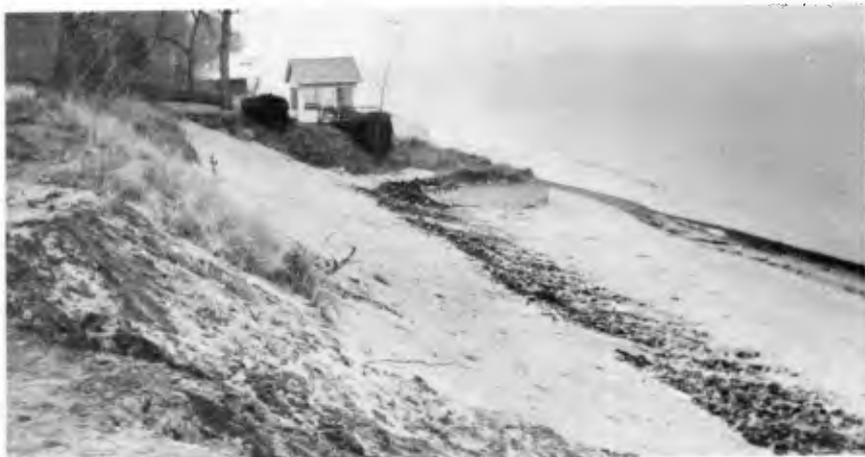
Figure 5 Michiana September 23, 1973

During the first year of study the structure performed very effectively and withstood four major storms. The revetment is shown in Figure 5. However, a storm in the spring of 1975 which produced breaking waves of about 7 feet (2.1 meters) for a duration of 24 hours caused most of the structure to collapse. The damage can be seen in Figure 6. The long duration of the storm rather than the wave heights had the most damaging effect. The storm was so severe that the steel seawall at the top of the bluff was threatened. Damage to the revetment resulted in a change of its slope from a ratio of 2 to 1 to 4 to 1. This left the backside 3 feet (.9 meters) lower after the storm. The underwater region immediately offshore had been severely eroded. The deeper water permitted waves larger than the revetment was designed to withstand to reach the shore. This contributed to the loss of sand behind the structure. Undermining of the revetment was probably caused by scour at the toe and overtopping. The asphalt-mastic revetment was more effective than the seawall as it was able to protect the bluff (and the road) even in its damaged condition.

The revetment can be seen one month after completion of construction in the fall of 1973.

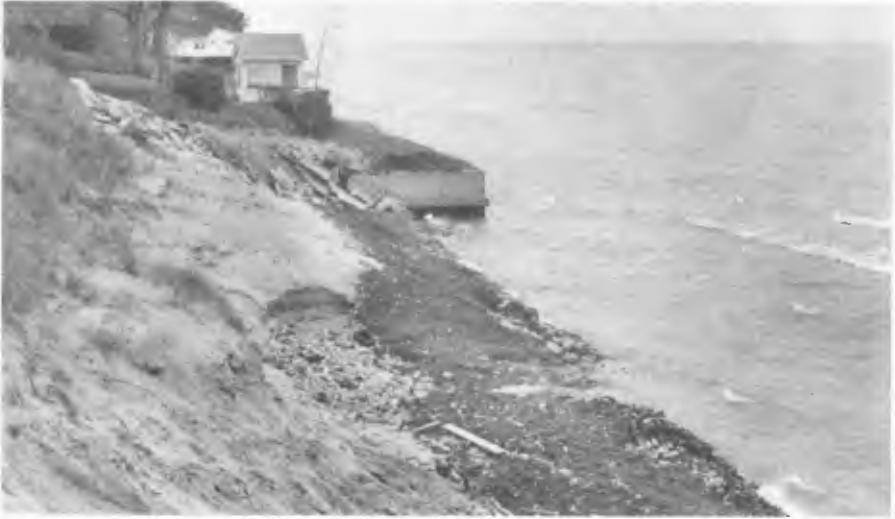
Figure 6 Michiana October 20, 1975

It appears that the asphalt-mastic revetment performs quite well during most storm activity. The damage to the revetment from the unusually long storm also may have been caused by wave reflection off the steel wall at the north end. This is supported by the fact that 75 feet (22.9 meters) of revetment closest to the wall suffered severe slumping whereas the next 75 feet (22.9 meters) was hardly damaged.

Until it failed, the revetment was able to withstand all wave attacks. Even in its collapsed position, it provides a small level of protection from minor storms. The revetment has remained unchanged since the spring storm. Bluff recession has continued, however, and the road at the top of the bluff is threatened.

Large portions of the sand behind the structure have been washed out causing the structure to collapse. Despite its collapsed condition the revetment has maintained its integrity. Emergency fill operations are evident at the south end of the project near the concrete seawall. The entire beach area has been eroded as is evident by the exposed steel pile foundation beneath the concrete seawall.

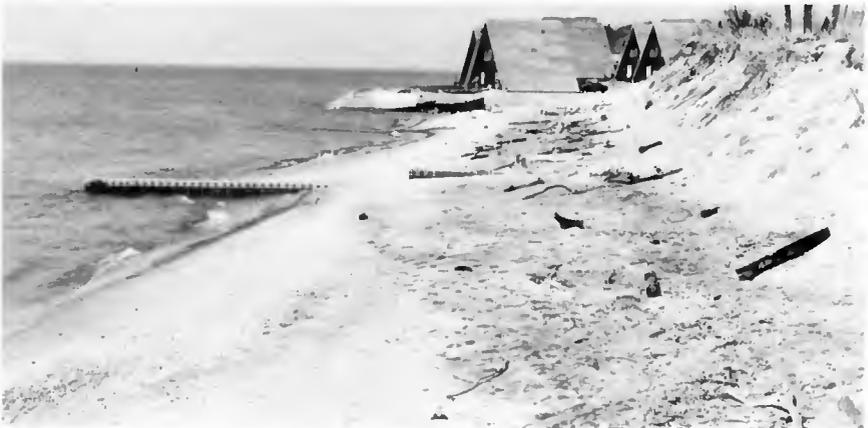
Figure 7 Lincoln Township April 20, 1974

The shore protection structures installed at this site consist of a groin system with two groins 240 feet (73.2 meters) apart. Two types of groins were used: a 40-inch (101.6 cm) diameter Longard tube, 120 feet (36.6 meters) long, and a 90-foot (27.4 meter) long timber pile groin. The two structures are shown in Figure 7.

Despite the initial tear, the Longard tube has suffered only moderate damage. The lake end of the tube (approximately 30 feet [9.1 meters]) has been lost and the whole structure has settled about 3 feet (.9 meters) along the centerline. It is very possible that the tube would have settled in this locale even without the influence of the heavy equipment. The rate of settlement increased again in the fall of 1975 after remaining relatively stable for about a year. It has not been determined if this is due to sand washing out of the tube from the lakeward end or by settlement. The tube still acts successfully as a groin in trapping sand and protecting the bluff. Design modifications could be incorporated, such as placing the tube on a foundation (preferably rubble) and covering the tube with an armored protective coating. This modified groin would be a good low-cost method of shore protection, though not as inexpensive as the present design. The present method of placing a 40-inch (101.6 cm) diameter Longard tube on a sandy lake bottom will only serve as a temporary method of erosion control.

The timber pile groin, installed in the winter prior to this photograph, is evident in the foreground. Part of the Longard tube, constructed the previous fall, can be seen in the background (near the tripod). Settlement in the tube is particularly evident at the shoreline.

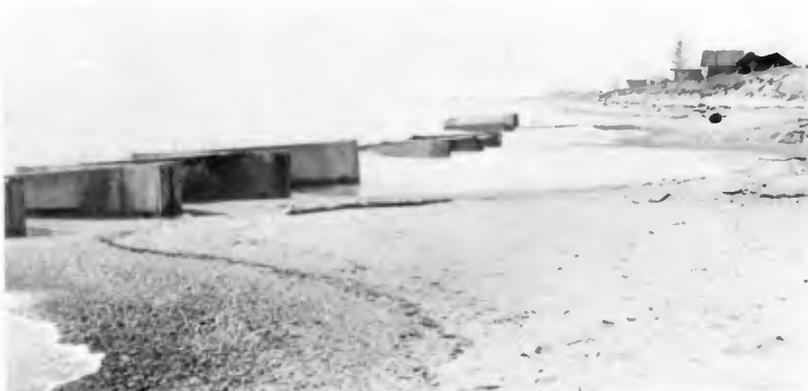
Figure 8. Pere Marquette Township April 29, 1974

The breakwater system performed quite effectively in building up a beach and preventing bluff recession for the first year. Figure 8 shows the structure in the spring of 1974. Eight major storms were experienced at this site. A major storm with 6- to 10-foot (1.8 to 3.0 meter) waves in the winter of 1975 caused extensive damage to the structure and bluff. All three structures were damaged by settlement and panel breakage. The north section lost two entire panels and settled over 3 feet (.9 meters). It is now completely submerged; this can be seen in Figure 9. One panel was lost off of the center section which also settled and tilted radically. The remaining walls are badly chipped and cracked and have tilted toward shore. Major bluff recession has continued, up to 30 feet (9.1 meters) during the second study year. The bathhouse protected by the breakwater has been completely destroyed.

This view shows the south and north set of panels (looking north) shortly after construction. The center panels were installed in the fall of 1973. The newer set of panels were placed at a higher elevation (with more freeboard) than the center section. As is evident, these panels were initially very effective in trapping sand.

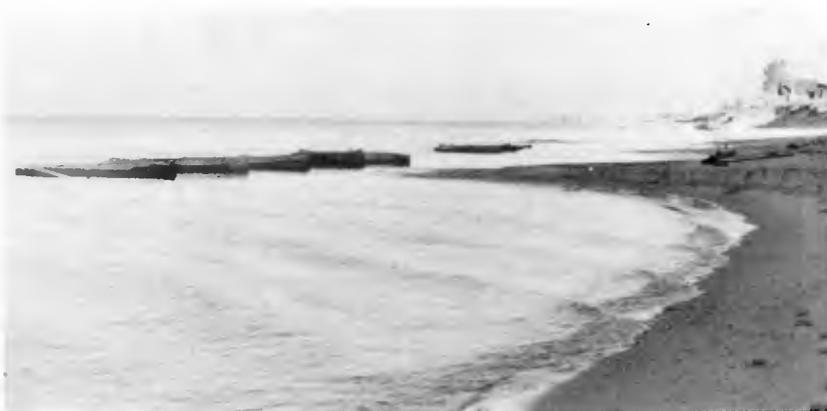
Figure 9 Pere Marquette Township October 12, 1975

In this photograph (looking north) it is evident that the north and south sets of panels have settled considerably. Effectiveness of the structures has been reduced and the bluff behind the structures (not shown) has been considerably damaged by storms.

This experimental use of precast zig-zag walls was intended for onshore use only. Unless redesigned, this type of structure should not be used as an offshore breakwater. Necessary design modifications, however, would eliminate this system from the low-cost category. The private homeowner could not install this structure himself because heavy construction equipment is required. This is not a recommended method of shoreline protection as used in this program. Other breakwater designs, although very expensive, should be used if site conditions require that method of shore protection.

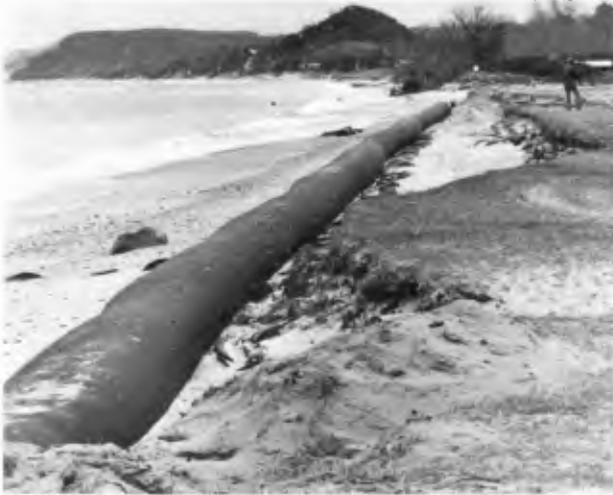
Figure 10 Empire November 3, 1973

This picture was taken shortly after construction was completed. The filter cloth foundation and the low sand bluff to be "protected" by the tube is evident.

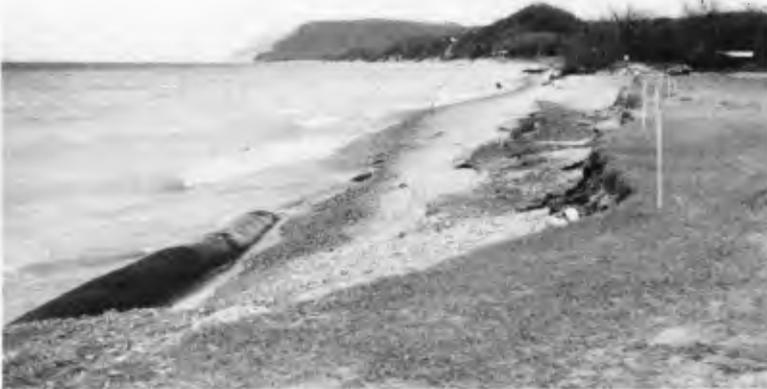
Figure 11 Empire March 7, 1974

Recession rates as high as 30 feet (9.1 meters) a year have been experienced at the Village Park in Empire Village. This open coast area with 3-foot (.9 meter) sand bluffs was selected for testing a 40-inch (101.6 cm) diameter Longard tube utilized as a seawall. The 300-foot (91.4 meter) tube was laid on a filter cloth foundation parallel to shore at a cost of \$30 per foot (\$98 per meter) of shoreline. The tube can be seen immediately after it was installed in the fall of 1973 in Figure 10. Shortly after construction, the tube was attacked by 5-foot (1.5 meter) breaking waves for a 14-hour period. Probable maximum wave height was 11 feet (3.4 meters). Due to the shoreline configuration, waves pounded directly against the structure. The single tube was unable to withstand this wave attack and was destroyed. The damage can be seen in Figure 11. If the tube had been sewn to the filter cloth, it may have been more effective.

As evident in this photograph, a large portion of the structure has settled out of site. Bluff recession has continued at a high rate.

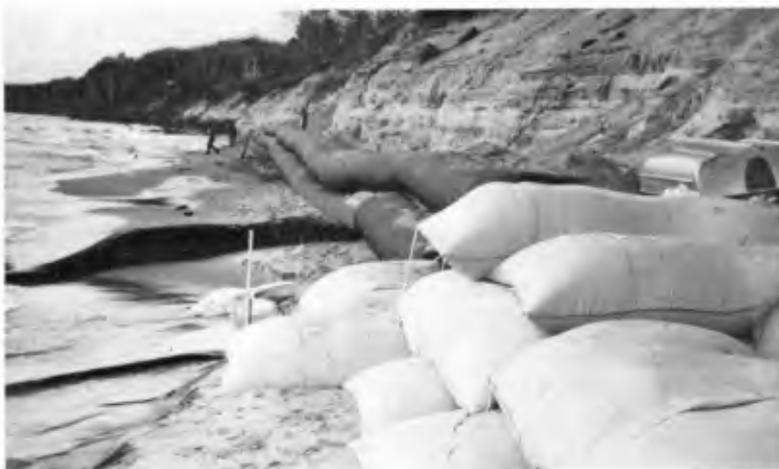
Figure 12 Moran Township November 4, 1973

This site is located along U.S. 2 in Moran Township. The 30-foot (9.1 meter) sand bluffs found here have been severely eroded. Two styles of seawalls were selected for testing. Three 40-inch (101.6 cm) diameter Longard tubes were installed in a pyramid configuration (one on top of two) on filter cloth parallel to the shoreline within 10 feet (3.0 meters) of the waterline. The tubes extended for 300 feet (91.4 meters). The second structure consisted of giant sandbags placed in four different stacking patterns at the toe of the bluff, parallel to the shoreline, for 250 feet (76.2 meters). The different stacking sequences were incorporated to test their relative effectiveness. All Longard tubes were installed in the fall of 1973. At the east end of the tubes, the sandbag structure was installed in the spring of 1974. A view of this site can be seen in Figure 12. The costs of construction

The Longard tube structure and one of the stacking patterns of the sandbag structure, both used as seawalls, are shown here. The short stub groin protruding lakeward from the Longard tubes was removed. The active sand bluffs to be protected by the seawalls are evident.

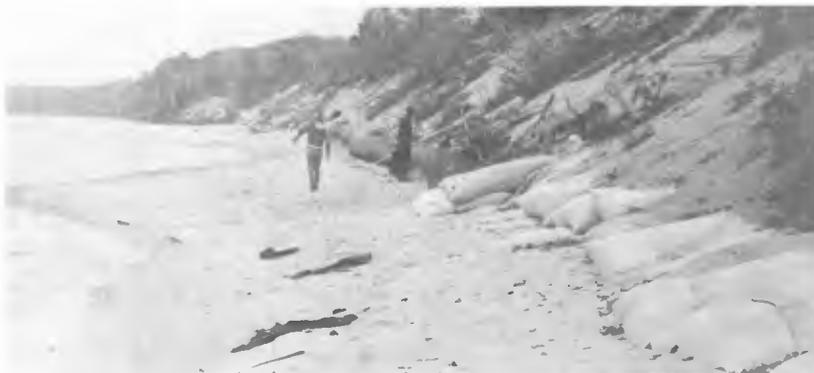
Figure 13 Moran Township October 12, 1975

per foot (meter) of shoreline for each was \$60 (\$197). Five major storms have since been experienced but only minor problems have been experienced. The top Longard tube shifted out of position due to back pressure from the slumping bluff and had to be shimmed up. The western 50 feet (15.2 meters) moved lakeward about 3 feet (.9 meters). The lower tube is now covered with sand, apparently from sand washing in and around it (no vertical movement of the tube has occurred). The condition of the structures in the fall of 1975 is shown in Figure 13. Despite this, the tubes have retained their original effectiveness. The top of the bluff behind the structures has continued to recede and slump. This occurred because the sand bluff was not in a stable position. The most dramatic bluff loss has occurred behind the sandbags and between the two structures. The sandbag structure, despite some bag loss due to vandalism, has remained stable and performs effectively. Both structures have effectively protected the bluff from major erosion damage (although the shoreline adjacent to the structures has also only experienced minor recession). There is a wider expanse of beach in front of the Longard tubes than the sandbags. This appears to be more of a natural phenomenon than an indication of relative structure effectiveness.

This is a view of the site two years later. Many sandbags have been lost and the tube has remained stable. Recession activity is evident as shown by the number of trees and vegetation scattered along the face of the bluff. This action is a result of erosion damage prior to the installation of the test projects. The shoreline in front of these structures has stabilized as well as the shoreline in the adjacent areas (no cause and effect relationship is apparent).
