BREACH/INLET INTERACTION AT MORICHES INLET

E.J. Schmeltz,¹A.M.ASCE, R.M. Sorensen,²M.ASCE
M.J. McCarthy,³A.M.ASCE, G. Nersesian,⁴M.ASCE

ABSTRACT

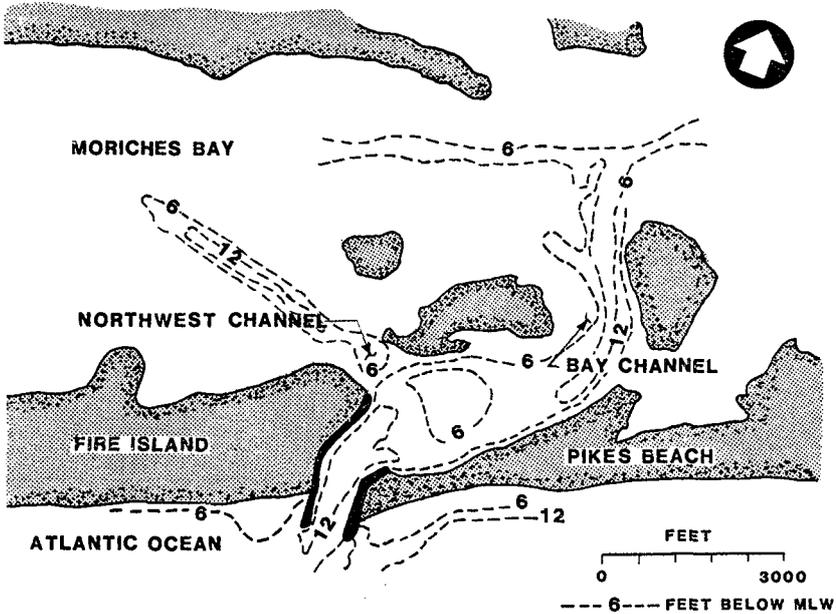
Figure 3 - Plan of Inlet and Adjacent Channels

The ebb tidal flow through the Northwest Channel from the ICCW to the inlet is directed at Pikes Beach (see Figure 3). With increased flow, owing to increased inlet throat area, channel dredging and the ebb flow pattern in the main channel, the bay side of Pikes Beach adjacent to the east jetty underwent significant erosion from 1955 on. Czerniak (Reference 4) in a study of the inlet conducted for the U.S. Army Engineers, New York District identified the possibility of the formation of a breach in that area on the basis of existing flow patterns.

The main (Bay) channel from the inlet to the ICCW developed a deep section adjacent to Pikes Beach (see Figure 3). Ebb flow concentrates in this section as it is deflected from a southerly to southwesterly direction. This, possibly assisted by the ebb flow from the Northwest Channel, was the likely cause of the severe erosion of the bay side of Pikes Beach adjacent to the inlet. The resulting necking of Pikes Beach is demonstrated by a photograph taken in January 1978, shown in Figure 5. Suffolk County had dredged sand from the bay to build up Pikes Beach to resist the necking of the beach but, as the photograph demonstrates, the reduction in beach width adjacent to the inlet was still quite significant.

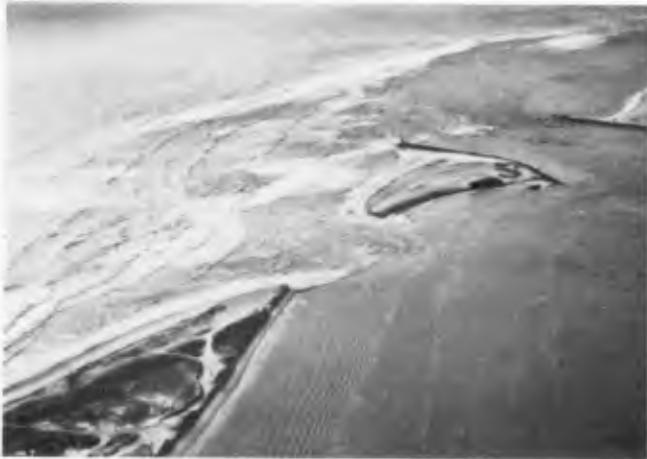
Figure 6 - Moriches Inlet and Breach Looking West (January 18, 1980)

A severe Northeast storm on January 14-16, 1980 caused the formation of a breach through Pikes Beach, at the narrowest section about 1000 feet (305 meters) east of the east jetty. Figure 6 is a photograph taken soon after the breach occurred. Apparently, wave action and stronger ebb tidal currents in the bay resulting from the stronger winds and higher water levels during the storm caused excessive erosion on the bayside and washover of the barrier island from the ocean side.

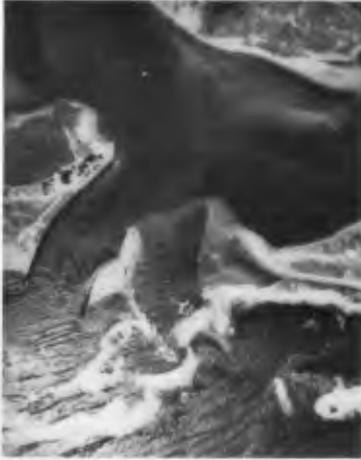
FIGURE 7
Breach Development
April 1, 1980

The initial width of the breach when first observed on January 16 was estimated to be on the order of 300 feet (90 Meters) and the depth was estimated at about 2 feet (0.6 meters). A hydrographic survey on January 20 indicated the breach to be 700 feet (215 meters) wide and an average of 3.3 feet (1 meter) deep below Mean Low Water (Reference 7). By May 1980 the fillet between the breach and East Jetty was entirely removed and by October 1980 the breach was nominally 2900 feet (885 meters) wide. Figures 7 through 9 provide a photographic history of the development of the breach. Comparative shorelines indicating the necking of Pikes Beach and the subsequent breach development are shown on Figure 10.

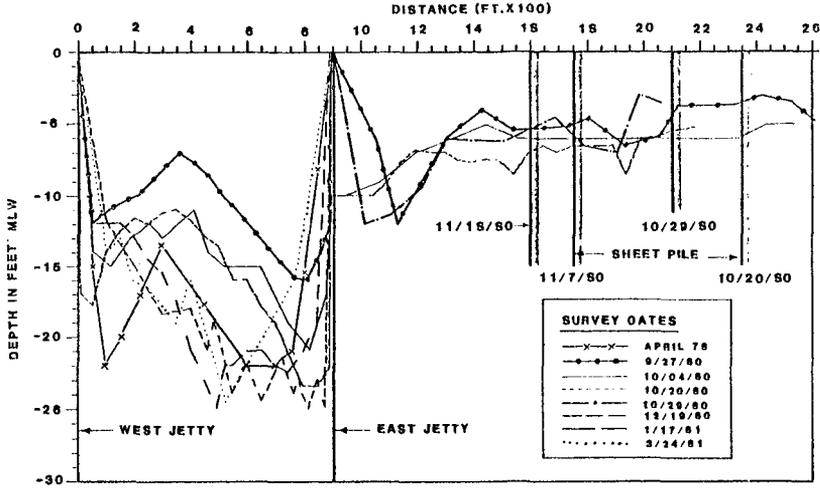
Figure 13 - Comparison of Cross-Sectional Areas

Breach and inlet cross sections obtained at various times prior to, during and after construction are shown in Figure 13 along with the relative locations of the temporary sheetpile closure structures. Cross section data is presented in tabular form in Table 2 for the breach, inlet and system total.

Initially, the inlet profile consisted of a relatively shallow channel on the west bank and a deep channel near the East Jetty. The breach was relatively flat and shallow until just east of the jetty where a small channel is apparent. As can be seen in the figure, both the inlet and breach began to deepen as closure was carried out. Examination of aerial photos also indicate significant shoaling in the ebb and flood tidal deltas. Overall the pinching off of the breach by the sheet pile retaining structure, however, resulted in a shift in tidal flow from the breach to the inlet with a commensurate increase in cross sectional area of the original channel.

As closure progressed, the channel in the breach adjacent to the East Jetty initially deepened in response to the decrease in width, but eventually closed. Concurrently, the inlet cross section enlarged. After closure, the inlet became deeper and began to change to a single channel more centrally located between the jetties.

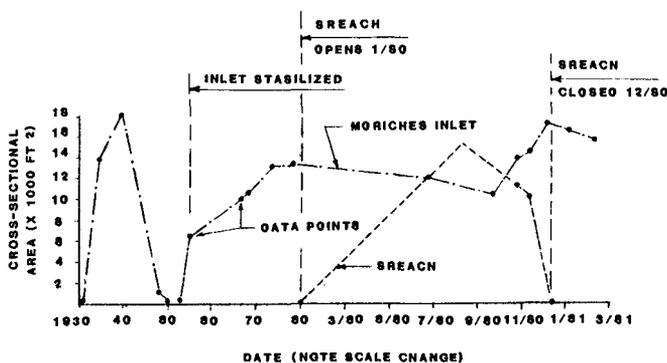
Figure 14 - Inlet/Breach Cross-Sectional Area Changes

The cross-section of the inlet decreased from July to late October. Subsequently the inlet cross-sectional area shows a persistent increase reaching a maximum in December shortly after closure was completed with the sheet pile walls. Subsequent measurements indicate a slight decrease in the inlet cross section which may correspond to an increase in hydraulic efficiency as the inlet moved towards its more stable, prebreach condition. Data on variations in inlet and breach cross section as a function of time are plotted in Figure 14. Data prior to the breach were obtained from reference 4.

It is interesting to note that earlier estimates by other investigators (References 4, 5) indicate a stable cross section of the inlet ranging from 16,000 ft² (1500 m²) to 20000 ft² (2100 m²). The latest available measurements of the cross section of Moriches Inlet prior to the breach, obtained in April, 1978, indicated an area of approximately 12500 ft² (1860 m²). It appears, then, that the inlet was probably moving towards its prebreach condition at the time of the final measurements in this program.
