PROTOTYPE TESTS ON RIPRAP UNDER RANDOM WAVE ATTACK  
J.D. Pitt and P. Ackers (Member ASCE)\*

This paper describes the performance of test panels of riprap on an offshore island in the Wash estuary, UK, for the first 2½ years after their construction, by which time all but one had failed. It outlines the methods used in obtaining and analysing data on stone size, wind, tides and waves. The techniques used in surveying the test panels for damage and the reduction of the survey data to yield quantitative estimates of damage are described.

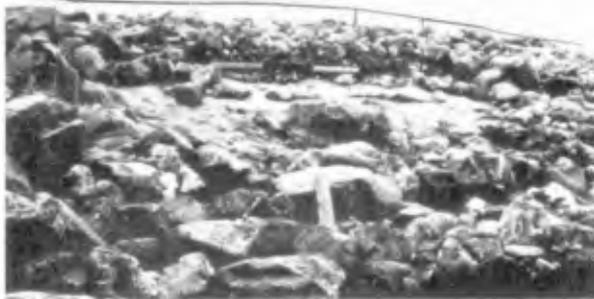
FIG. 6. FAILURE OF PANEL 1, NOVEMBER 1975.

It was unfortunate that large waves (H<sub>s</sub> just over 1 m) occurred with high water levels very early in the project, during the gale lasting from 16 to 18 November 1975, within days of laying the test riprap. The main effect was the total failure of Panel 1 (Figure 6). The riprap and the underlying filter were completely washed away from the central section of the panel, part being deposited in the lower section of the panel and part being completely lost. The upper limit of damage, about 6 m from the top of the panel, was marked by a near vertical face exposing the riprap and filter layers. The failure of Panel 1 had been expected to occur during the course of the first winter, but the occurrence of a severe storm so early meant that no results on progressive damage were available for this panel.

Erosion damage on Panel 2 was also serious on this occasion, being assessed at 112 D<sub>50</sub> stones. Damage was concentrated on the side

closest to Panel 1, and a considerable part was undoubtedly because of the loss of edge support resulting from the total loss of riprap and underlying filter from the central part of Panel 1. Table 2 lists the survey dates and the damage status.

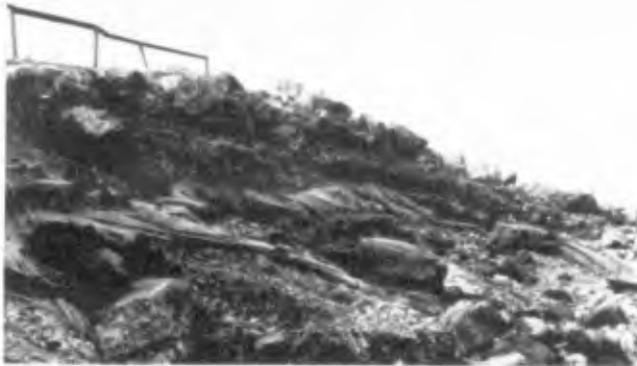
FIG. 7. FAILURE OF PANELS 3 AND 4, JANUARY 1978.

excess of the previous maximum ( $H_S = 2$  m) and resulted in the total failure of Panels 3 and 4 (Figure 7) (see Table 2, survey of 9.3.78). Panel 5, the permanent riprap, suffered very little damage. This was a very rare combination of wave attack and high tide: the tide level exceeded the calamitous 1953 storm surge in fact.
