## BREAKAGE OF CONCRETE ARMOR UNITS

Dennis G. Markle,<sup>1</sup> M. ASCE, and D. D. Davidson<sup>2</sup>

### Abstract

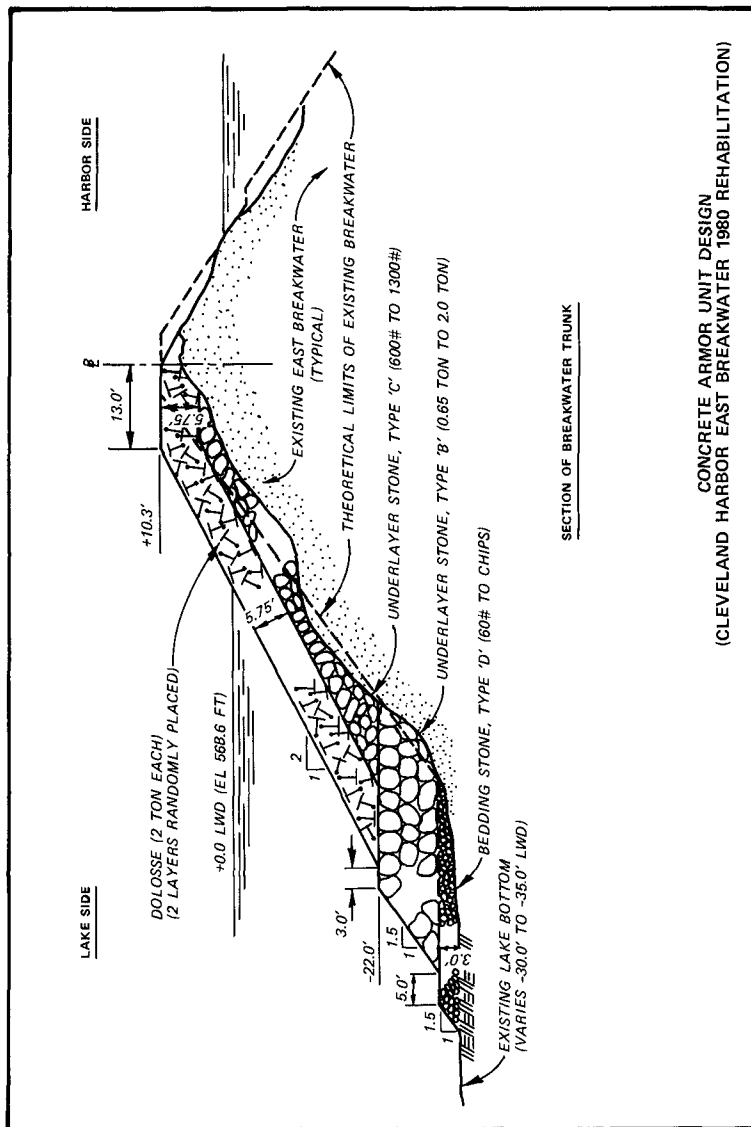
Figure 10. Cross section of Cleveland Harbor Breakwater Trunk

Cleveland Harbor is located on the southern shore of Lake Erie at Cleveland, Ohio, Figure 9. Cleveland is located about 110 miles (177 kilometres) east of Toledo, Ohio, and about 191 miles (307.4 kilometres) west of Buffalo, New York. The harbor is protected by a 20,970-ft (6,391.7 m) East Breakwater, 6,048-ft (1,843.4 m) West Breakwater and two 1,250-ft (381 m) arrowhead breakwaters. The arrowhead breakwaters are connected to the East and West Breakwaters at the main entrance to the harbor. The westerly 3,000 ft (914.4 m) of the East Breakwater is composed of a timber crib, constructed from 1887-1900, and a stone superstructure, constructed from 1917-1926. The remaining 17,970 ft (5,472.3 m) of the East Breakwater was constructed from 1903-1915. This portion of the breakwater is a rubble-mound structure with a keyed and fitted system of special shaped armor stone. Using construction similar to the original work, repairs were made on the East Breakwater in the years 1927, 1928, 1930, 1932-40 and 1946-78. During 1980, the eastern 4,400 ft (1,341.1 m) of the East Breakwater was rehabilitated. Two thicknesses of 2-ton (17,793 newtons) unreinforced dolosse were placed on the lakeside of the trunk, Figure 10, and around the head, Figure 11. Twenty-nine thousand seven-hundred dolosse were placed with a concentration of 161 dolosse per 25 linear ft (7.6 m) of the breakwater. Breakage of several dolosse occurred during the construction period and it was suspected that many of these were due to poor quality concrete and/or incorrect curing. Prior to completion of construction, but on a completed portion of the rehab, twenty two units (randomly located on the structure) were broken during a June 1980 storm. All units that were found broken after the 1980 storm were removed from the structure. Final construction on the dolos section was completed in November 1980, at which time a formal monitoring program to show armor unit movement and breakage on the rehab portion of the project was initiated. During the next year (primary period of consolidation and adjustment) randomly located breakage continued until by November 1981 the total number of broken dolosse observed was 329 (1.1 percent of the units placed). No adverse effect on the functional stability of the structure was noted during this time. On 6 April 1982, a particularly severe storm (hindcast waves of 12 ft (3.7 m) in height) occurred simultaneously with the highest lake level (+6.1 ft (+1.9 m) low water datum) ever recorded and caused damage to the rehabilitated dolos section. Although there was some displacement of dolosse over the crest of the trunk section, the primary damage was localized on the tip of the head section where a hole about 20 ft (6.1 m) in diameter at the armor surface penetrated to the underlayer stone. The exact cause of this localized damage is not known, but it is surmized by the authors that the combination of high water level, high wave action, and reflective characteristics of the Coast Guard tower monolith played a major role in the armor displacement. The number of units broken due to displacement from the damage hole was not available, but total breakage on the entire dolos section after the April 1982 storm was reported as 487 or 1.6 percent of the units placed.

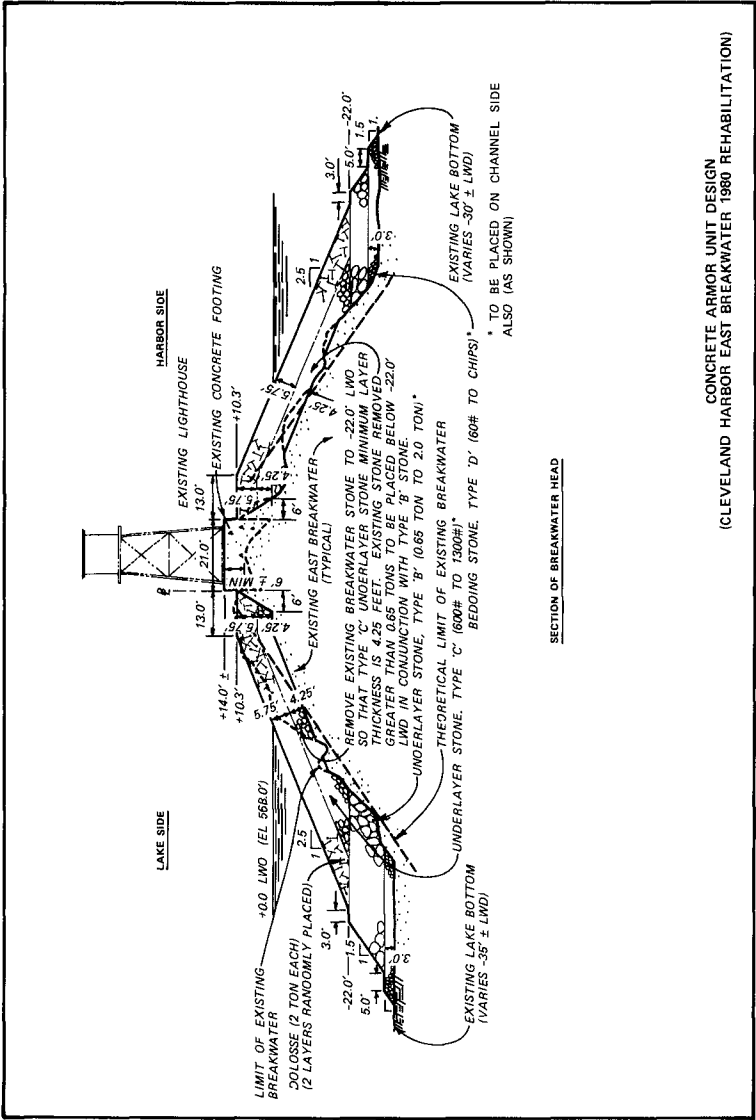
Figure 11. Cross section of Cleveland Harbor Breakwater Head

Diver's survey indicated that the broken dolosse are generally in a zone 4 (1.2 m) to 6 ft (1.8 m) above and below the water level. The head section is being repaired by placing approximately 200 dolosse in the localized damage area. The trunk section is not being repaired and does not appear to have any serious stability problems.
