Rehabilitation Methods for Damaged Breakwaters

R.L. Croeneveld *
A. Mol *
E.H. Nieuwenhuys *

Abstract

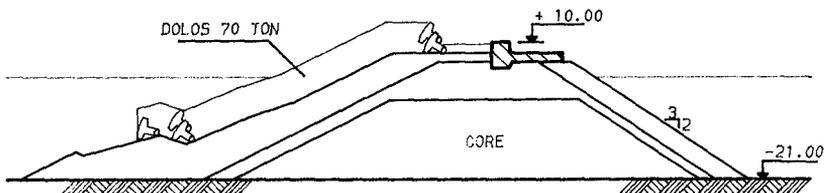
EXISTING SECTION-N.B.

The breakwaters are situated in waterdepths up to 20 m. The location is very exposed, in particular from north-westerly directions, but also from the North and occasionally from the East. Damage to the breakwaters occurred, however, under relatively quiet sea conditions. The first observations of damage were made soon after the completion of the construction of the breakwater. Damage was visually evident because armour units, which consist of 50 ton dolosse on slopes of 1:1.5 and 1:2, were broken.

Breakage of dolosse continued with time. Three years after the construction, over 3000 units were found broken, 17% of the total number of one breakwater and 25% of the total number on the other. In the areas with the greatest concentration of breakage the percentage was almost 50%. In addition, major cracks in the concrete crownwall of the South breakwater were found at several locations as a result of differential settlements.

Six alternative methods for rehabilitation of the North breakwater, of which the existing section is shown in Figure 7, were studied:

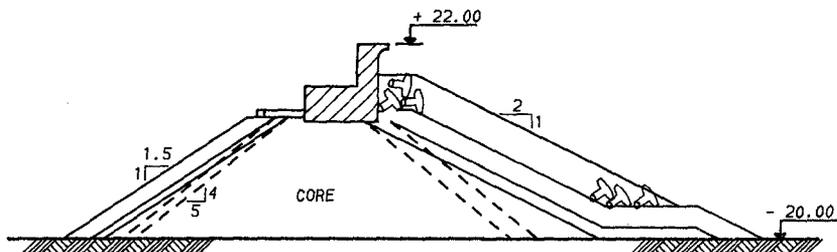
EXISTING SECTION - S.B.

For the rehabilitation of the South Breakwater, of which the existing cross section is shown in Figure 12, the possibilities were limited because this breakwater needed rehabilitation of the armour as well as strengthening to achieve better geotechnical stability. The alternatives considered were:

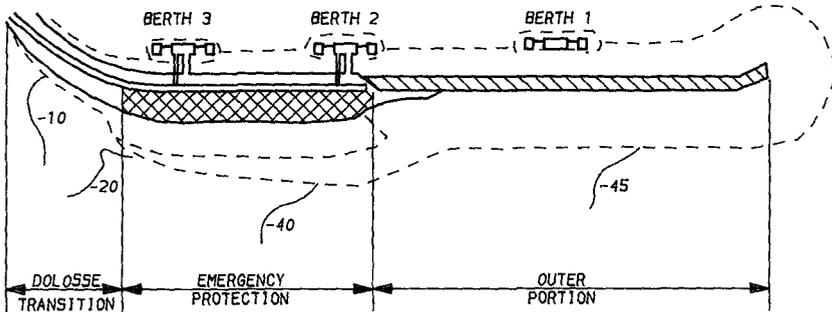
WEST BREAKWATER, SINES PORTUGAL

This concerns the West Breakwater of the port of Sines, Portugal, located at the Atlantic coast, which was severely damaged during two storms in the winter period of 1978-1979. Figure 15 shows the layout of the breakwater divided in three sections:

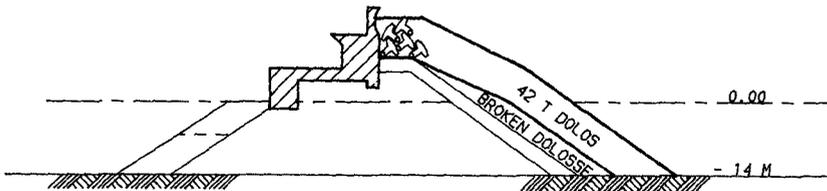
DOLOSSE SECTION

- the Section between berth 3 and the shore protected with dolosse (Figure 16)
- the Section between berths 2 and 3 previously repaired with new 90 ton Antifer type blocks (Figure 17)
- the outer portion, severely affected and at present unrepaired (Figure 18).

2. The section armoured by dolosse, situated close to the previously repaired section, needed improvement. The most economic solution should involve closing the subsea trench south of the Perceveira Islands thereby eliminating the large waves which were penetrating through this trench from westerly directions. A plan and cross section are given in Figures 19 and 20.
