CHAPTER ONE HUNDRED SEVENTY SEVEN

Surveys of Coastal Structures Using Geophysical Techniques

John R. Dingler and Roberto J. Anima*

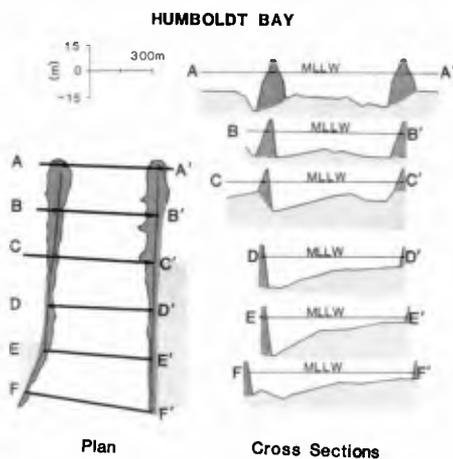
Figure 4: Plan view (left) of the jetties at Humboldt Bay, California showing the location of cross sections plotted on the right.

Water depth varies considerably and systematically throughout the inlet and adjacent nearshore zone, as shown in figure 4. Whereas water is deep on the southwest side of both jetties, only along the south jetty is the water deep adjacent to the inlet-side (inside) flank. Figure 5, a plot of additional profiles run perpendicular to the south jetty, shows the disparity in depth between its outside and inside flanks. Near the head of the south jetty, the water is deeper on the south (outside) flank; however, landward from the back of the head, the water is deeper on the inside.

jetty toes, as calculated from the sonographs, are shown in figure 4.

Southwest of both heads, storm waves produce large, year-round, scour holes along the heads that are slightly deeper in the winter. Perhaps tidal flows or shelf currents contribute to the extensive erosion in this area. Overlaying the bathymetry on the construction drawings shows that the jetty toes have been extensively undermined in this area (Doug Pirie, oral commun., 1984).

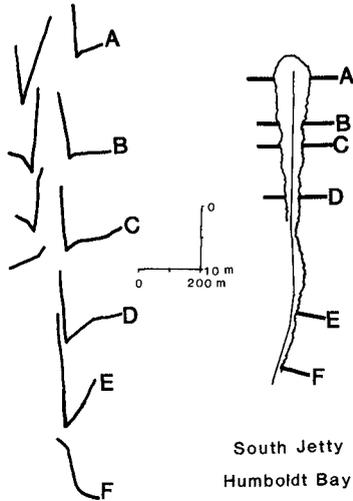
Figure 5: Profiles along the south jetty at Humboldt Bay, California. Zero on the abscissa is at the centerline of the jetty. Station numbers represent distances in hundreds of feet, with the largest value being at the jetty head.

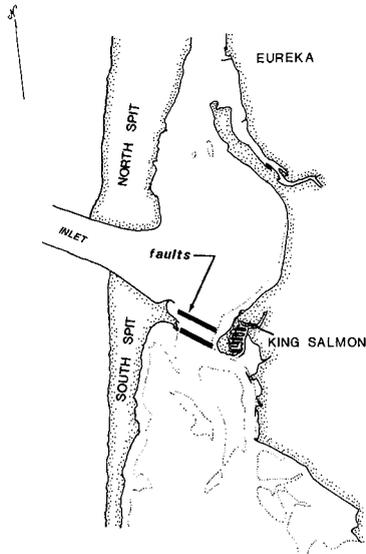
The seismic profiles showed that the shallow subsurface is sandy. Transects in the bay that crossed the center lines of both jetties show subsurface faulting that would lie under the south jetty when extended (fig. 6). However, over 20 m (66 ft) of unfaulted sediment overlies the faults. Waves distorted the offshore records to the extent that subbottom features could not be discerned. Attempts to locate buried armor were not successful.

Figure 6: Location and trend of subsurface faults inshore of the south jetty at Humboldt Bay, California.

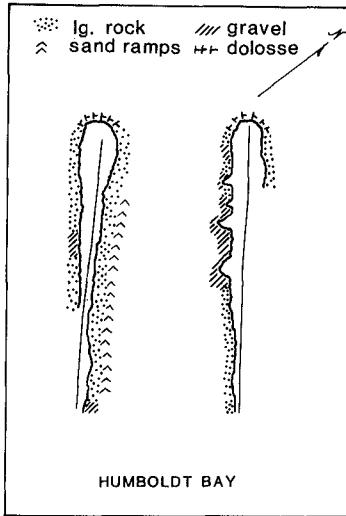
The scuba dives, although conducted when water visibility was poor, led to the discovery that the jetty toes have different makeups. As shown on figure 7, the toe of the south jetty varies from large rock, to dolosse, to large rock with extensive sand that forms ramps up the flank, whereas the toe of the north jetty varies from large rock, to dolosse, to large areas covered with gravel and small rock.

Figure 7: Location of armor types and sand ramps along the jetties at Humboldt Bay, California.

Along the inside of the south jetty, strong tidal currents appear to have eroded the bottom, creating a continuous depression. Here, the divers found sand that formed ramps from the floor up the flank. The location and orientation of these sand ramps--abutting the east side of large armor and whose axes are tilted slightly shoreward-- suggest either flood-tide control or control by the distribution of armor. The entrance channel is periodically dredged to 13 m (43 ft). Its proximity to the inside of the south jetty may contribute to the extreme scour along that stretch of the toe.

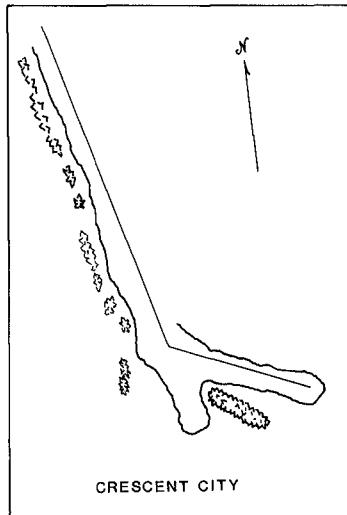
The sonographs showed extensive bedrock outcrops. On many records, such as the one shown in figure 8, it was hard to separate the breakwater toe from the naturally outcropping material. Figure 9 shows the location of the toe of the breakwater and of features thought to be outcrops rather than the breakwater itself. At one site just west of the corner of the breakwater, divers noted that the bulge is actually bedrock and that the toe is straight.

Figure 9: Location of the toe of the outer breakwater at Crescent City, California, as interpreted from sonographs. Also shown are bedrock outcrops near the breakwater.

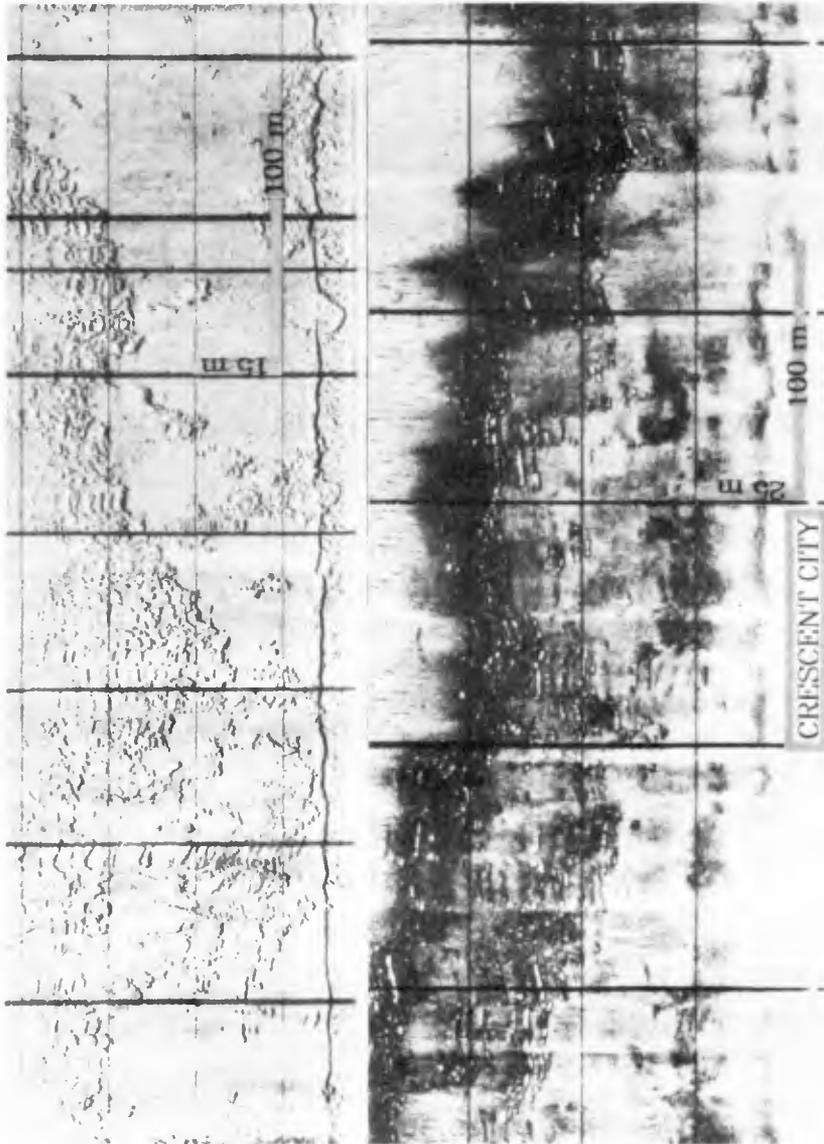
Figure 8: Sonographs of the bottom adjacent to the corner of the outer breakwater at Crescent City, California. Strong reflectors are bedrock outcrops. A 500-kHz sonograph is to the left, and a 100-kHz sonograph to the right.

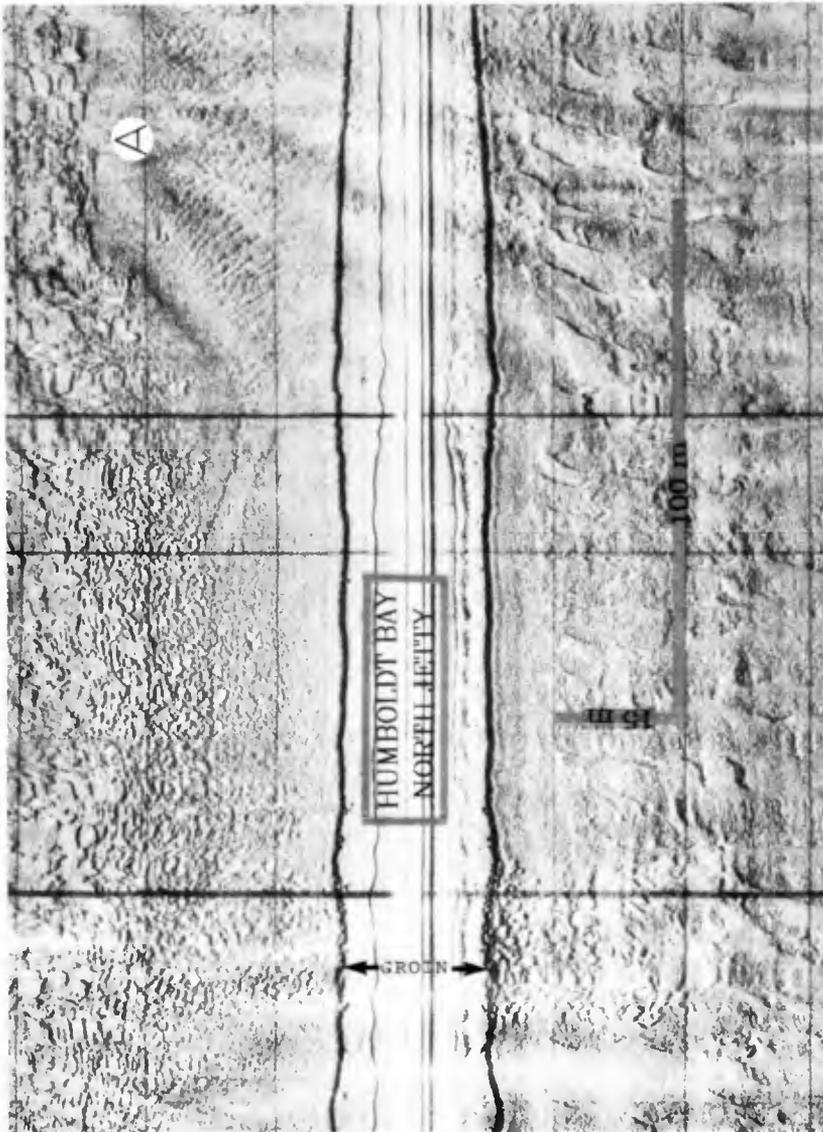
Patterson and Pope (1983) showed that side scan sonar can be used to recognize individual armor units and perhaps to recognize slope changes and missing armor. However, such detailed work requires ideal conditions, which, in many areas, occur only a few days per year. Those who plan surveys must, therefore, decide on whether or not it is economically feasible to wait for the right conditions. Although during this study wave conditions precluded our identifying individual armor or slope changes, variations in armor size between areas showed on the sonographs. Divers found that the groins along the north jetty at Humboldt Bay contain small rock, whereas the rest of that jetty has large rock or dolosse at the toe. Figure 10 shows how these differences appear on a sonograph.

Figure 10: Sonograph of a groin along the inside of the north jetty at Humboldt Bay, California. The patterns on the sonograph indicate that the size of the material composing the groin and adjacent toe is smaller than the size of the material farther shoreward (A).
