REEF RUNWAY WAVE PROTECTIVE STRUCTURE, HONOLULU INTERNATIONAL AIRPORT, OAHU, HAWAII, STABILITY PERFORMANCE EVALUATION

Robert S. Chun*, Edward K. Noda**, Elaine E. Tamaye***

Abstract

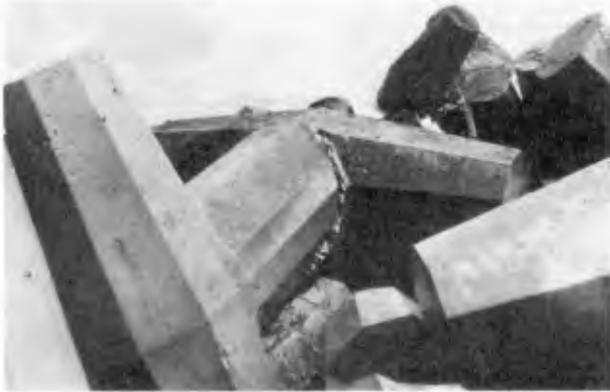
Station Location		No. of Damaged Dolos			Dolos	Design	Stability Coef. K _s		No. Dolos	Percent Damage	
From	To	U/Water	A/Water	Total	Size	H _{max} (ft)	Design	Actual	Placed	Design	Actual
Breakwater Head		2	0	2	6T	13.8		6.6			
85+00	86+00	6	2	8	6T	13.8		6.6			
Head	86+00	8	2	10	6T		6.8	6.6	1,234	0%	0.81%
86+00	88+64	16	5	21	4T	13.8-12.7		14.8-11.5			
88+64	91+64	22	8	30	4T	12.7-16.8		11.5-26.6			
91+64	95+25	31	6	37	4T	16.8-19.3		26.6-40.4			
95+25	96+25	14	4	18	4T	19.3-18.5		40.4-35.6			
98+25	101+25	12	6	18	4T	18.5-15.4		35.6-20.5			
101+25	104+25	14	4	18	4T	15.4-15.2		20.5-19.7			
104+25	107+25	13	9	21	4T	15.2-13.1		19.7-12.6			
107+25	110+00	13	6	19	4T	13.1-15.1		12.6-19.3			
86+00	110+00	135	47	182	4T		32	11.5-40.4	9,510	2%	1.91%
110+00	113+25	12	4	16	6T	15.1-20.2		12.9-30.9			
113+25	116+25	9	1	10	6T	20.2-25.2		30.9-59.9			
116+25	120+00	28	7	35	6T	25.2-16.1		59.9-15.6			
110+00	120+00	49	12	61	6T		64	12.9-59.9	3,083	4%	1.98%

In general, the damaged units were found scattered randomly throughout the structure, and the primary armor cover appeared to retain its original integrity. The broken dolos were intermixed with the unbroken units, and a few units were displaced from the structure. However, it was difficult to determine where the displaced units came from. Figures 4 and 5 show typical damages to the dolos.

FIG.4 TYPICAL DOLOS BREAKAGE (6-TON UNITS AT STA 119+25)

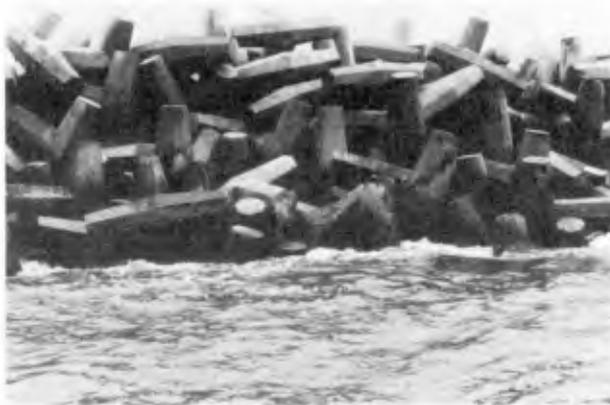
120+00	125+25	19	5	24	4T	16.1-11.8		23.4- 9.2			
125+25	128+25	7	4	11	4T	11.8-16.8		9.2-26.6			
128+25	131+50	10	3	13	4T	16.8- 9.3		26.6- 4.5			
120+00	131+50	36	12	48	4T		32	4.5-26.6	4,182	2%	1.15%
TOTAL		228	73	301					18,009		1.67%
6 ton Total		57	14	71					4,317		1.64%
4 ton Total		171	59	230					13,692		1.68%

FIG.5 TYPICAL DOLOS BREAKAGE (4-TON UNITS AT STA 128+50)
