FIELD INVESTIGATIONS ON WAVE-DISSIPATING CONCRETE BLOCKS COVERING VERTICAL WALL BREAKWATER

Michio Gomyoh¹, Kazuhiko Sakai², Tomotuka Takayama³,
Kojiro Suzuki⁴, Shigeo Takahashi⁵

The failures experienced in Japan by wave-dissipating concrete blocks (WDCB) covering vertical wall breakwaters are investigated, and the deformation characteristics such as failure features and factors are examined.

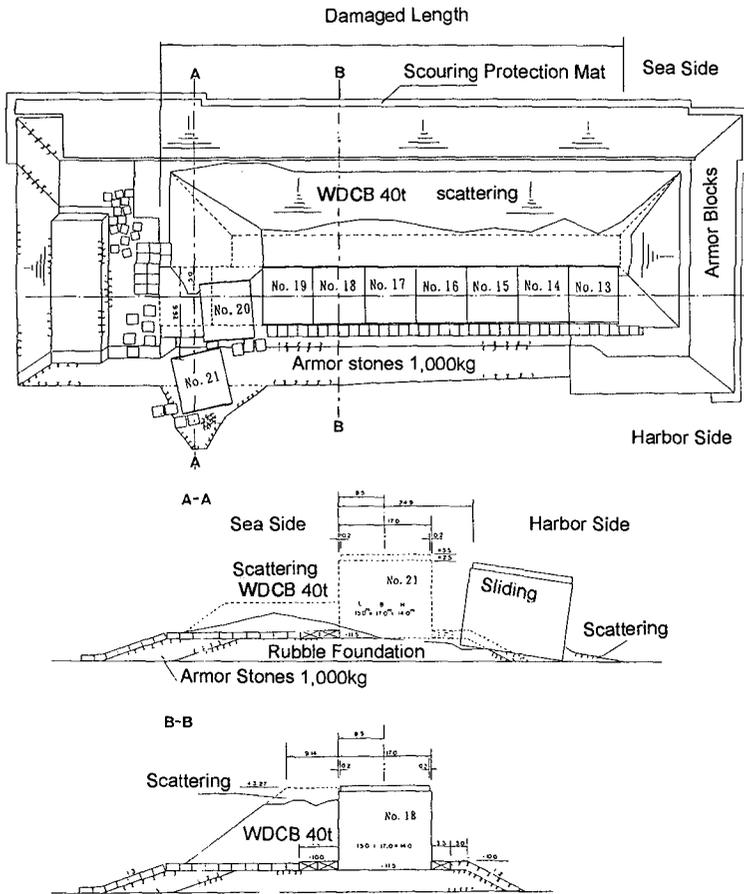
Figure 2 shows the scattering of WDCB, 40 t Tetrapods, and the damage of caissons of No.2 breakwater at Hachinohe Port (Case 6,7). The important point to note in these cases is that the scattering of WDCB was found to be severe at the breakwater head/sectional end, A-A line, and that it was very mild at the trunk section, B-B line, in spite of neighboring the damaged area. The predominant reason responsible for the former is the action of severe wave force at the sectional end as pointed out by Takahashi et. al.(1993). A nesting process of the scattering of WDCB and the caisson sliding due to increase of wave force acting on the caisson wall lead to the larger scattering. Similar failure features like this are observed at east breakwater in Mutu-Ogawara Port (Case1,2,3), No.1 breakwater in Hachinohe Port (Case 4,5), Nagasaki Port (Case9,10,11), and Wakimisaki Port (Case12,13).

Figure 2. Scattering of WDCB at breakwater trunk section and head sectional end (Hachinohe Port)

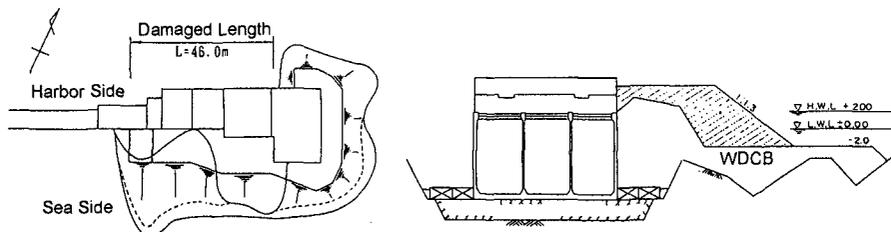
Figure 3. Scattering of WDCB covering a reef (Kametoku Port)

Figure 3 shows the scattering of WDCB, 50t Dolos, covering the reef at Kametoku Port (Case18). Here, the south breakwater is located on the natural reef around the Tokunosima island, and its head on the edge of reef whose bottom slope is steep. This scattering occurred due to both waves breaking there suddenly and resultant severe currents.

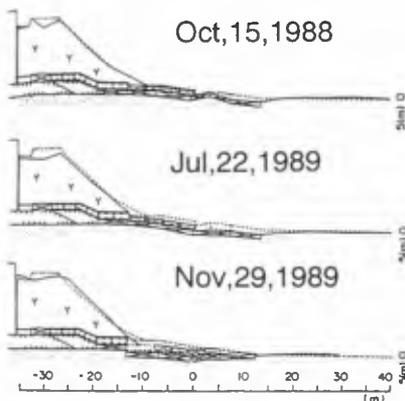
Of particular interest, the failure at Miyazaki Port is a typical one caused by long-term, gradual settlement of blocks, being a sometimes hard-to-recognize type of damage that frequently occurs in areas where sand transport is significant. Figure 6 shows that the cross-sectional change such as settlement of WDCB, 64t Tetrapods and armor blocks. Although the nesting process of blocks and/or scouring at the toe area have generally been considered to be the main cause, block settlement may instead be due to various wave actions weakening the sand bed to such an extent that the blocks literally sink into it. Figure 7 shows a photograph supporting this possibility, i.e., the entire body of blocks appears to have moved toward and down during settling. This characteristic feature is also observed at Kushikino Port.

Figure 6. Cross-sectional change of south breakwater at Miyazaki port

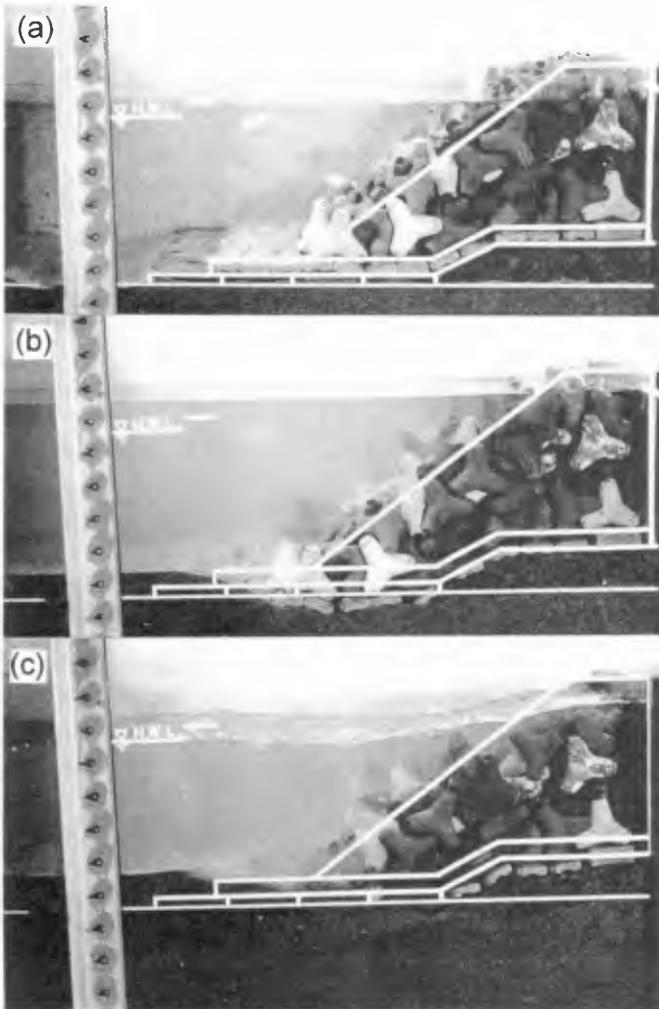
Then, to clarify whether weakened strength of the sand bed is responsible for settlement of blocks, we liquefied it by supplying pore water from bottom of the bed. Figure 8 shows a photograph of the results. The important point to note is that the settlement of the block section is quite definitive, i.e., the blocks at the toe area have sunk into the sand bed and the entire body of blocks has moved forward and down (Figure 8(b), (c)), being a similar behavior to that actually observed (Figure 7) and quite different from the not-liquefied case (Figure 8(a)). These results indicate that weakening of the bed caused such settlement deformation, and that as wave loadings most likely lead to bed weakening, the phenomenon of wave-induced liquefaction may play a key role.

Figure 8. Block settlement deformation due to weakening the sand bed by liquefaction
