## CHAPTER 330

### STRUCTURAL RESTORATION OF CORAL REEFS DAMAGED BY VESSEL GROUNDINGS

**Kevin R. Bodge, Ph.D., P.E.<sup>1</sup>**

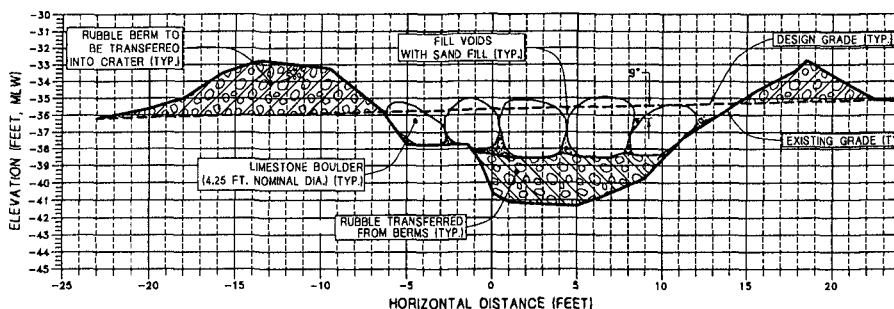
Figure 2: Typical section of Elpis site restoration.

Damage at the deeper Elpis site (about -11 m, MLW) primarily included two adjacent craters, measuring 69 m<sup>2</sup> and 163 m<sup>2</sup>, likewise formed by the ships' screws as she tried to free herself. The

depth of the craters, below ambient grade, varied from 0.5 to 2.3 m. The volumes measured 127 m<sup>3</sup> and 200 m<sup>3</sup>. The craters' seabed was composed of sand and coral rubble similar to that of the Maitland site, but featured numerous large coralline boulders of up to 1.8-m diameter. The sand fraction was carbonate, with  $d_{50} = 0.6$  mm. Adjacent to the craters were three berms consisting entirely of relic *Acropora cervicornes* (elkhorn) coral rubble that had been initially ejected from the craters. This naturally branched rubble, primarily 10- to 25-cm long by 3-cm diameter, was interlocked but easily succumbed to dismantling by hand or jet probe. The berms' relief varied from 0.3 to 1.2 m with crest widths of 0.6 to 1.5 m, and totalled about 30 m<sup>3</sup> in volume.

The selected alternative for the deeper *Elpis* site involved temporary relocation of the existing coralline boulders (i.e., those with existing biota), from the craters to the surrounding seabed. The coral rubble berms would then be mechanically relocated back into the craters from which the rubble was ejected. An armor layer of 1.2-m marine limerock boulders (totalling 400 tons) would be then placed atop the rubble. The voids were then to be partially filled with aragonite sand (approx: 60 m<sup>3</sup>). The temporarily relocated coralline boulders, originally salvaged from the crater, would be then replaced atop the imported boulders and sand fill. (See Figure 2.)

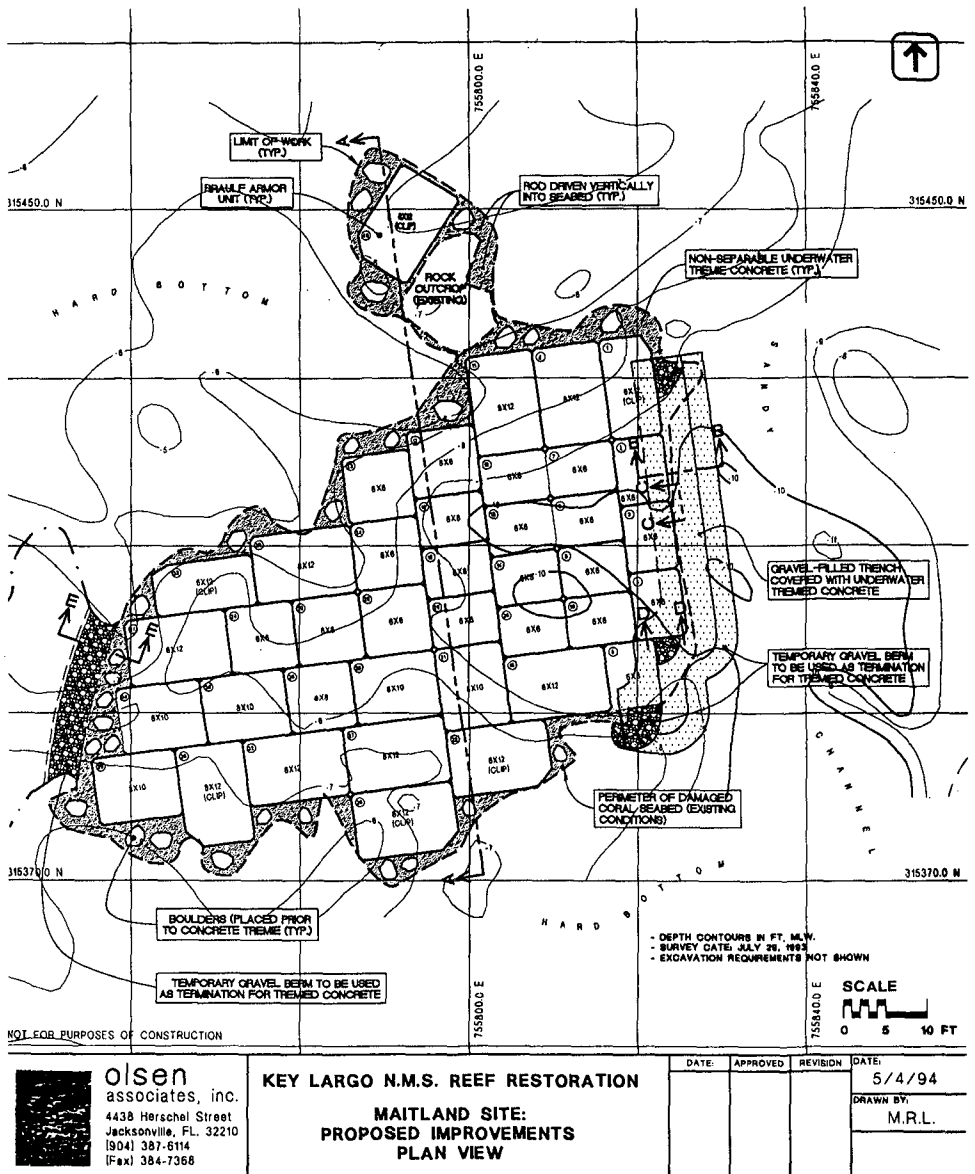
Figure 3: Plan view of Maitland site restoration.

Damage at the shallower Maitland site (-1.8 to -3.0 m, MLW) consisted primarily of a 370-m<sup>2</sup> crater, varying in relief from 0.1 to 1.0 m, relative to the ambient seabed. The crater was formed by the ships' screw when an attempt was made to free the vessel under her own power. Since its creation, the crater had partially infilled with rubble, but had also doubled in size from what was originally two separate holes. The expansion of the crater was due to wave- and current-induced erosion of its coralline perimeter -- a thin (< 1.5-m) semi-continuous crust overlaying 15-m of densely-packed gravelly-sand. The volume of the crater, measured below the ambient seabed grade, was about 115 m<sup>3</sup>. The seabed of the crater featured a matrix of sand and 7- to 20-cm diameter, loose coral rubble with scattered larger pieces measuring up to 50-cm.

The selected alternative for the shallow *Maitland* site (-2.5 m MLW) involved precision placement of 40 pre-cast "Reef Replicating Armor Units/Living Foundations" (RRAULF's) into the crater, and an underwater pour of specially-designed non-separable concrete (approx. 45 m<sup>3</sup>) intended to bind the fragile coral perimeter to the armor units and to fill the gaps between the units (Figure 3). The finished elevation of the work was designed to match that of the natural seabed (Figure 4).

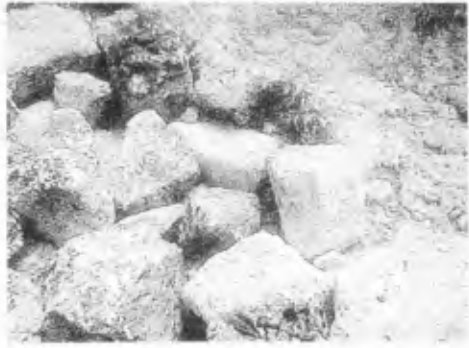
**Figure 8:**

Photograph of upcurrent Elpis site crater immediately after restoration. Voids between the boulders provided extensive fish habitat and vertical facing for coral larvae recruitment, but resulted in an aesthetic that contrasted with the ambient seabed.

At the Elpis site, the rubble berm material was transferred into the craters using both a crane-operated grapple and diver-operated water jet. The latter was more successful, by far, than the former. The limerock armor boulders were placed individually by grapple. The fill sand was placed by a crane-supported, diver-operated 3.5-m<sup>3</sup> hopper. Tidal currents carried some of the sand as much as 150-m downcurrent, and resulted in the upcurrent crater being filled with sand to a notably lesser degree than the downcurrent crater (see **Figures 8 and 9**, respectively). As seen in **Figure 9**, local fishes were attracted to the work within hours of its completion.

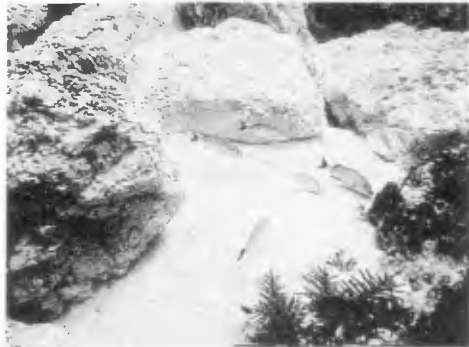
**Figure 9:**

Photograph of downcurrent Elpis site crater immediately after restoration. Voids between the boulders were more effectively filled with carbonate sand, resulting in an excellent aesthetic match with the ambient seabed.

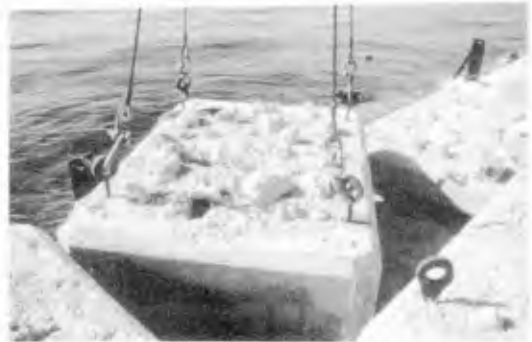
**Figure 11:**

Photograph of one of the 40 pre-cast reef-replicating armor units being lowered to the seabed. The lifting eyes were unscrewed from the units' threaded inserts after installation.

After precision placement of the 40 armor units (placed with 5-cm maximum allowable gap between units, and tighter tolerances for vertical differential), and placement of the perimeter boulders and coral/gravel berms, the underwater concrete was placed using a swing-tube pump with 5-cm hose, PVC nozzle, and diver-operable ball-valve. The concrete was batched aboard the barge using a portable ("junior") mixer.

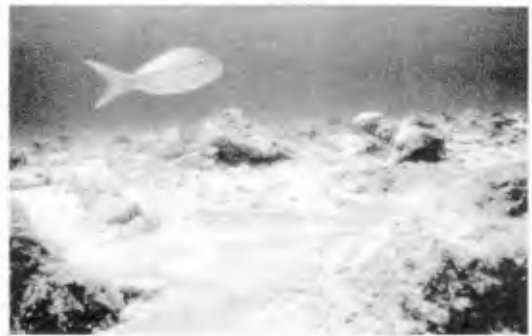
**Figure 12:**

Photograph of the top surface of the Maitland site repair, taken several days after project completion. The ambient seabed is in the far background. A grouted joint between adjacent armor units is discernible below the fish, in the foreground.

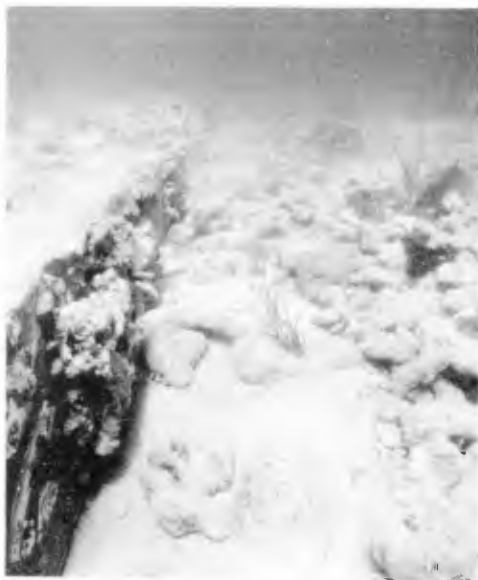
**Figure 13:**  
Photograph of exposed side-face of Maitland restoration, where the repair was terminated adjacent to an existing sandy channel. The restoration is on the left, the ambient seabed is on the right.
