## CHAPTER 365

### **RICHARDS BAY NORTH BREAKWATER - REPAIR OF A ROUNDHEAD: MONITORING, MODEL TESTING, DESIGN AND CONSTRUCTION**

#### **ABSTRACT**

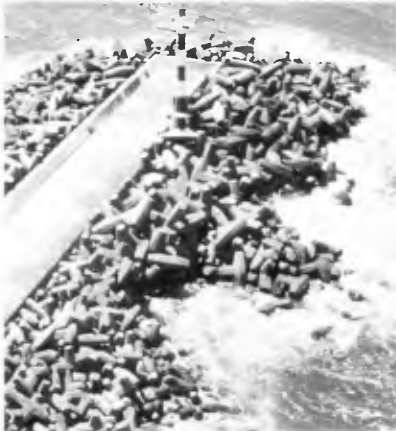
FIGURE 1: View of North Breakwater and Cross-Section through head.

deteriorate the fastest. At stations P2 and P3 on the round-head, the damage was mostly localized in cusps, which are visible in Figure 1. A sharp increase in the rate of damage in the worst areas, since 1992 (72 months), can be seen in Figure 2. This damage has mainly been attributed to bottom scour resulting in increased wave heights reaching the breakwater, ie. increased depth limited wave heights. Station P1 also lies at the transition between the 5t and 15t dolosse, which is at an inherent weak point in the armouring.

Repairs which were carried out in 1986/87 using 200 additional 15t dolosse have proved unsuccessful, mainly due to the toe damage and sea-bed erosion mentioned above. No model tests were done for these initial repairs. The area where the 15t dolosse on the roundhead meet the 5t dolos trunk (Figure 1) has also been a focus of damage, likely as a result of poor interlocking between the different sized units.

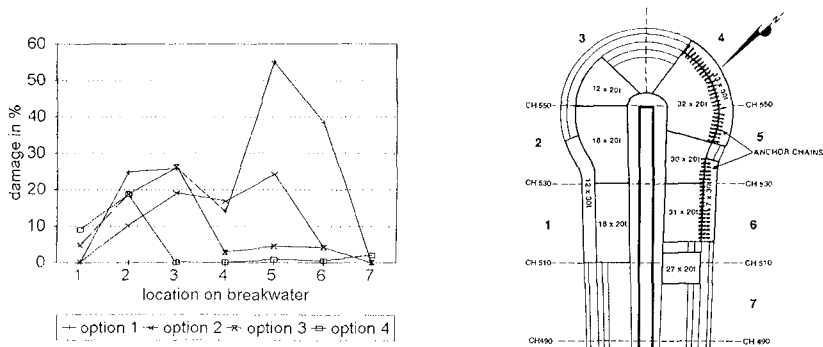
FIGURE 5: Comparison of Damage to the Repair Options Tested

A comparison of the damage at the end of each run is shown graphically in Figure 5. The x-axis presents the section of the breakwater which starts at the northern-side of the breakwater, around the head to the southern side of the breakwater. These location numbers are given in Figure 5. Repair Option 4 is clearly the best option.

For all the repair options, the existing 15t dolosse were well protected by the additional dolosse. For repair options 1 and 2 it was clear that again, similar to the prototype, the highest damage could be observed just behind the head at the southern side of the breakwater. The eddies caused by the waves passing around the head were responsible for rolling the toe dolosse along the surface of the rubble. Once a dolos had been extracted from the slope it was easily rolled along by big waves.

The 30t dolosse, which were fixed by anchor chains, reduced the damage in that specific area considerably. Repair Option 4 showed acceptable damage levels for all the repair dolosse, apart from the area on the northern side of the head where the 20t dolosse showed higher damage - poor interlocking of this section may have been the cause. The damaged 15 t dolosse on this side were not reprofiled as was done on the southern side, which meant that the 20t repair dolosse were not interlocked properly in a double layer. Although the original prototype damage (CSIR, 1994) on the northern side of the head is less than one third of that on the southern side, it is felt that the repairs would have been more effective if the whole northern side had also been properly prepared (reprofiled) before the repair.

- a) Before any repairs, as many as possible of the broken pieces of dolosse should be removed without disturbing adjacent dolosse.
- b) Crane and ball surveys should be used to identify all underwater depressions, both before and during construction of the repair.
- c) Particular care should be taken when placing the dolosse to ensure that dolosse interlock as well as possible with the

- d) For the placing of dolosse, both above and below water, a predetermined grid pattern should be developed with angles and distances for the crane, or x,y references for DGPS positioning.
- e) The 30t toe dolosse should be anchored by chains.

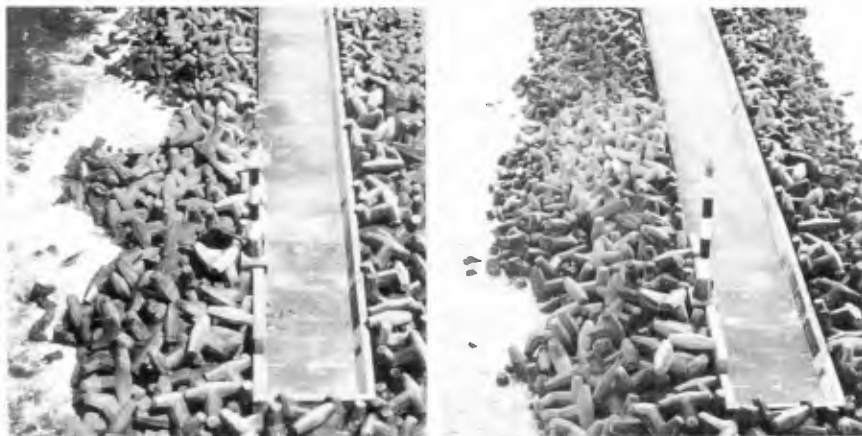
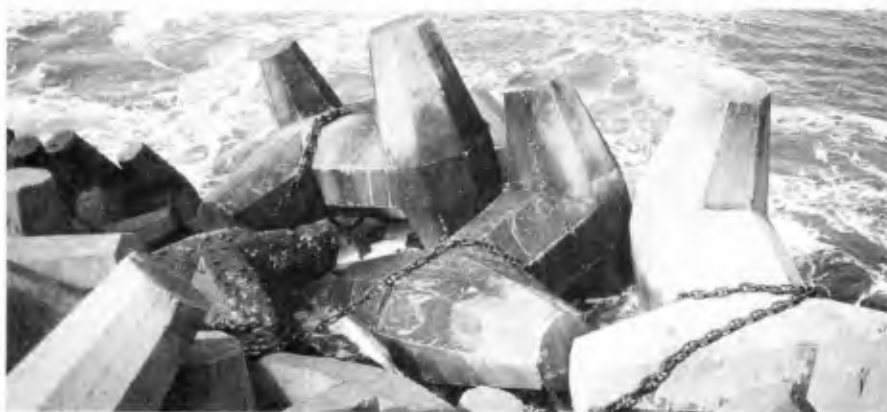
Planning for the repair was well underway by mid 1996, when a breakdown of the special crane (the only crane which could fit onto the breakwater and have sufficient reach for placing the 30t dolos toe) resulted in having to delay the final repair to the end of 1996. As the localised damage on the southern side of the roundhead was starting to

expose the underlayer rock, it was decided to carry out emergency temporary repairs. These took the form of filling the cusps with 5t dolosse (which could be placed with a smaller mobile crane). This repair was not extended further than the original slope profile so that it would form part of the underlayer of the final repair. The same construction method was used as described above. Figure 9 shows this section before and after the emergency repair. Figure 10 shows the chained 30t dolosse at the start of the final repair in December 1996.
