APPLICATION OF SHORE PROTECTION SCHEMES IN HORNBÆK

ABSTRACT

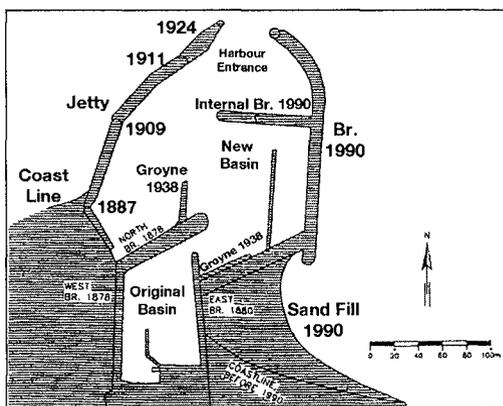
Figure 2 - Development of Hornbæk Harbour 1878-1990.

As shown in Figure 2 the breakwater west of the original basin has been extended gradually from 1878 to 1924 in response to continuous upstream accretion and sedimentation in the protected area east of the breakwater.

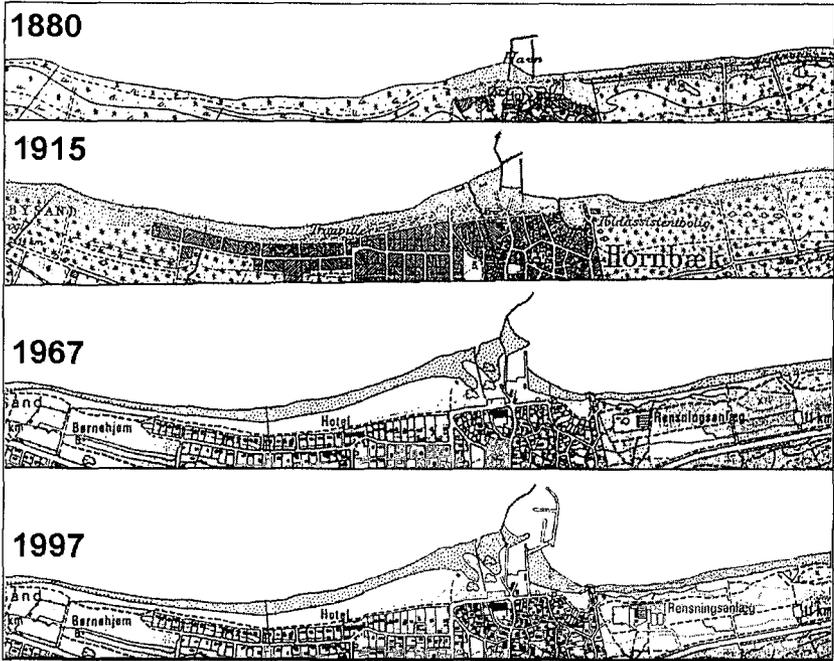
Figure 3 - Development of the coastline adjacent to Hornbæk Harbour, 1880-1997.

The development of lee-side erosion east of the harbour and accretion west of the harbour is seen in Figure 3. From 1880 to 1997 the lee-side erosion has been of the order-of-magnitude of 50 m whereas the advance of the coastline to the west has been in the order of 100 m.

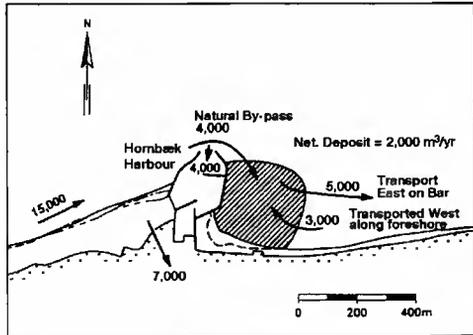
Figure 4 - Sediment at Hornbæk Harbour, before nourishment and artificial bypassing.

Based on a study of the wave climate and storm surges a numerical study of the littoral drift budget was carried out using the LITPACK modelling system. Findings from this study was used for assessing the amount of sand needed for beach nourishment east of the harbour. Figure 4 shows a detail of the sediment budget for the harbour area in 1995. The cumulated transports show a net accumulation of sediment in the region just east of the harbour of around $2,000 \text{ m}^3/\text{yr}$.

Sediment trapped in the harbour mouth ($4,000 \text{ m}^3/\text{yr}$) is dumped near-shore along the beach east of the harbour resulting in a total transport of $6,000 \text{ m}^3/\text{yr}$ further east along the coast.

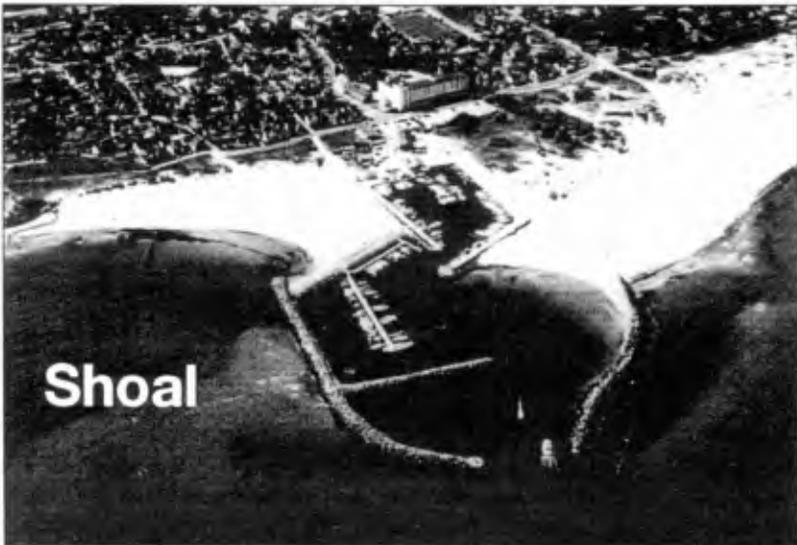
Figure 5 - Aerial view of Hornbæk Harbour.

The sediment is clearly deposited in the formation of a large shoal (Figure 5) which is expected to connect with the beach area further east of the harbour closing off a shallow water area. At this point in time there will probably be a decision about whether to fill in the shallow water area creating a wide beach or about relocating the sediment in the shoal to the coastline proper.

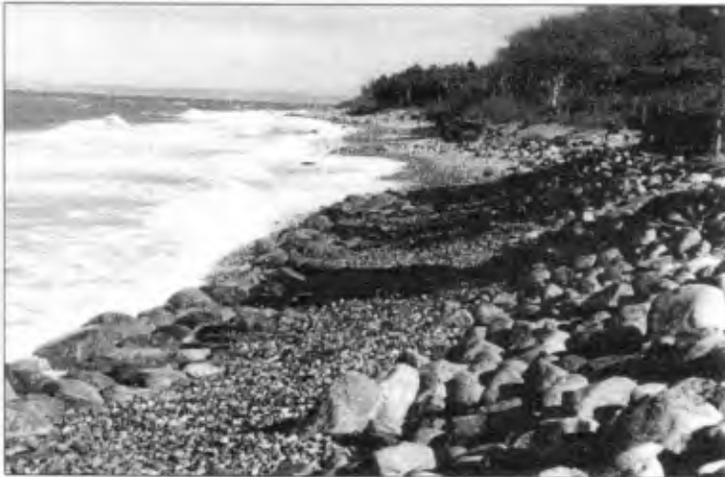
Figure 7 - Berm Structure on completion

Figure 7 shows the berm shortly after completion. The waves have washed some of the shingle ashore which conceals the larger part of the berm structure and allows for safe passage along the beach.

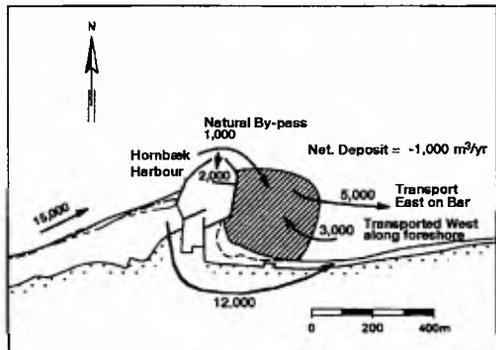
Figure 9 Sediment budget including artificial nourishment

Figure 9 shows the estimated sediment budget for the harbour area while nourishment is taking place (compare with Figure 4). For the given example 12,000 m³/yr of sediment is mined west of the harbour and used as nourishment east of the harbour. The western breakwater has been rounded and sedimentation in the access channel has decreased to 2,000 m³/yr. The corresponding maintenance dredging of 2000 m³/yr is dumped nearshore east of the harbour.

The littoral transport west of the harbour remains the same, resulting in a natural bypass of $1,000 \text{ m}^3/\text{yr}$ to the shoal. The shoal is also receiving $3,000 \text{ m}^3/\text{yr}$ from the east coast and loses $5,000 \text{ m}^3/\text{yr}$ towards east, resulting in an annual loss of sand from the shoal of $1,000 \text{ m}^3/\text{yr}$. The shore east of the harbour now receives $2,000 \text{ m}^3/\text{yr}$ from the shoal and $14,000$ by artificial nourishment resulting in a supply to the downdrift shore of $16,000 \text{ m}^3/\text{yr}$.
