BREAKWATER REPAIR: MONITORING, MODELLING, AND CONSTRUCTION

Abstract

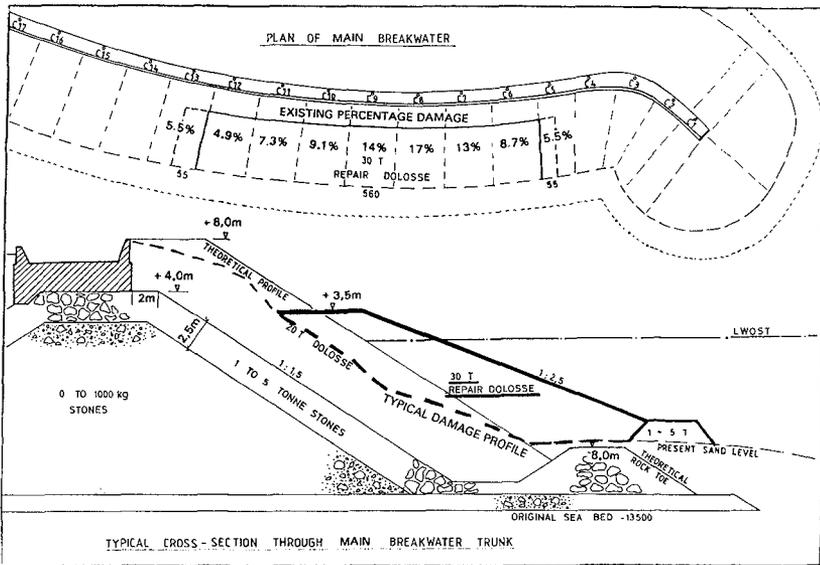
Figure 2: Plan View of South Breakwater and Cross-Section through trunk.

The original breakwater construction used a total of 13 400 20t dolosse on the trunk, and 2 200 30t dolosse on the roundhead, which amounts to approximately 10 dolosse per metre of breakwater. The original depth at the head was -18m and -14m along the outer curve of the trunk. The worst damage prior to the repair, located at station C8, was 17% dolosse displaced or broken (Figure 2).

Besides the deeper trap and steep side slopes, there has also been scour at the toe of the original breakwater (seismic surveys carried out by CSIR in 1993 confirmed the toe erosion (CSIR,1994)). The damage profile along the breakwater (shown in Figure 2) matched the plan of the sand-trap, with the highest damage area aligning with the deepest parts of the trap. The 3D basin model tests, which modelled various trap layouts, confirmed that the sand-trap allowed higher depth limited waves to reach the breakwater.

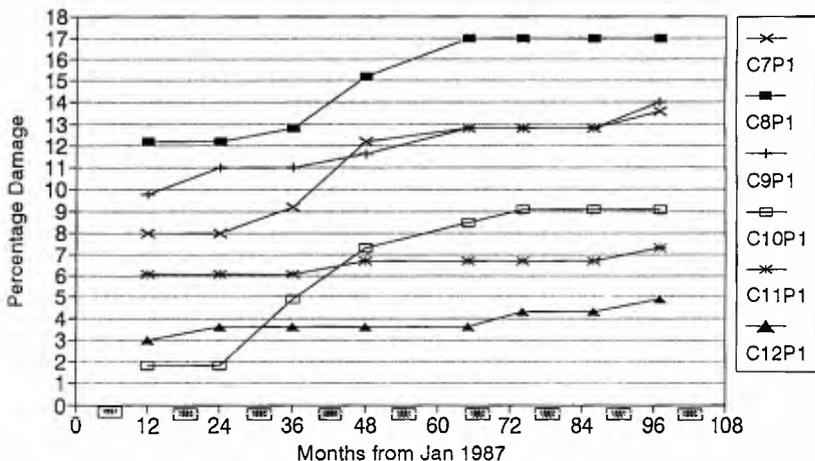
Figure 3: Rates of Damage to Worst Stations since 1987

The occurrence of low pressure cyclonic storms (cyclones Demoina and Emboa in 1984) subjected the breakwater to wave heights exceeding the 7,9m 1:50 year design H_{mo} . Storm wave set-up and low atmospheric pressure associated with these storms also had the effect of raising the water level, thereby raising the depth limited wave heights reaching the breakwater. There have also been a number of lesser, but still powerful storms with wave heights in excess of 6m - the latest being experienced in 1990. The rates of damage are shown in Figure 3 for the worst stations on the trunk section.

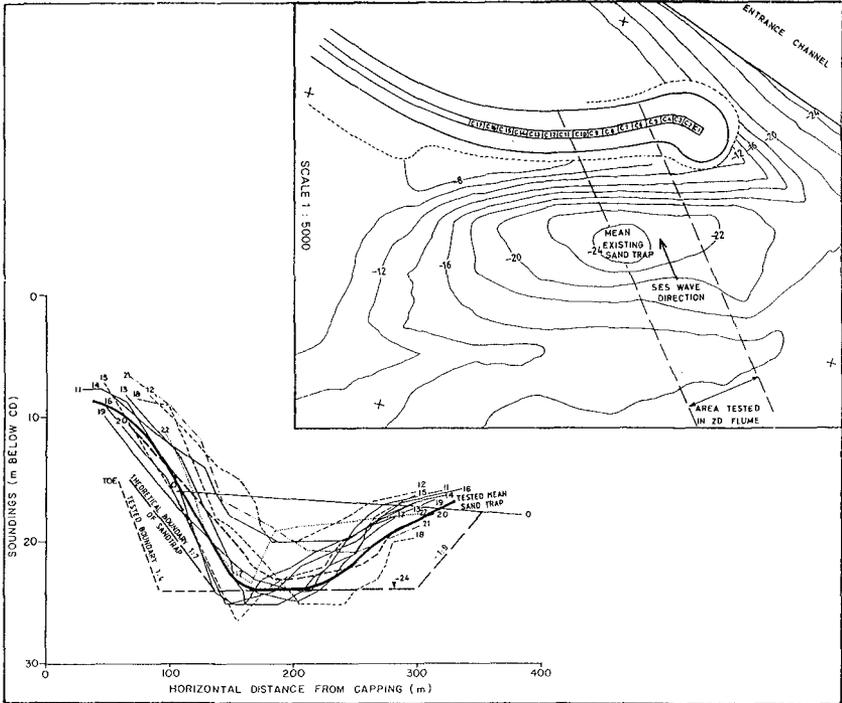
Figure 5: Plan and Cross-Sections showing Average Sand-trap Position.

much closer to the breakwater than originally anticipated (up to 60m closer). The depth of the sand-trap has reached -24m and the side slope as steep as 1:4,7. Figure 4 shows the dredger and Figure 5 the average position and sections through the sand-trap.

Figure 6 also shows, both in model and prototype results, that the worst damage occurred between stations 7 and 9. Hydrographic surveys of the sand-trap between 1977 and 1991 have shown that, almost since completion of the breakwater, the deepest area of the sand-trap was located opposite stations 7 to 9 (Figure 5). This also coincided with the area where the sides of the sand-trap were steepest and closest to the toe of the breakwater. One model test which was carried out with a larger deeper sand-trap resulted in an increase in damage proportional to the extension of the sand-trap, which indicated that the increased breakwater damage could be linked to the sand-trap dredging.

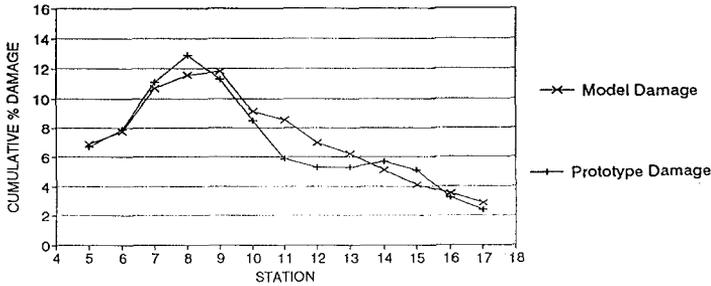
Figure 6: Prototype versus Calibrated Model Damage

In order to calibrate the physical model, a calibration test was carried out in which the prototype damage resulting from the storm history was reproduced in the 3D model (Figure 6). A number of repair options were then investigated, starting with the simplest option, and extending the repair until a stable solution was found. Before each repair was constructed, the original damage was replicated in the model. The repaired breakwater was then exposed to the conditions described above.

In the model, the number of dolos movements was determined by the digital analysis of video images taken before and after each run. In addition, the number of dolosse which were rocking was recorded visually and by cine camera during each test. However due to the difficulty in observing movements over the whole test area, it was decided to use the video measurement of small movements ($<h$), as an estimation of rocking dolosse. This was then calibrated against the recorded prototype damage to give a calibration factor of $0.4(<h) + (>h)$, which gave an accurate simulation of the prototype damage profile along the trunk of the breakwater between stations 5 and 17 (Figure 6).

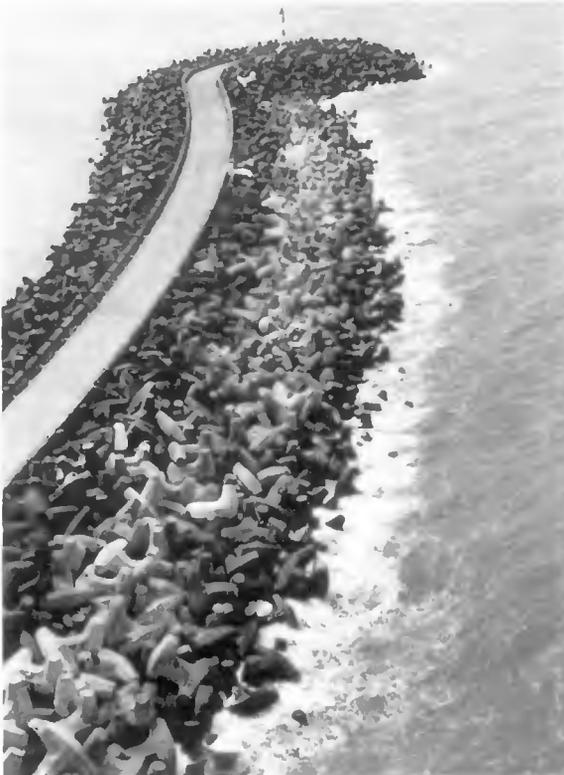
Figure 11: Successfully Completed South Breakwater Repair

The completed repair can be seen in Figure 12, which shows the uniform profile and good integration with the original structure. A final ball survey of the repair showed that for most profiles, there was a perfect match between the design and surveyed profile. This was achieved by accurate dolos placing with the aid of DGPS on the crane. This repair which was completed in June 1998, has already withstood two storms in excess of the 1:1yr design wave height above 4m. A photographic aerial survey done after these storms showed less than 1% damage resulting from the initial "shake down". Annual surveys will be continued, to monitor the performance of the new shaped 30t dolosse.
