BREACHING AND TSUNAMI WATER DRAINAGE AT OLD RIVER MOUTH LOCATIONS DURING THE 2011 TSUNAMI

Hitoshi Tanaka¹, Mohammad Bagus Adityawan¹, Keiko Udo² and Akira Mano²

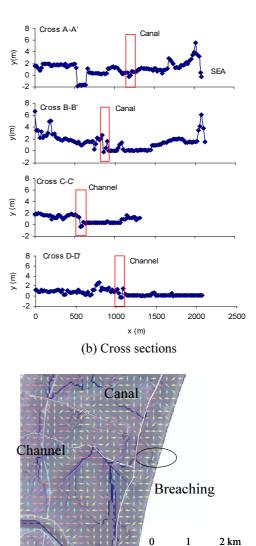
Figure 13. DEM Analysis at the Akaiko Coast

The cross sectional profile at the Akaiko Coast is given in Fig. 13(b). Cross A-A' and B-B', perpendicular to the shoreline, show that the topography has mild slope towards the canal. Cross C-C' and D-D', parallel to the shoreline, show that the topography also has mild slope towards the channel. Thus, the return flow was gathered from all directions in the canal as well as in the channel. This agrees well to the flow accumulation analysis. Figure 13(c) clearly shows that the flow was gathered in both channel and canal. Therefore, the meeting point of the canal and the channel received flow from all directions, which may lead to a more severe breaching than in the Arahama Coast. The estimated breaching width at the Akaiko Coast (130 m) was more than twice of that at the Arahama Coast (50 m). This confirms that the return flow towards the old river mouth was stronger in Akaiko Coast.
