CHAPTER 35

EROSION AND CORROSION ON MARINE STRUCTURES, ELWOOD, CALIFORNIA

H. J. Schaufele

Engineering Department, Signal Oil and Gas Company
Los Angeles, California

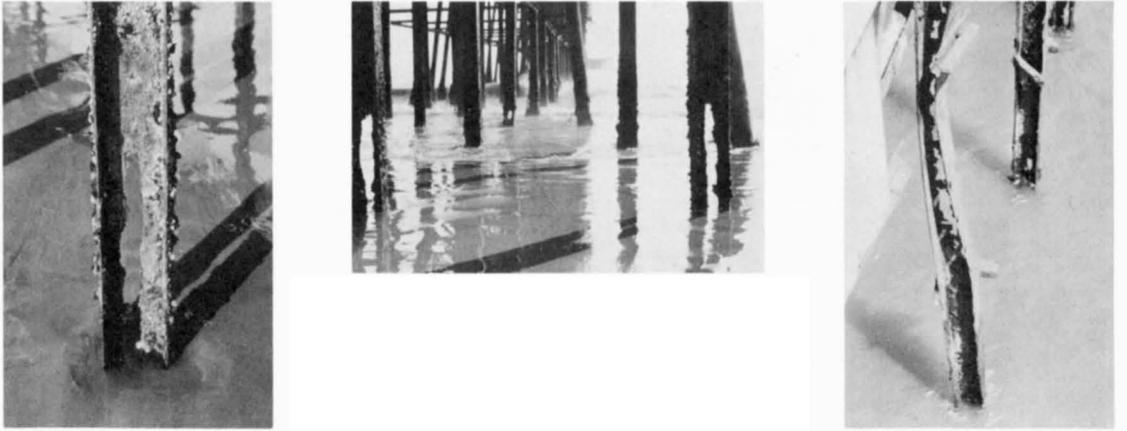
- A -

General Effect on Unprotected H Piling.

(Breaker line) In about three years, noticeable wear and sharpening of flanges was noted where structural shapes were used. In five years the cross-section was considerably reduced and lenticular holes appeared in the webs.

("H" pilings) Those oriented so the web was normal to the wave direction were especially susceptible to abrasion. Many piers have had their piling replaced or reinforced in the breaker line within five years.

Piling, breaker line or sand bottom area. All piling should be cylindrical or circular in cross section to provide as near as possible a streamline flow past the pile for any direction of wave impingement. An auxiliary sleeve over the pile of sufficient length to cover same between the limits of sand depth, is desirable. This choice of section provides an equal section modulus for any axis; also, if paints, wrapping, etc., are used, the circular cross-section provides less comparable surface area to cover and no angles, corners or sharp edges where it is difficult to build up coatings.

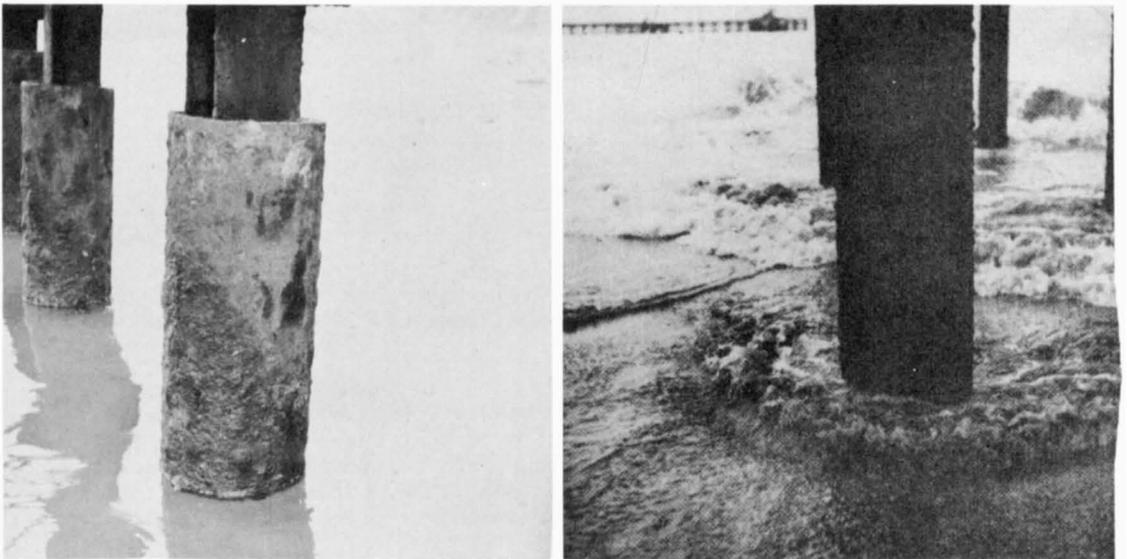
- B -

This detail of design proved to be very effective as the adjacent piers have had to have piling in the breaker range replaced or protected within five years after installation.

Protection Provided in the Planning 8 in. H Piling, 14 in. diameter, 3/16 in. thickness driven cylinders, interstitial space cleaned out and filled with 1:2 cement grout. In service 21 years without maintenance or coating of any type.

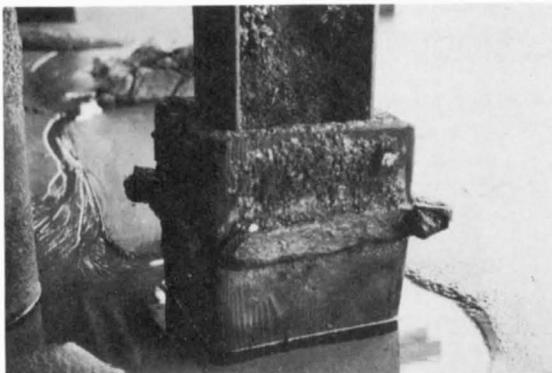
creosoted two inch thick planks, securing same with 1/2 in. x 2 in. galvanized bands top and bottom. Incidentally, after fifteen years, the wood is intact but the top bands are cut through. Reference to illustrations will show the wisdom of this choice on new work and the boxing of piles already driven (Figs. 1 and 2).

- A -
Protection Provided after Construction 10 in. H Piling, 2 in. x 12 in. creosoted boxing secured in position by 1/2 in. x 2 in. galvanized clamps. In service 16 years. Condition: Timber - good; clamps - cut through at corners.

Piling should be spaced a minimum of five diameters for a dampening of eddies set up by adjacent piling. The piling should be filled with concrete for additional strength and stiffness to resist any distortion, or the pile should be sealed off or neutralizing agent should be added to prevent interior corrosion. Structural sections in the breaker range can be protected by boxing, preferably with creosoted plank secured with heavy metal straps.

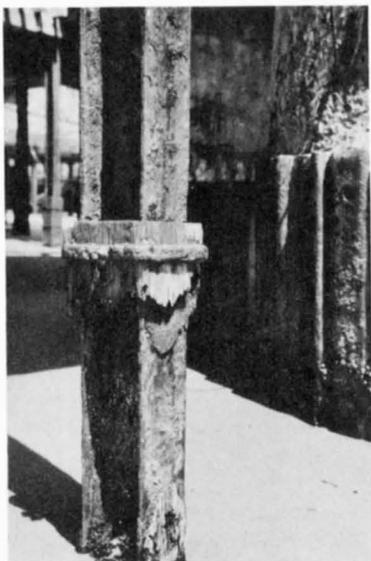
- B -
Attempts to Protect after Construction. Same as cut A except untreated timber.

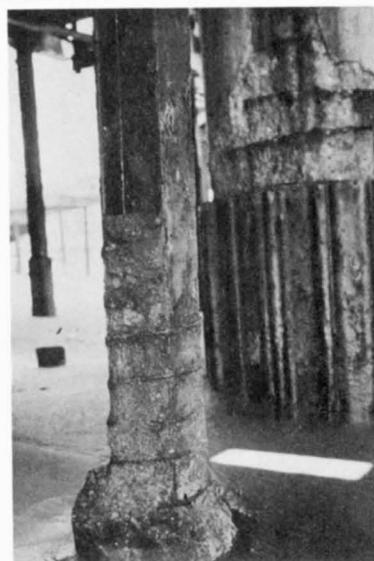
- C -
Attempt to Protect after Construction. Spiral-wrapped reinforced concrete. Failed when sheet iron form failed. Still protected, however. Limited to Tidal Range.

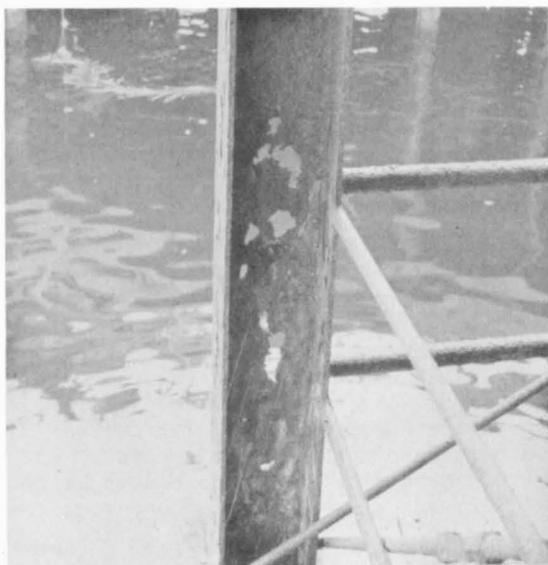
- A -

- A- Very severe case of oxidation in atmosphere above tide range. 10 in. H Pile, 0.564 in. web thickness; no protective coating. In service 16 years.
- B- 8 in. H pile, 0.300 in. web thickness, coated with 1/16 in. of Asphalt Chromate Emulsion. In service 21 years. Never retouched.
- C- At Base of Piling beyond the sand line in deep water where the bottom is mud and decaying kelp. This is a highly anaerobic area.
- D- Action on Auxiliary Non-structural Sleeves placed by diver at base of piling.

Coatings above the low tide range, certainly in our case, have proved to be better than the additional uncoated steel.

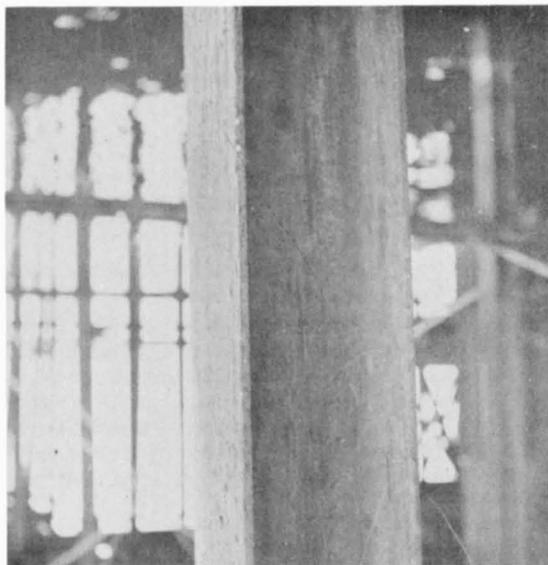
- B -

The condition of the piling given a protective coating twenty years ago is a convincing argument in favor of a protective coating at least for oxidation in the zone above the water line.

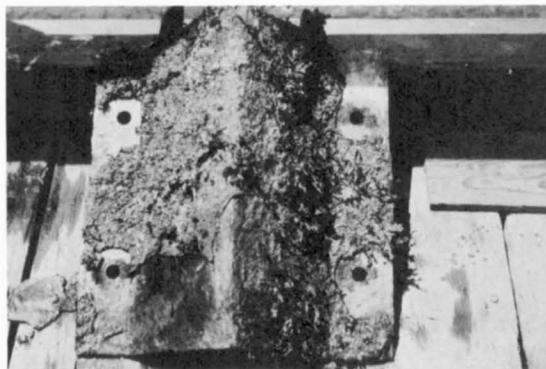
- C -

At approximately 2 ft. above the bottom, a highly anodic area was found with a noticeable loss of section. This may be related to the point of flexure; however, the environment is highly anaerobic, common to harbors and areas of decaying kelp. We corrected this by having a diver add metal sleeves to the piling and subsequent inspections have shown this has corrected the condition. The metal loss, whether it be chemical or electrolytic, is now from the auxiliary metal jacket rather than the pile and we believe that no further loss of metal will take place at this critical point.

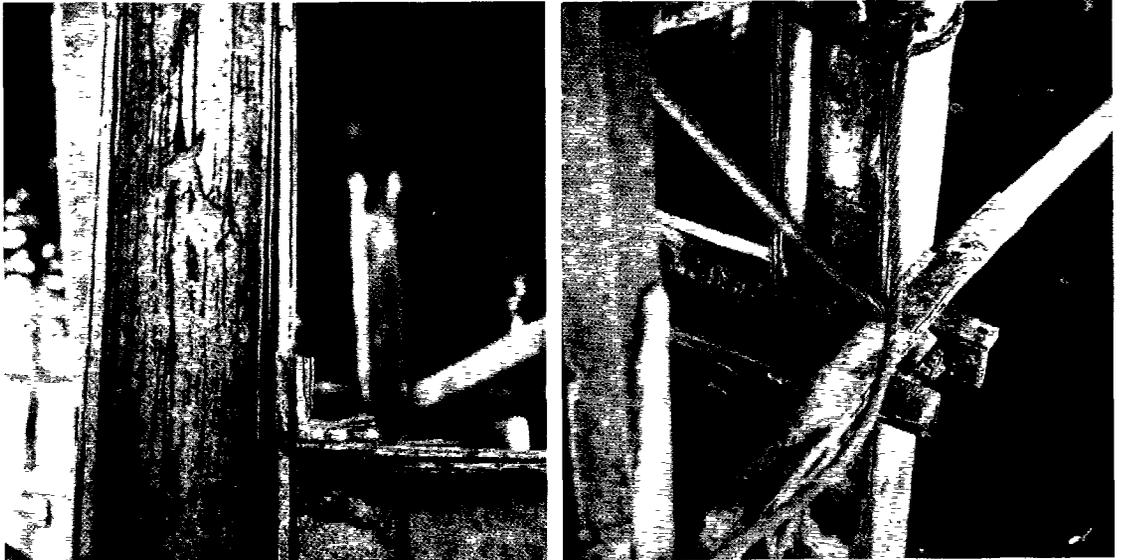
- A -

Our next perceptible loss of section on uncoated piling was above the water in the vicinity of the horizontal bracing welded to the piling. The loss of pile cross-section can be seen by eye on removal of the laminations of rust. The flange thickness is reduced to about sixty percent of its original thickness and, strangely, in a few cases, the webs are badly corroded. This condition does not exist to such a marked degree, if at all, where the piling and joints were coated twenty years ago. This again is a point of restraint and flexure. The only cure so far is removal of the section and welding in a "dutchman".

- A- Typical Corrosion in vicinity of restraint showing laminations of rust. In service 16 years. No coating protection.
- B- Typical Corrosion in vicinity of restraint with rust removed. Note loss of section on the flange. In service 16 years.
- C- Note absence of above conditions where steel was coated with Asphalt Chromate Emulsion. In service 21 years.

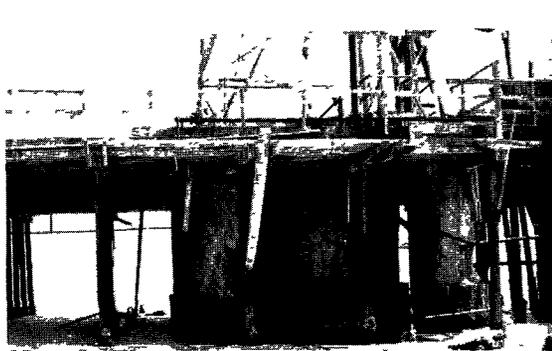
- A -

- A- Mass Concrete in Wave Area.
- B- Vertical Rise from Sheet Pile Forms.
- C- Mass Concrete in 1/4 in. Steel Shell above high tide line. Note weld failures.
- D- Mass Concrete in 1/4 in. Steel Shell above high tide line. Note shell failure.

Concrete. Concrete offers the same picture as anywhere else along the Southern California coast. It "grows," whether reinforced or mass concrete. We have had success with high-silica cements and a scientifically graded aggregate for density, stripping and coating as soon as possible to exclude moisture. This also has protected ordinary Portland cement concrete.
