CHAPTER 158

ANALYSIS OF 42-TON DOLOS MOTIONS AT CRESCENT CITY

Thomas R. Kendall, M. ASCE*

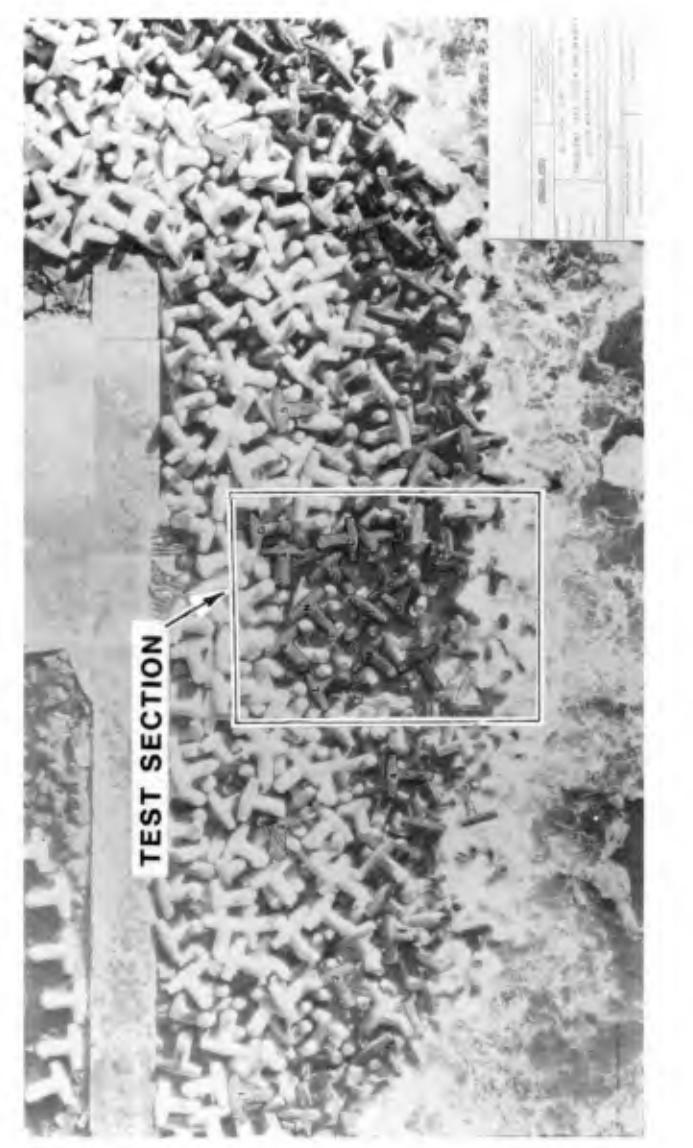
The twenty-six dolosse which have been marked in this monitoring project are shown in Figure 1. Eighteen of these are located in the instrumented section and eight are distributed uniformly throughout the remainder of the dolos field. Twenty two of these dolosse are located in the upper dolos layer and have been marked with three targets each which allows their movement to be described with six degrees of freedom. The remaining four, which are located in the lower dolos layer of the test section, have only one clearly visible surface each which has been targeted for monitoring.

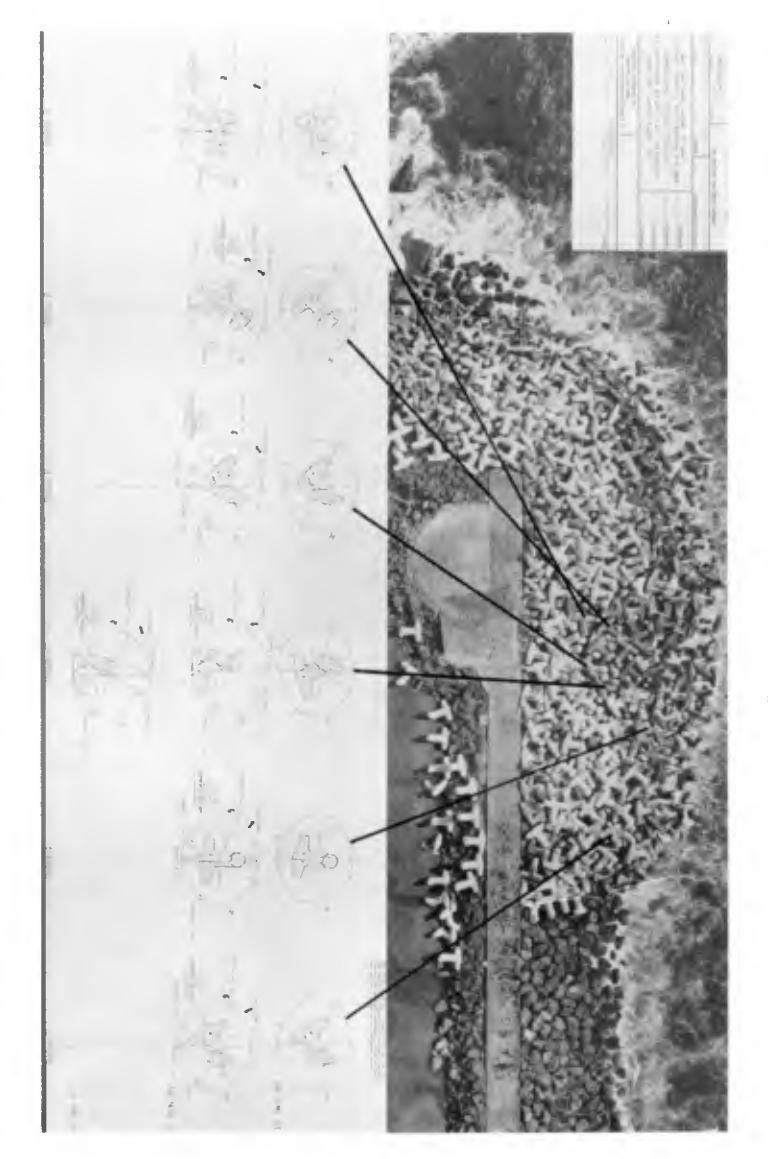
Computer generated three-dimensional drawings are used to illustrate the dolos movements measured. Time-series graphics for each surveyed dolos are presented as "exploding diagrams" projecting from their respective dolos indicated on a base map (aerial photograph) of the dolos field (Figure 2). Multiple sheets are required to track all moving dolosse. A separate sequence is maintained for the phogrammetric surveys and the periodic land surveys which are conducted on targeted dolosse as a check on the photogrammetric results. The example sheet shown in Figure 2 has a graphic entry for the earlier two surveys (lower two rows) for all dolosse shown. However, between the second and third surveys, only dolos `L' moved beyond the theshold used for precipitating an updated orientation graphic (15 centimeters movement on any target) and, therefore, the third (upper) survey row only shows an entry for dolos `L'.

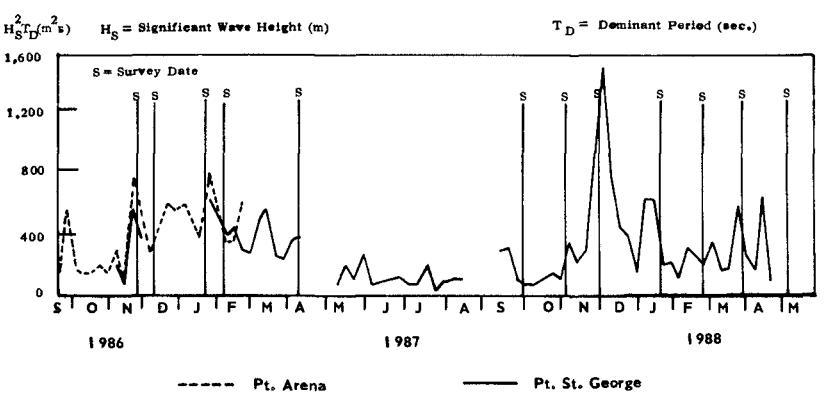
Figure 3 - Timing of dolos surveys relative to offshore wave power.

Figure 3 relates the timing of all surveys conducted during the first two seasons to the wave power encountered. The dates of both land surveys and photogrammetric surveys are indicated on the figure. Offshore wave power as defined on the figure has been plotted (as opposed to wave energy) because of the importance of wave period to the stability of the highly porous dolos armor layers. The "reservoir effect" of the pores, as explained by Burcharth and Thompson (1983), makes dolosse more vulnerable to long-period waves.

The first winter season was relatively moderate and the second season was more severe. Based on the available wave and tidal records for the area, it is concluded that a small percentage of individual waves each season (more during the second) approached design magnitude. The design storm, however, was not experienced.
