LONC TERM EXPERIENCE WITH SEAWALLS ON AN EXPOSED COAST

by Orville T. Magoon¹, Joan L. Pope², Robert L. Sloan³, and Donald D. Treadwell⁴

Appropriately designed, constructed, and maintained rubble mound seawalls are an efficient and cost-effective means of protecting erodible sections of exposed coastline. This conclusion is supported by more than 25 years of satisfactory seawall performance along the Pacific Ocean coast of Santa Cruz County, California, U.S.A. Important factors in satisfactory seawall performance include a clear understanding of the oceanographic and geologic design parameters, a vigorous inspection program during construction, and continued observation and maintenance of the structures.

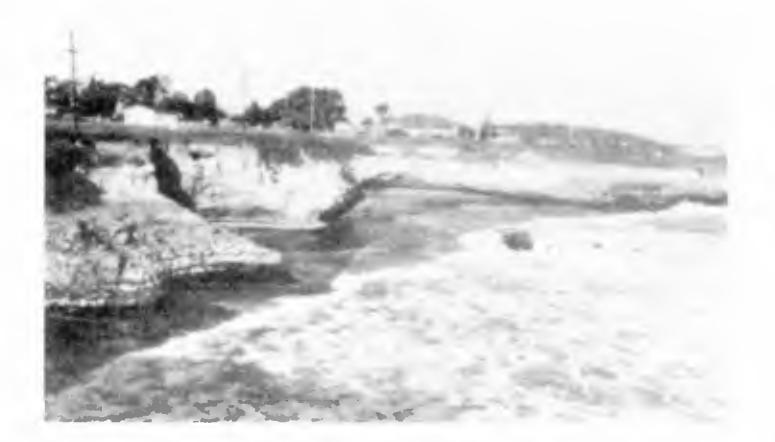
The erosion of the beaches and cliffs on the northern side of Monterey Bay between the west limits of the City of Santa Cruz and New Brighton Beach State Park had been progressive for many years (Figure 3). The recession of the cliffs had cut through public streets, destroyed both public and private land, and threatened to destroy residences and other buildings. Individual efforts by local interests to combat the erosion problem were historically insufficient in scope or failed in their intended purpose.

Figure 3 - Beaches and Cliffs near West Cliff Drive

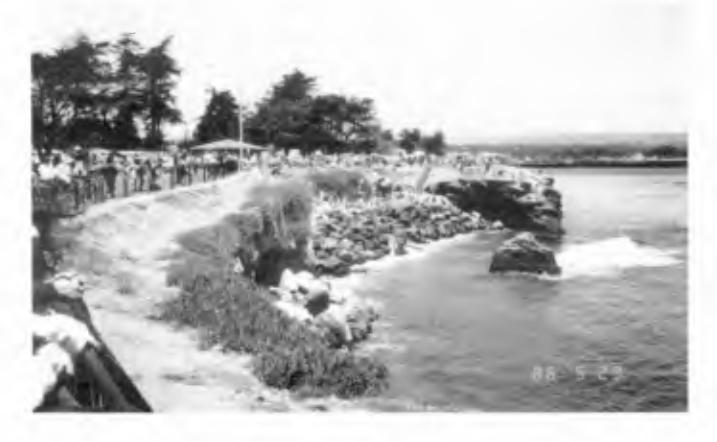
An inspection of these rubble mound seawalls and revetments in early 1988 indicated that over ninety percent of them are in a very serviceable or nearly as-built condition (Figures 8 and 9). Damage or potential damage to the remaining five to ten percent appears to be caused by the following: (1) erosion and/or collapse of the bluff material landward of the seawalls with subsequent loss of backing or support which allowed rubble to be displaced; (2) erosion of the bluffs at the terminal ends of the seawall, allowing lateral movement, loss of core material, and subsequent damage; (3) erosion of material under the toe or foundation and subsequent settlement of wall (for relatively small displacements of the toe, remedial action of placing relatively minor quantities of additional armor stone appeared satisfactory); and (4) inadequate design wave height, related to difficulties in determining wave

Figure 8 - Seawall near Santa Cruz (May 1988)

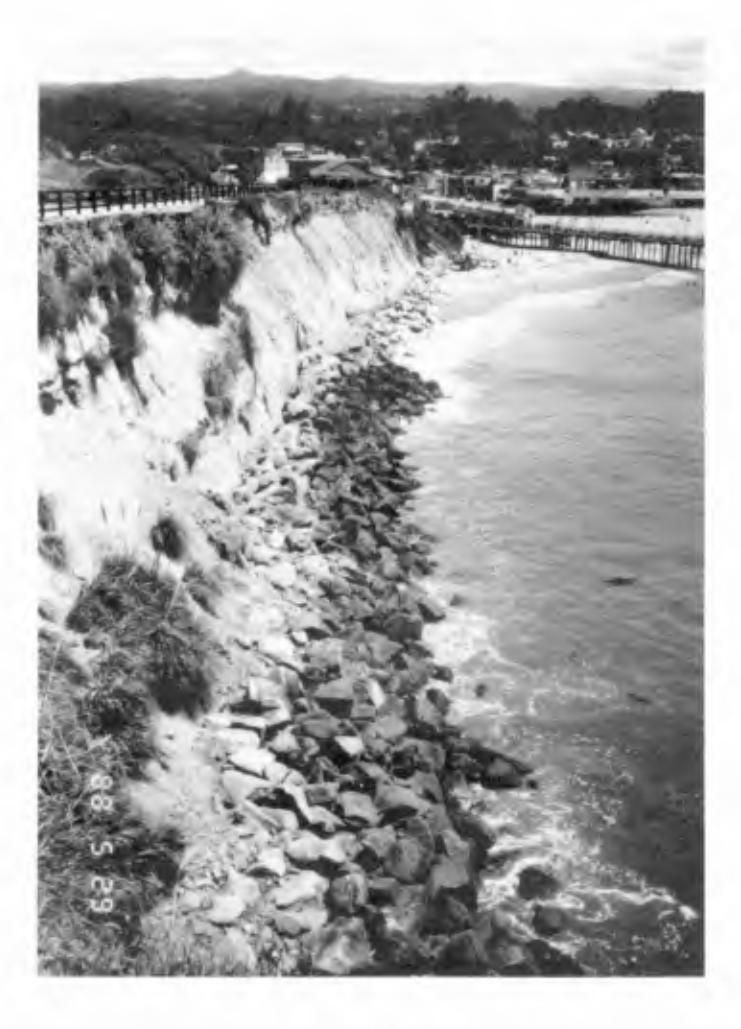
Figure 9 - Seawall near Capitola (May 1988)
