DAMAGE ALONG COASTS IN SENDAI BAY CAUSED BY THE 2011 GREAT TSUNAMI

Kazuya Sakai¹, Takaaki Uda¹, Toshiro San-nami² and Tatsuya Shimizu³

Keywords: 2011 Great Tsunami; tsunami damage; trench formation; coastal dike; coastal forest

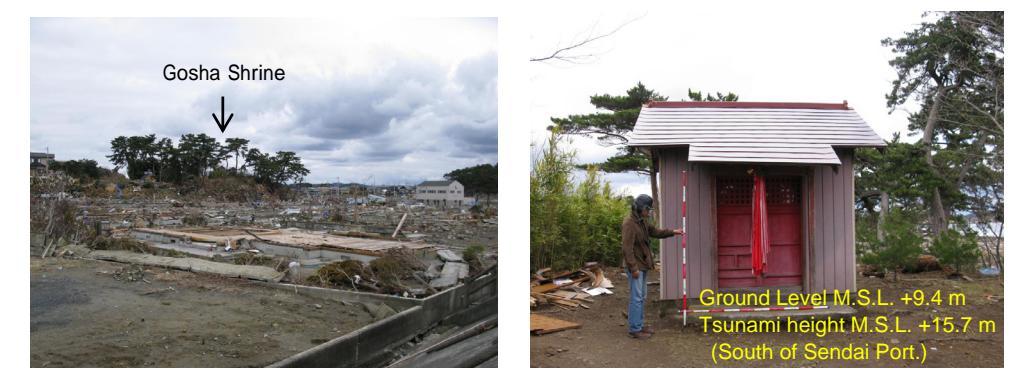
Photo 1, taken on top of the coastal dike facing north, shows the coastal condition. The tsunami flowed over the crown of the coastal dike and strong currents flowed down the back slope of the dike, and all the houses built along the coastal dike were completely destroyed leaving only their foundations. An isolated hill surrounded by pine trees could be seen 150 m inland of the coastal dike, which seemed to be unaffected by the tsunami. On top of the hill exists Gosha Shrine, which survived the tsunami, as did many shrines in other areas subjected to the large tsunami.

Photo 2 shows the front of the shrine. Tsunami debris was scattered around the shrine, implying that the ground level was approximately equal to the tsunami inundation height. Photo 3 shows the side wall of the shrine, where a large amount of tsunami debris was also scattered. From these observations,

Photo. 1. Devastated houses with only their foundations left and Gosha Shrine located on top of isolated hill.

Photo. 2. Front of Gosha Shrine.

the tsunami inundation height was measured to be +9.7 m above MSL at this location, taking the debris scattered around the shrine into account.

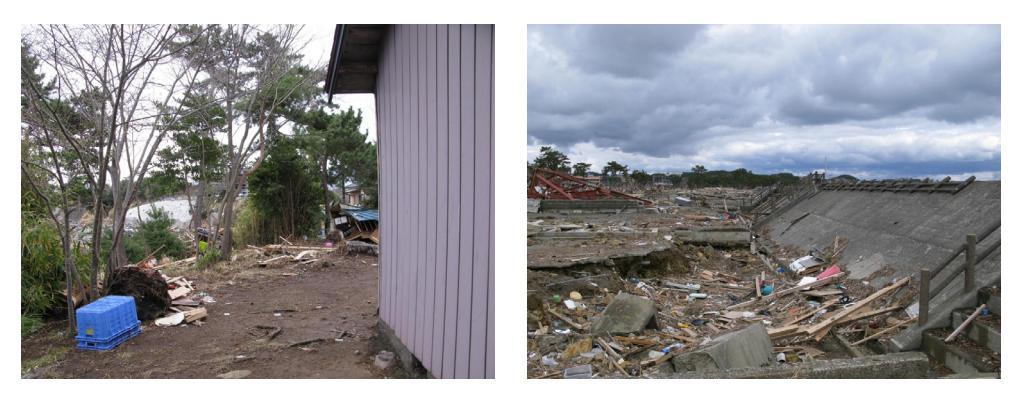
Photo. 3. Sidewall of Gosha Shrine and Photo. 4. Tsunami damage immediately inland of tsunami debris. coastal dike.

Photo 4 shows the scouring hole formed by the overflow of the tsunami over the top of the coastal dike, where houses had been built, as shown in Fig. 4(a) before the tsunami. All the houses were destroyed by tsunami currents. Photo 5 shows the site of the complete breakdown of the coastal dike, as shown in Fig. 4(b). A large hole was formed by the tsunami currents that broke down the concrete coastal dike.

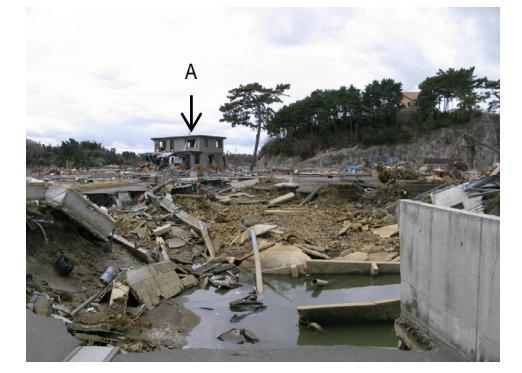
Photo. 5. Breakdown of coastal dike.

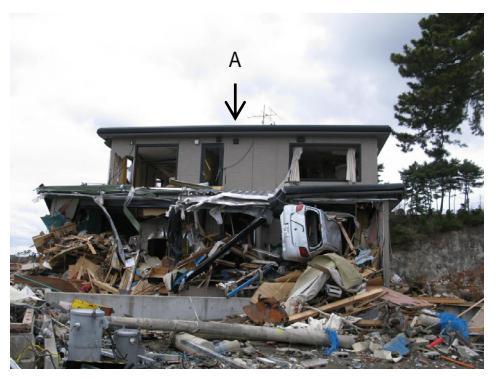
Photo. 6. Destroyed house and debris inside it.

Photo 6 shows the two-story house (indicated by an arrow A in Photo 5) severely damaged by the tsunami. A car and debris from houses were carried into the room. Photo 7 shows a large body of water left behind the coastal dike after the breakdown of the coastal dike, as shown in Fig. 4(b), owing to the tsunami currents. A deep channel was formed inland of the coastal dike. North of the breakdown of the coastal dike, the sandy beach in front of the coastal dike was severely eroded with a backshore elevation decrease of 2.4 m, as shown in Photo 8, although the dike itself was left intact.

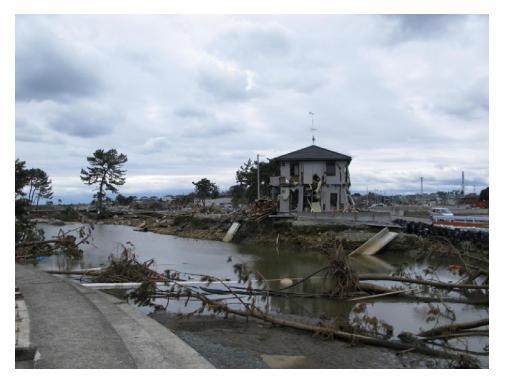
Photo. 7. Large body of water left behind coastal dike after its breakdown.

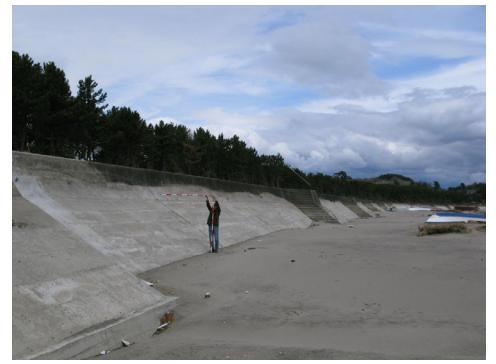
Photo. 8. Erosion of sandy beach by 2.4 m depth due to tsunami.

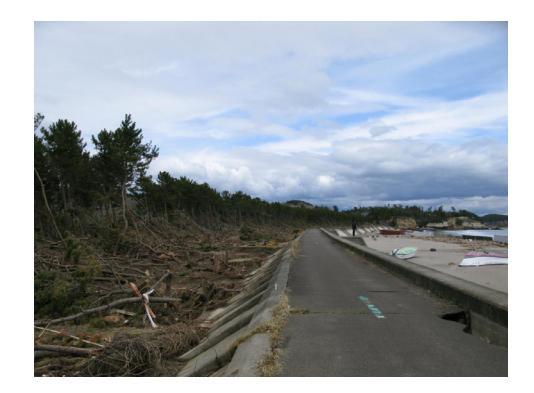
Photo 9 shows the destroyed pine trees in the coastal forest zone behind the coastal dike. Before the tsunami, pine trees densely grew close to the coastal dike, but almost all the trees fell in the landward direction. At a location where the direction of the coastal dike slightly changes, the asphalt pavement on the crown of the coastal dike was torn off and carried away, forming the scouring hole shown in Photo 10. Photo 11 shows the rocky headland located at the north end of the beach, where a steel signboard fell down in the direction normal to the coastline, showing the propagation direction of the tsunami.

Photo. 9. Damaged coastal forest due to tsunami overflow.

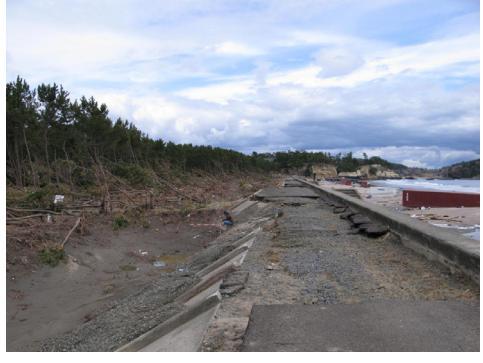
Photo. 10 Damaged coastal forest and scouring behind coastal dike.

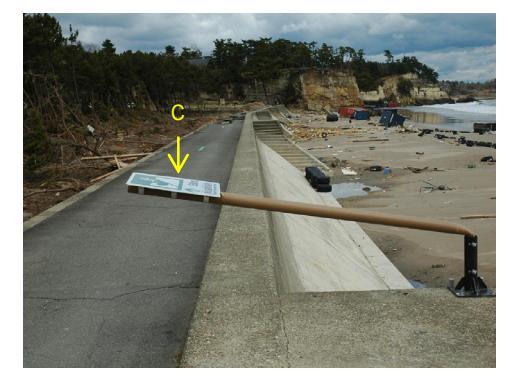
Photo. 11. Steel signboard that fell normal to coastline.

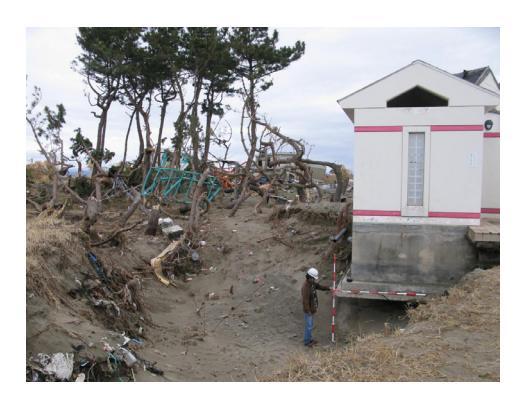
Photo 12 shows a large scouring hole formed at the south corner of a public restroom located at the entrance to the beach seaward of point A in Fig. 6. At the corner of the building, a large scouring hole of 3 m depth, directed slightly northward, was formed; the depth was greatest at the corner of the building and gradually decreased landward. Sand was not deposited in the vicinity of this hole, implying that sand was transported further landward by tsunami currents.

Photo. 12. Large scouring hole formed at south corner of public restroom.

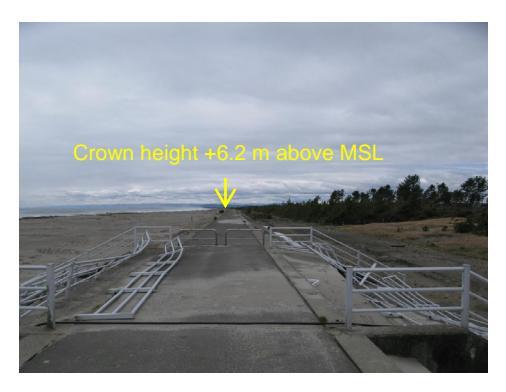
Photo 13 shows the crown of the coastal dike facing south with an elevation of +6.2 m above MSL. The steel fence on the crown fell landward, suggesting the generation of strong tsunami currents. Although tsunami currents flooded over the dike, the coastal dike did not completely break down and the back slope of the dike retained its original shape. Photo 14 shows the damage to houses facing south. The houses were completely destroyed except for their foundations.

Photo. 13. Concrete coastal dike with crown height of +6.2 m protecting seaward side of residential area.

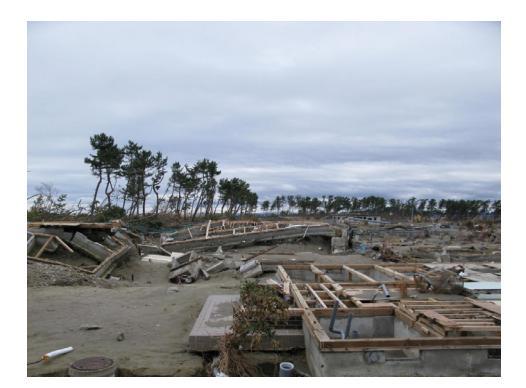
Photo. 14. Damage to houses.

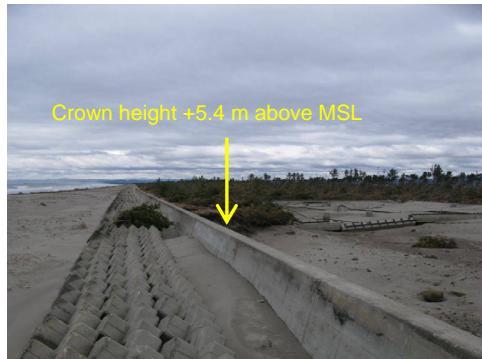
The seaward side of Arahama Town was protected by the concrete coastal dike with a crown height of +6.2 m, as shown in Photo 13. However, the crown height of this coastal dike decreased to +5.4 m above MSL at the south end of the residential area, and this coastal dike changed from a structure with a trapezoidal cross section to a vertical seawall, as shown in Photo 15. This allowed the tsunami to easily flow over the seawall.

Photo. 15. Vertical seawall with smaller crown height.

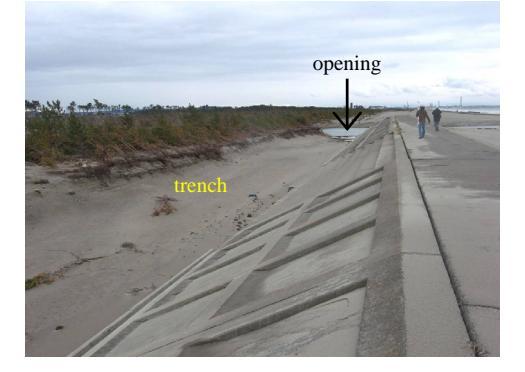
Photo. 16. Deep channel formed at toe of back slope of coastal dike.

In the northern part of the study area, a deep trench was found at the toe of the back slope of the coastal dike, as shown in Photo 16, and the depth of this trench increased northward. The fact that the pine trees immediately inland of this trench obliquely fell inland demonstrates that this trench was mainly formed by the tsunami flow over the coastal dike. Furthermore, the longshore return flow of the tsunami along the coastal dike toward the opening, as shown in Photo 16, is considered to have deepened the trench owing to the blockage of the tsunami return flow by the coastal dike. The deepening of the trench toward the north end is evidence of the development of the longshore return flow of the tsunami along the coastal dike.

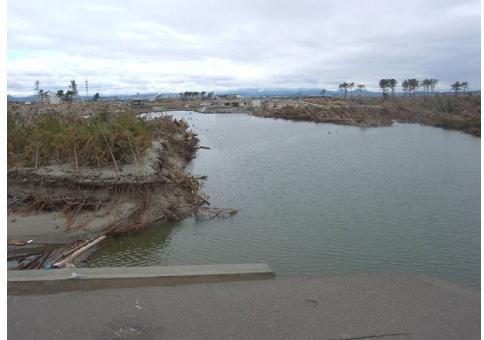
Photo. 17. North end of coastal dike and wide body of water.

Further north of this area, there was no dike and a wide body of water was observed, as shown in Photo 17. Before the tsunami, this area was covered with a coastal forest (Fig. 6(a)); however, after the tsunami, it was severely eroded, leaving a wide channel (Fig. 6(b)). Considering that there was a sandy beach before the tsunami, as shown in Fig. 6(a), this channel is considered to have been formed by the concentration of the tsunami return flow. Further north of this channel perpendicular to the shoreline, there were no coastal protection facilities except for a wooden fence preventing wind-blown sand from entering the area, enabling the tsunami to easily inundate the hinterland.

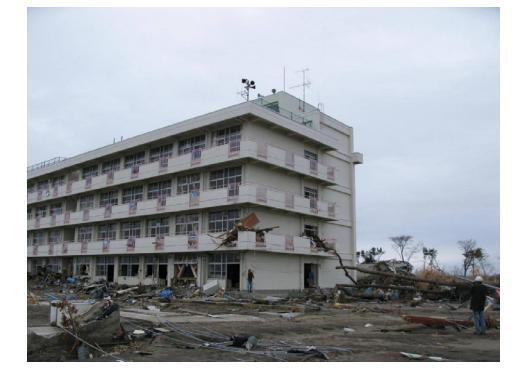
Arahama elementary school was a four-story building made of reinforced concrete located 600 m inland of the coastal dike. The first floor was severely flooded and the second floor was also inundated, as shown in Photo 18. Photo 19 shows the condition of the south side of the school building. A large amount of driftwood was deposited on the south side of the second floor of the building. The elevation of the upper limit of the driftwood was +5.5 m above the ground level. Because the ground elevation around the school was +1.5 m above MSL, the tsunami inundated the building up to a level that was +7 m above MSL. Photo 20 shows the debris accumulated in a corridor of the school building. At the end of the corridor of the first floor, the deposited debris reached the ceiling, and a long pine tree and a car were transported into the corridor.

Photo. 18. Damage to Arahama elementary school.

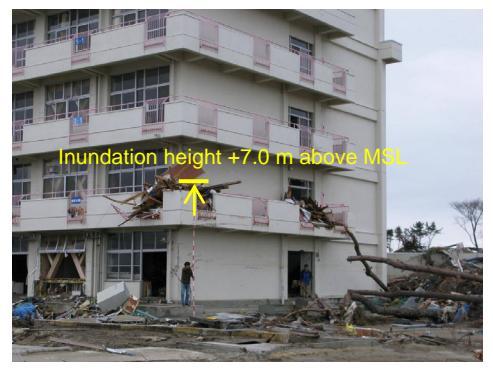
Photo. 19 Condition of south side of school building.

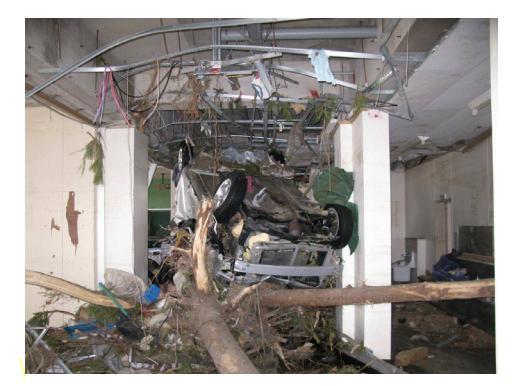
Photo. 20 Debris accumulated in corridor of school building.

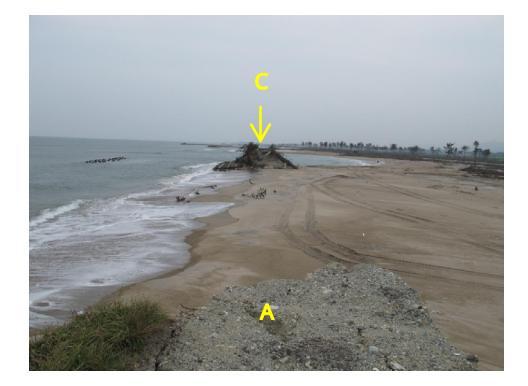
Photo 21 shows part of the destroyed coastal dike, facing south from point A shown in Fig. 8(b). At a location 100 m south of point A, the remains of the coastal dike were observed and the sandy beach extended between points A and C. Sand deposition was not observed near point C in April 2011, as shown in Fig. 8(c), although a cuspate foreland had formed near point A. This implies that a large amount of sand was transported and deposited by wave action during the period between April 2011 and August 12, 2011.

Photo. 21. Part of destroyed coastal dike.

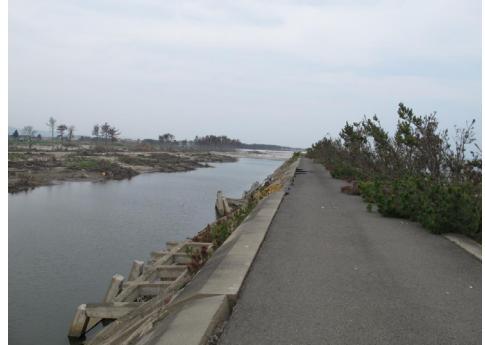
Photo 22 shows the coastal dike and a trench north of point A. There was no deformation of the asphalt pavement of the crown, although the pine trees planted on the seaward slope of the dike were uprooted. In contrast, the back slope of the concrete dike was destroyed, and a trench of 50 m width was formed inland of the destroyed back slope. The destruction of the back slope was considered to be due to the local scouring at the toe of the back slope and the suction of the sediment that filled the dike when the tsunami flooded over the dike. Photo 23 shows the damage to the crown in an area further north. The back slope, as well as the asphalt pavement, was much more severely damaged than that in the southern part. Approaching the north end of the coastal dike (point B in Fig. 8(b)), the coastal dike was destroyed and almost the entire crown of the dike collapsed (Photo 24).

Photo. 22. Crown of coastal dike north of point A.

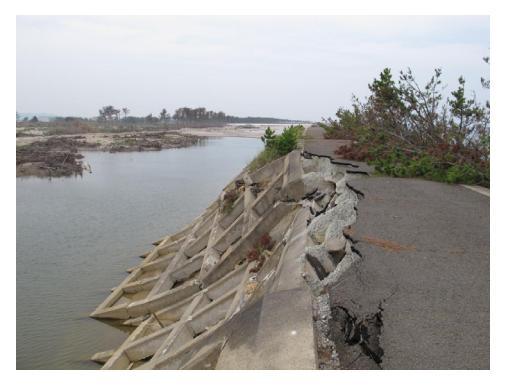
Photo. 23. Damage to crown in area further north.

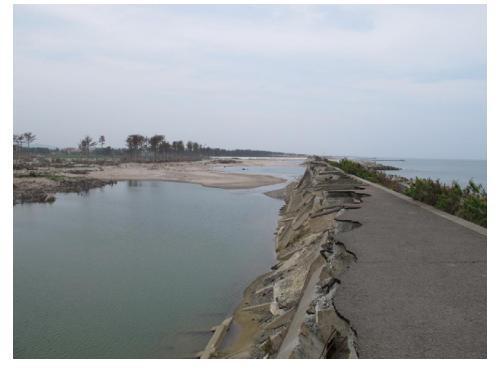
Photo. 24. Severely damaged coastal dike.

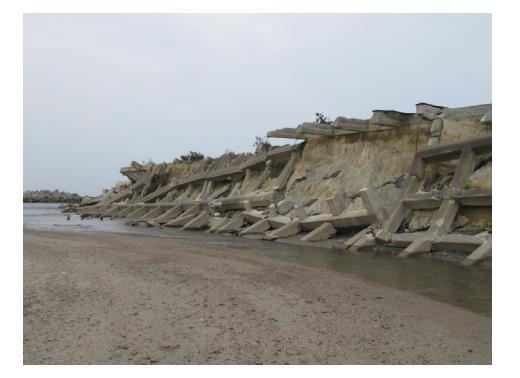
Photo 25 shows the cuspate foreland behind the coastal dike, which was formed near point B, as shown in Fig. 8(b). Because the partly destroyed coastal dike functioned as an impermeable detached breakwater, a large-scale cuspate foreland was formed behind the partly destroyed dike. In contrast to the severe damage to the back slope, no major changes were observed on the seaward slope, as shown in Photo 26.

Photo. 25. Cuspate foreland behind partly destroyed coastal dike.

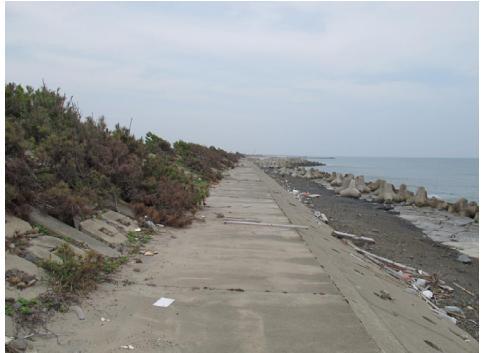
Photo. 26. Seaward slope without major changes.

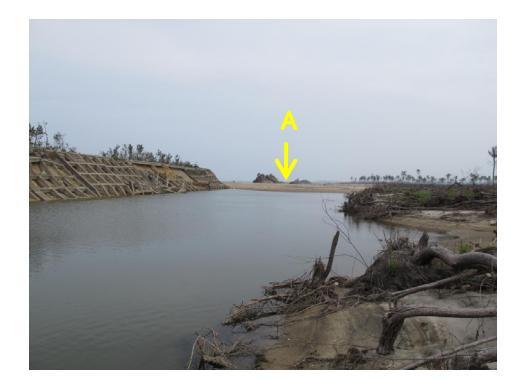
Photo. 27. Photograph of uniform trench formed alongshore behind coastal dike (south).

The Yamamoto coast was severely eroded even before the tsunami, there were no sandy beaches, and the coastline was protected by a concrete coastal dike and concrete armor units. In this area, the coastal dike was severely destroyed. Photo 27 shows a uniform trench formed alongshore behind the dike facing south. Most of the back slope was destroyed by the tsunami and subsided. In addition, subsidence of the back slope also occurred owing to the discharge of earth that filled the dike. It is considered that because the trench was continuously formed alongshore, the scouring occurred two-dimensionally.

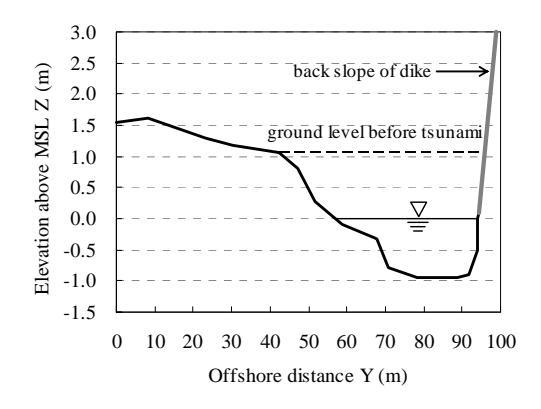
Figure. 9. Measured cross section of trench behind the coastal dike.

Across the trench formed inland of the damaged dike, where sand deposition did not occur, the cross-shore profile (Fig. 9) was measured across the trench. The width and depth of this channel at the ground level were 50 m and 2 m, respectively.

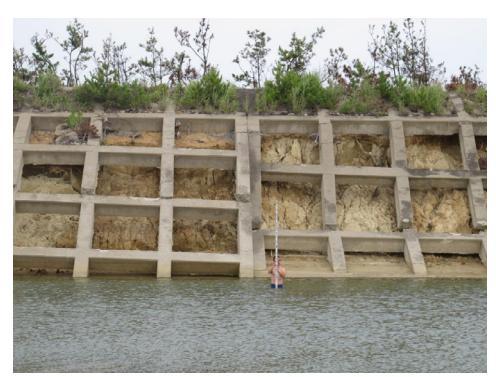
Regarding the back slope of the coastal dike, the sediment that filled the dike was discharged and the concrete slab was broken. Such conditions can be clearly observed in Photo 28, in which concrete frames were broken and left in the air owing to the scouring. Taking the development of the trench behind the partly destroyed dike into account, it is concluded that the ground level rapidly decreased

near the toe of the back slope, forming openings beneath the toe. The sediment was discharged through these openings, and finally the back slope was destroyed.

Photo. 28. Trench formation and back slope of damaged seawall.
