Chapter 26

CASE HISTORY OF SHORE PROTECTION AT PRESQUE ISLE PENINSULA, PA.

Charles E. Lee Great Lakes Division, Corps of Engineers Chicago 15, Illinois

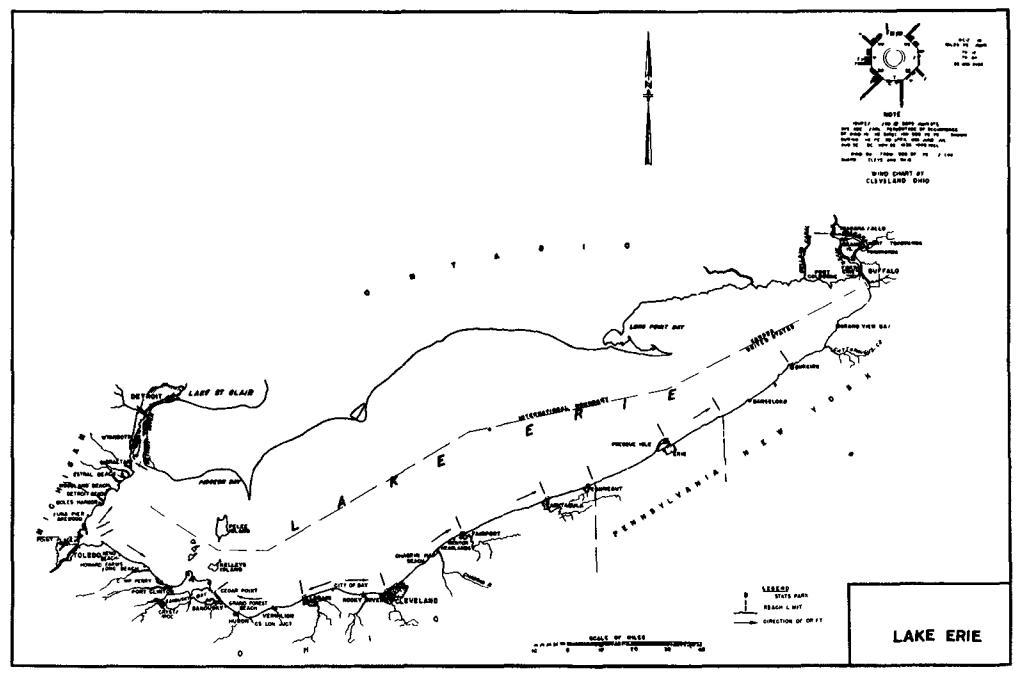
Fig. 1.

Presque Isle Peninsula is located at Erie on the south shore of Lake Erie, 75 miles southwest of Buffalo, New York, and 102 miles east-northeast of Cleveland, Ohio. Lake Erie, one of the Great Lakes chain, is an elongated body of fresh water, 9,940 square miles in area, lying between Buffalo and Toledo, Ohio. Its maximum length and width are 241 and 57 miles, respectively, with its major axis lying in an east-northeast direction. The lake is comparatively shallow with a maximum depth of 210 feet and an average depth of about 58 feet. The 30-foot depth curve along the south shore of the lake is approximately one mile offshore. Except at the extreme ends, the lake is free of shoals and islands. Presque Isle Peninsula and Long Point, Canada, a similar peninsula to the north project from opposite shores and constrict the width of the lake at this point to 26 miles (Fig. 1).

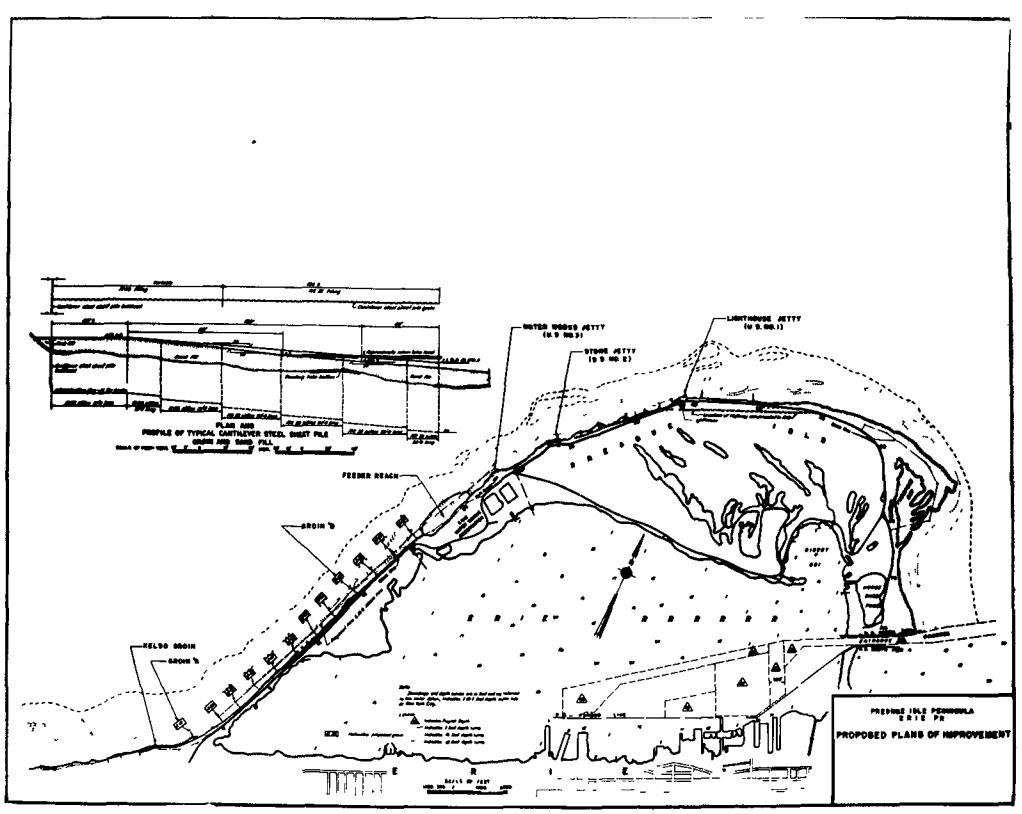
Fig. 2.

Conditions during the three years prior to this survey were somewhat more severe than typical years as lake levels were high. The high levels allow damaging waves to progress further inland with consequent increased erosion of the shore. The second survey indicated that (see Fig. 2):

a. The permeable groins installed by the state had settled 2.5 to 3.0 feet. Inspection indicated that some accretion occurred with easterly winds but erosion occurred with more frequent westerly winds;

b. General erosion had occurred in the unprotected areas excep at the distal end of the peninsula;

c. No appreciable changes had occurred in the sections where protective works (groins and bulkheads) were constructed, except at groin "B" where a three foot deep accumulation of sand occurred adjacent to the updrift side. It was concluded that groin "A" was providing protection although the amount of onshore accretion was not as large as at groin "B".

A plan consisting of revetment and bulkhead alone was considered for protection of the peninsula. However, this method was eliminated in the final selection of plans because of advantages offered by a spending beach. Spending beaches furnish protection and also provide recreational area, a principal function of the peninsula. A comprehensive plan using this method was recommended in the report. After reviewing the recommendations of the District and Division Engineers, the Beach Erosion Board recommended the comprehensive plan described in the following paragraphs (see Fig. 2).
