# DETAILED PLANNING OF BEACH NOURISHMENT BASED ON MONITORING OF COASTLINE UNDULATIONS AND DUNE EROSION

H. Toxvig Madsen<sup>1</sup>, S. Bjerre Knudsen<sup>1</sup> and P. Soerensen<sup>2</sup>

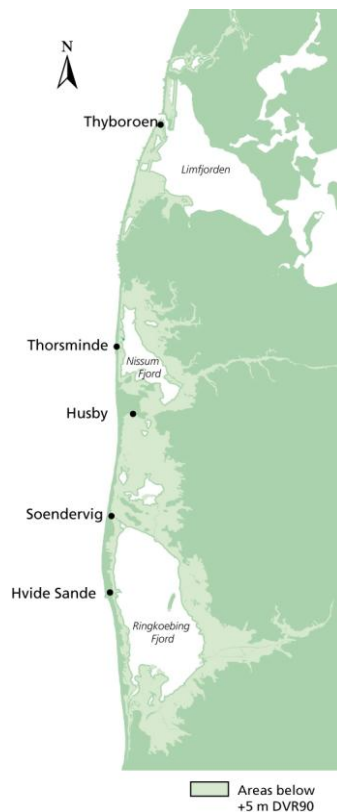
The hinterland is characterized by three systems of narrow lowland spits, see Fig. 3. The rest of the hinterland is generally also low-lying, so there is some latent risk of flooding on this stretch of coastline.

Figure 3. Low-lying areas in the hinterland

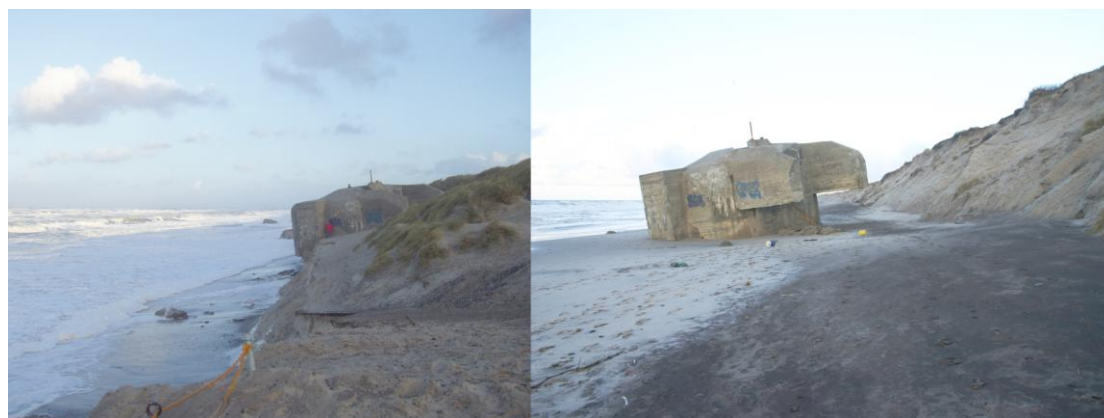
The natural coastal retreat rate is 1.0 m/year which is low compared to the rest of the stretch. During a storm in January 2005 about 25 m of the dune was removed by the sea leaving a number of holiday cottages amongst the dunes at high risk of sliding down onto the beach in the next storm, see Fig. 5.

Figure 5. The dune foot before and after the storm at Soendervig
