# EXPERIMENTAL STUDY INVESTIGATING VARIOUS SHOREFACE NOURISHMENT DESIGNS

D.J.R. Walstra<sup>1,2</sup>, C.W. Hoyng<sup>3</sup>, P.K. Tonnon<sup>1</sup>, L.C. Van Rijn<sup>1,4</sup>

*Keywords: shoreface nourishment, physical experiment, process measurements*

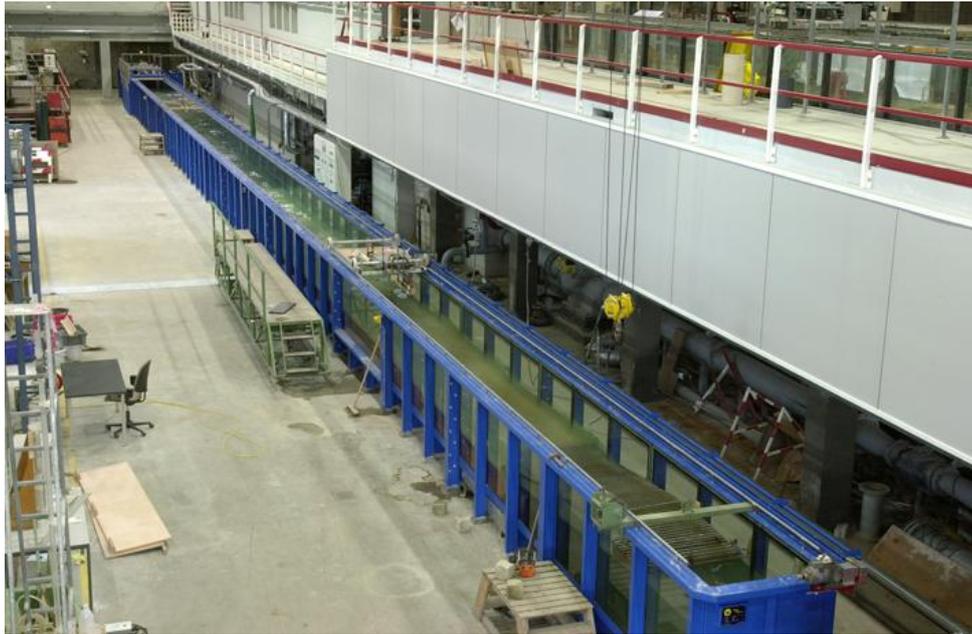
Figure 1. Scheldt flume at Deltares.

The experiments have been conducted in Deltares' Scheldt flume. The flume, consisting of an iron bottom and glass walls, has an overall length of 56 m, a width of 1 m and a depth of 1.2 m. The wave generator located at the beginning of the flume is equipped with an online active reflection compensation in which reflected waves are compensated for by separating them from outgoing waves. In addition, the wave board is equipped with second order wave steering to compensate for spurious waves.

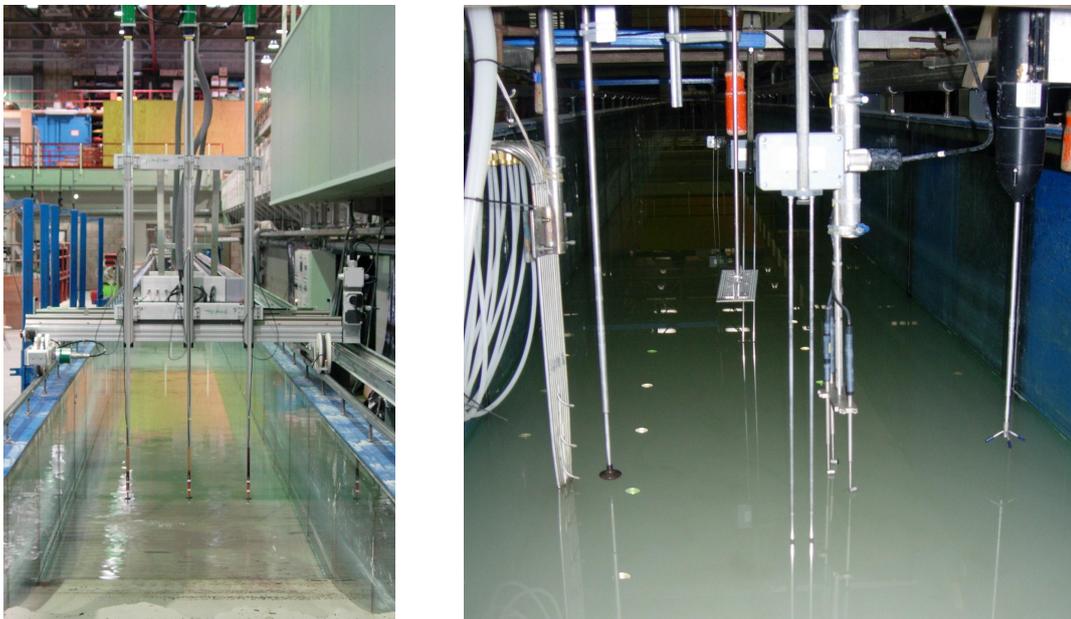
Figure 2. Left: bed profiler with three probes. Right: carriage with (from left to right): TSS, EMS, reference rod, WHM, ASTM and ADV.

During the experiments, bed profiles, water level variations, flow velocities, sediment concentrations and sediment transport have been measured. The flume is equipped with a rail-guided carriage, which allows automatic profile surveying. Three probes at a mutual distance of 25 cm move up, forward and down again (Figure 2). At fixed time intervals the bed profile is measured by the bed profiler. The results of the three parallel measurements give the average bed profile. Cross-shore non-uniformity of the bed profile has been checked and can be neglected.

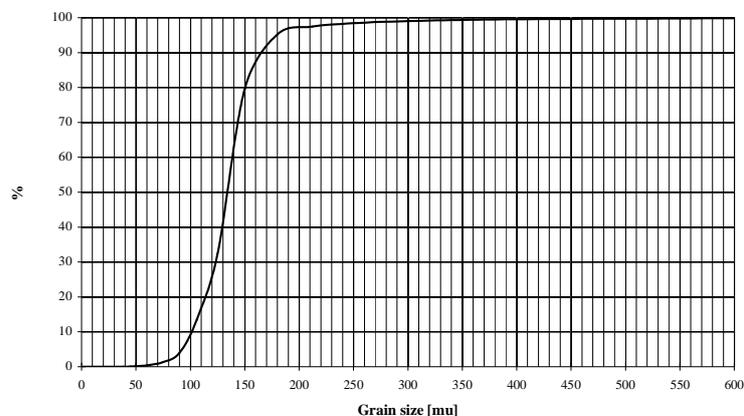
Figure 3. Grain size distribution of the sediment in the Scheldt flume.

The sediment used for the tests in the Scheldt flume is Sibelco AF100 sediment. D50 is slightly larger than 130  $\mu\text{m}$  (Figure 3).

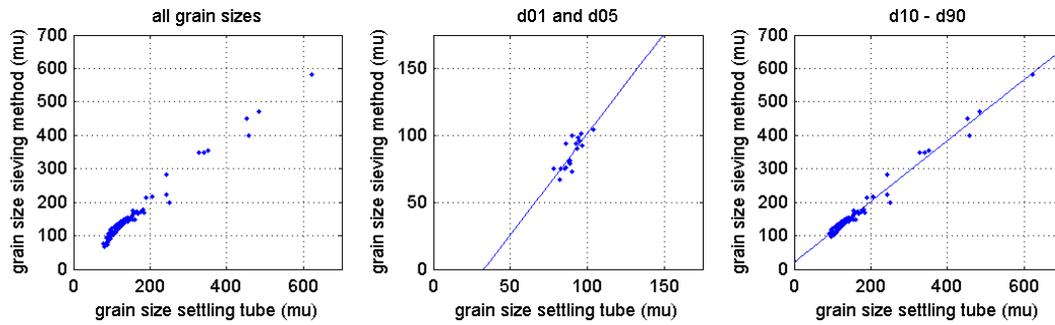
Figure 4. Calibration of Visual Accumulation Tube (VAT) with sieved sediments.

A Visual Accumulation Tube (VAT) was used to determine the suspended sediment grain size and fall velocity from the sand collected by the TSS. The VAT consists of a settling tube with a length of about 2 m and a diameter of approximately 3 cm. The sample is released on top of the tube by means of a simple clamp device. Under the settling tube a small tube is suspended in which the deposit height can be determined as a function of time. Based on this information, the fall velocity distribution can be determined. In the left plot of Figure 4 sieved sand is compared with VAT estimates. It can be seen that for smaller sediment the VAT under-estimates the grain size slightly. This due to the fact that for small grains cohesive forces and trapping becomes relative more important. Therefore separate conversions were determined which are shown in the middle and right plots of Figure 4:

$$\begin{aligned} D_s &= 1.5D_{vat} - 49 && \text{for } D_{01} \text{ to } D_{05} \\ D_s &= 0.91D_{vat} + 20 && \text{for } D_{10} \text{ to } D_{90} \end{aligned} \quad (1)$$

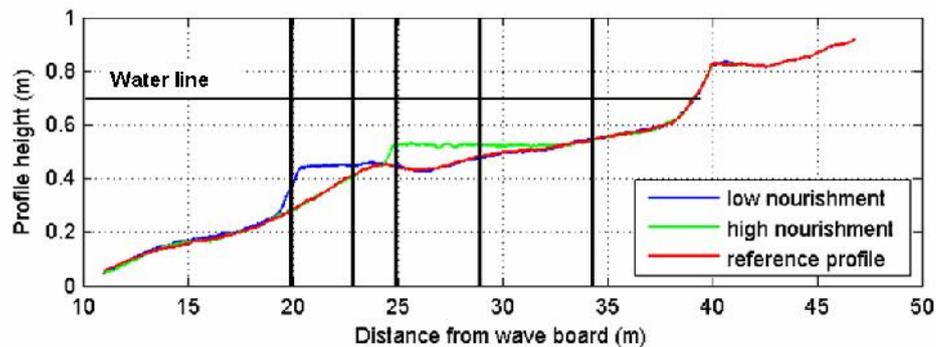
Figure 5. Initial profiles for the reference case and both nourishment cases, vertical black lines indicate positions of detailed hydrodynamic and sediment concentration measurements.

The experiments were designed to investigate two different nourishment designs with identical volumes: a nourishment relatively high in the profile covering the trough and a nourishment relatively low in the profile just seawards of the breaker bar (see Figure 5). In addition a natural profile was also considered to act as a reference. All profiles were subjected to an accretive and an erosive wave condition (Table 1).

Besides regular profile measurements (0, 1, 3, 8, 16, 24 hours) detailed velocity and sediment concentration measurements were carried over the water column out at five horizontal locations (indicated in Figure 5).

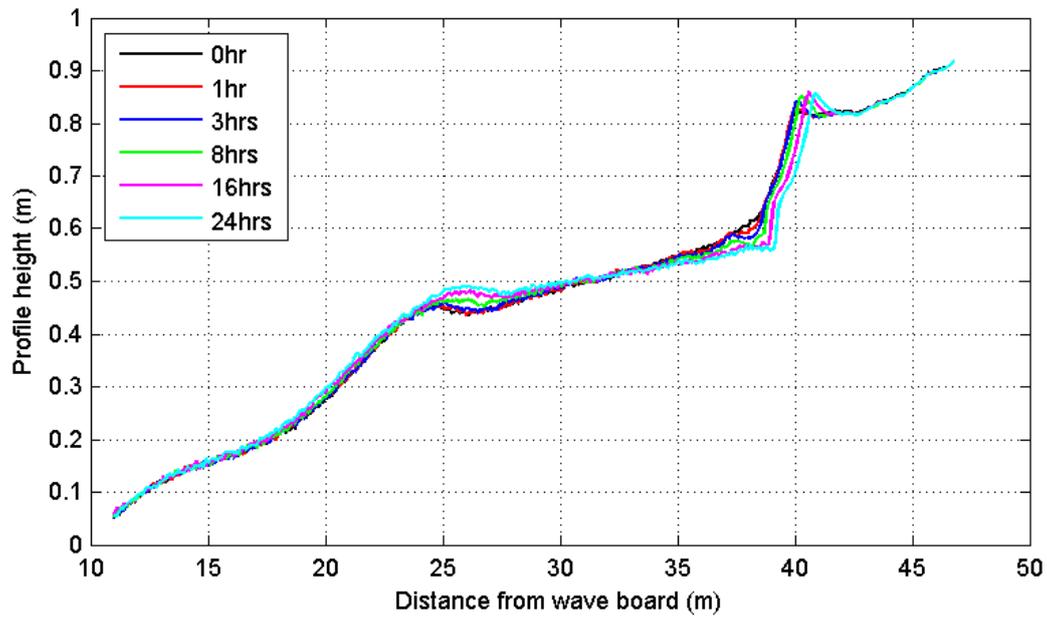
Figure 6. Observed profile development for the reference profile under accretive wave conditions.

In Figure 6 to Figure 11, the beach profile development of the reference tests and the tests with the two nourishment designs are shown. It is clear that for the both accretive and erosive wave conditions the upper part of the profile ( $x > 32$  m) is eroding. However, for the reference case (Figure 6 and Figure 7), the bar at  $x=24$  m is showing an opposite migration response to both wave conditions. The erosive wave condition results in an offshore migrating breaker bar, whereas the accretive wave condition results in a landward migration of the breaker bar.

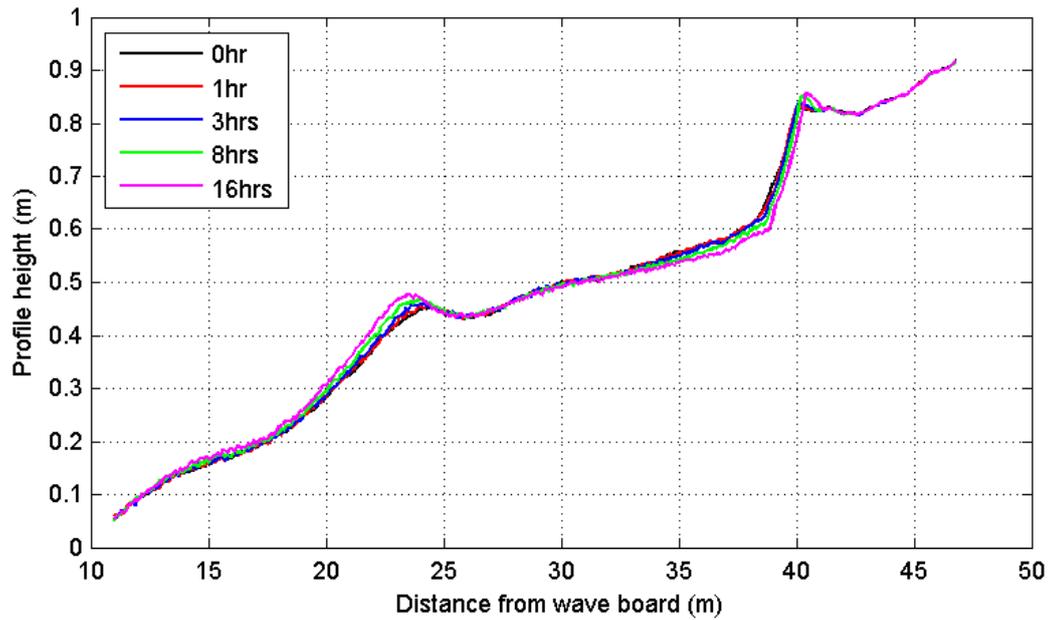
Figure 7. Observed profile development for the reference profile under erosive wave conditions.

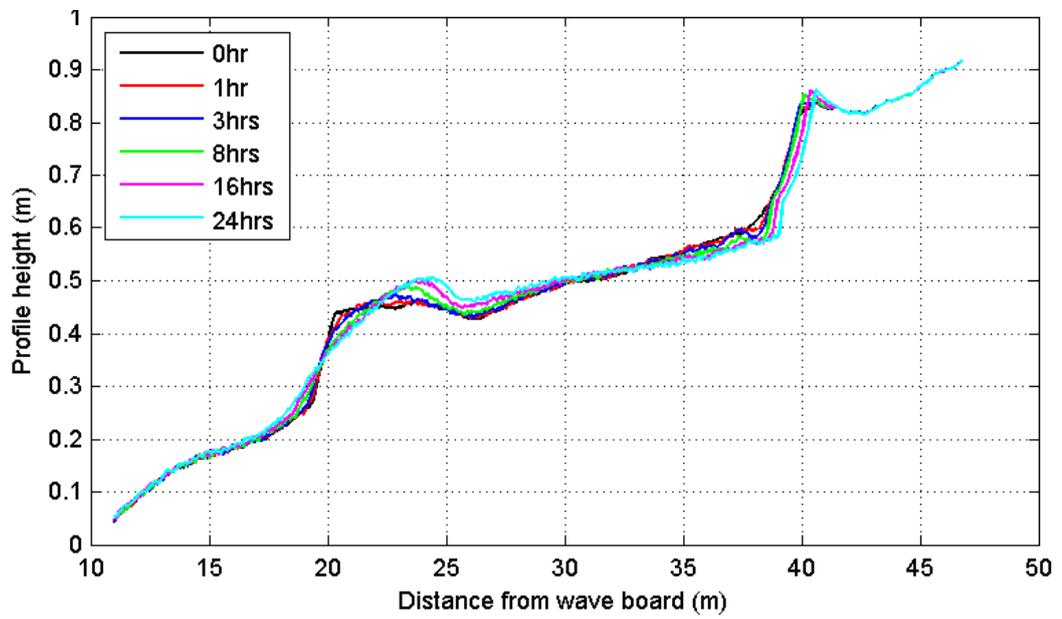
Figure 8. Observed profile development for the low nourishment profile under accretive wave conditions.

The observed nourished profile developments under accretive waves (Figure 8 and Figure 10) show that the low nourishment has a similar response as the reference profile, whereas the high nourishment is more or less stable. The height of the breaker bar of the reference tests and of the test with the low nourishment increases. The nourished sand is transported landward and a bar is developing with a crest at about 0.5 m. However, the upper part of the profile is still eroding for both nourishment designs.

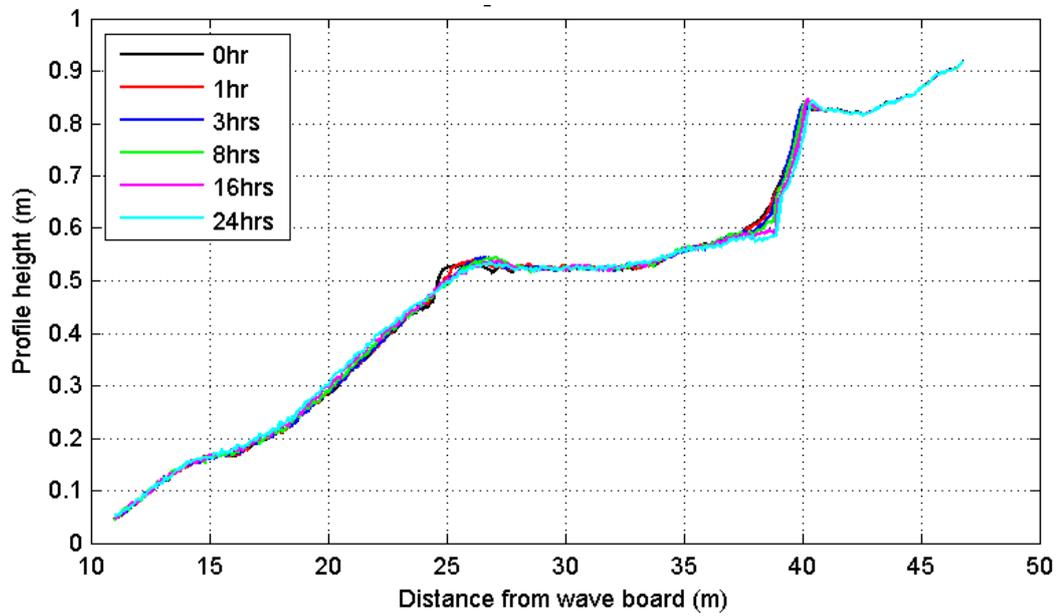
Figure 9. Observed profile development for the high nourishment profile under accretive wave conditions.

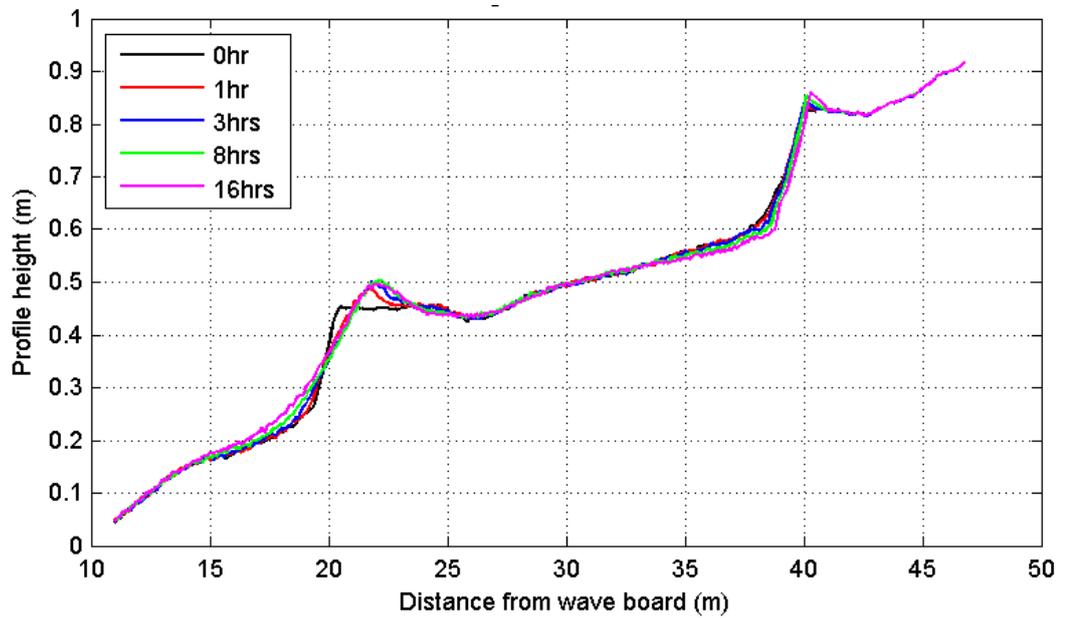
Figure 10. Observed profile development for the low nourishment profile under erosive wave conditions.

For the erosive wave condition the lower nourishment reacts in a similar way as for the accretive wave condition: a bar is developing at the nourishment with a crest height of about 0.5 m. The high nourishment now shows a clear offshore migration with a bar emerging with a similar crest height of 0.5 m.

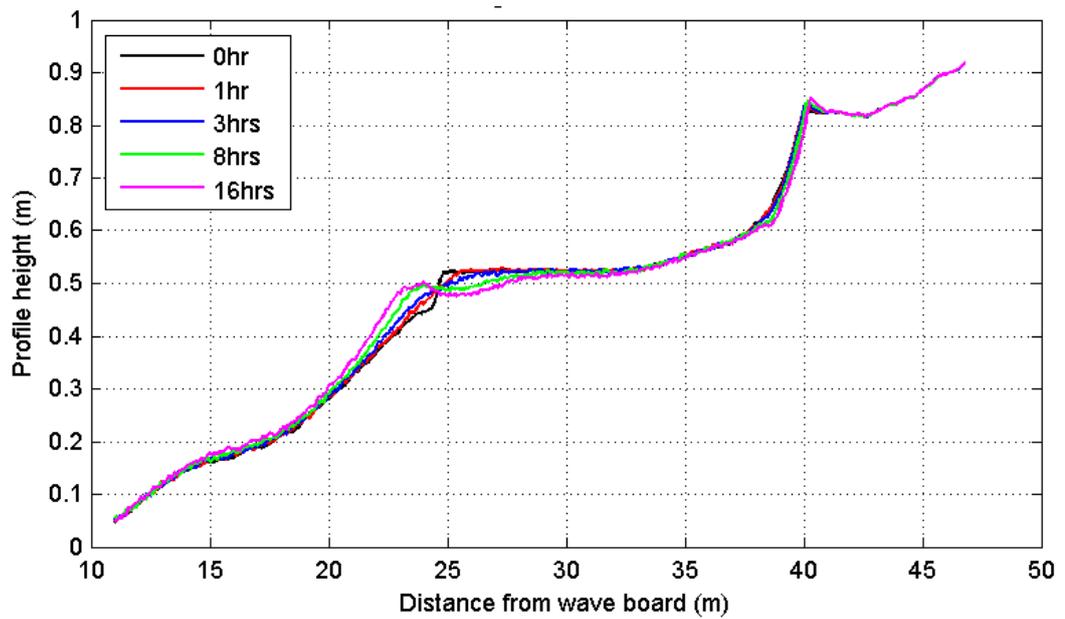
Figure 11. Observed profile development for the high nourishment profile under erosive wave conditions.

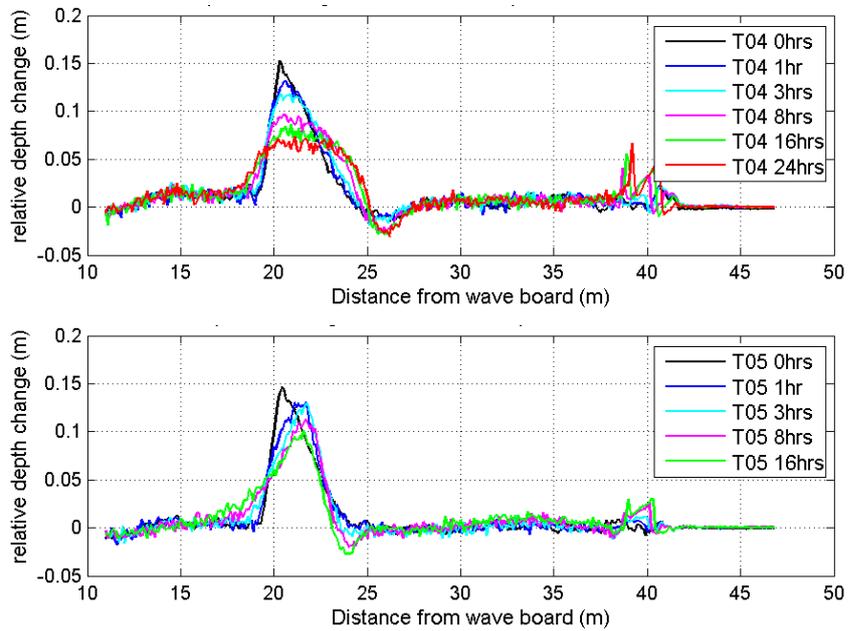
**Figure 12. Profile change relative to reference case for the low nourishment design (top: accretive conditions, bottom erosive conditions).**

By subtracting the reference profiles from the nourished profiles the impact of the nourishments is visualized. As the profiles were measured at the same times, the relative impact can be assessed as the profiles are changing during the experiment. In Figure 12 the relative changes for the low nourishment design are shown for the accretive condition (top plot) and erosive condition (bottom plot). For the accretive wave condition a relative large part of the sediment is moved onshore. For the erosive wave condition more of the nourished sediment is stable with some diffusion at both distal ends. The upper part of the profile shows a relative increase which, as both the nourished and reference profile are eroding in this area, should be interpreted as an absolute decrease of the erosion due to the nourishment. The same relative changes are evaluated for the high nourishment design in Figure 13. Compared to the low nourishment, the high nourishment shows more diffusion of nourished sand across the profile. The high nourishment design results in a decreased erosion of the upper part of the profile for both the accretive and erosive wave conditions.

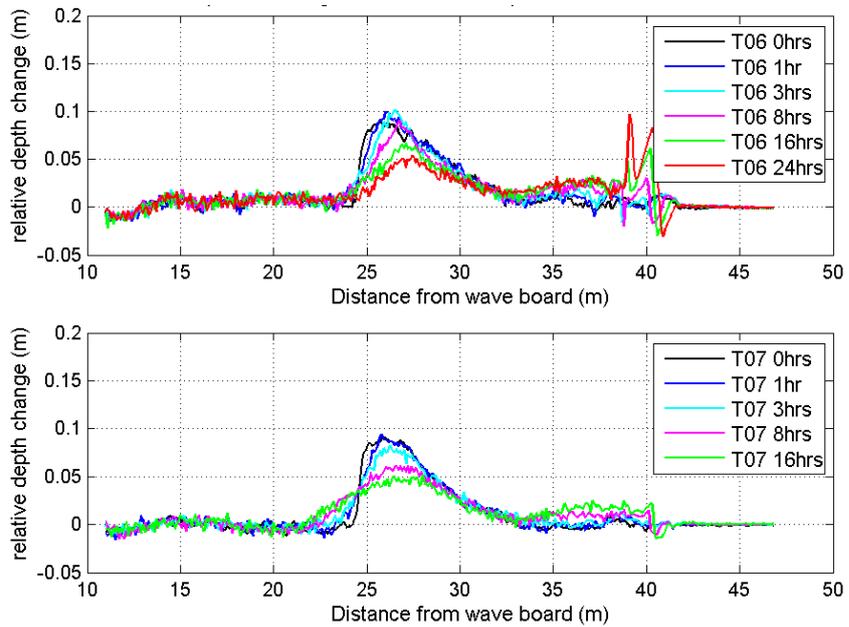
**Figure 13. Profile change relative to reference case for the high nourishment design (top: accretive conditions, bottom erosive conditions).**

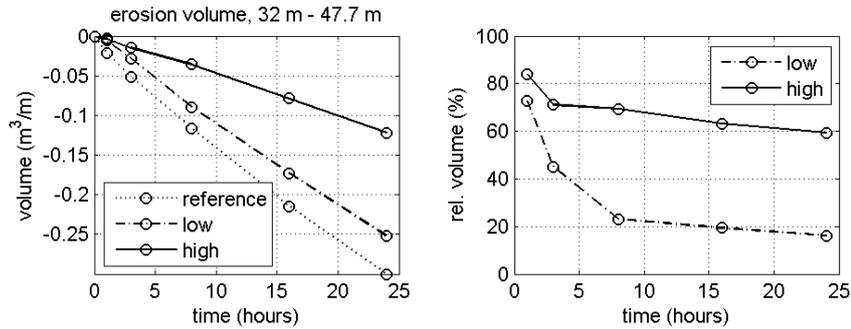
Figure 14. Left: absolute erosion volumes for the accretive tests for the reference profile (T02), the low nourishment design (T04) and high nourishment design from  $x = 32\text{m}-47.7\text{m}$ . Right: temporal development of same volume, relative to the reference profile.

The erosion volumes are determined for the upper part of the profile ( $32\text{m} < x < 47.7\text{m}$ ) to quantify the effect of the two nourishment designs. Figure 14 (Figure 15) shows the erosion volumes of the accretive (erosive) tests for the reference and nourished profiles. It can clearly be observed that both designs have a positive influence on the upper profile development. The reference profile is subject to the largest erosion,  $0.3 \text{ m}^3/\text{m}$  for the accretive test and approximately  $0.2 \text{ m}^3/\text{m}$  for the erosive test. The larger erosion of the upper part of the profile for the accretive waves is most-likely caused by the fact that the initial profile in the present experiment was obtained by subjecting a profile to 8 hours with the erosive wave condition (the starting profile was the measured final profile from the experiments by Koomans and Bosboom, 2000). Therefore the upper part initial profile is probably more in equilibrium with the erosive wave condition, resulting in less erosion for this wave condition.

The low nourishment reduces the erosion to  $0.25 \text{ m}^3/\text{m}$  for the accretive test and  $0.12 \text{ m}^3/\text{m}$  for the erosive test. The high nourishment results in the largest reduction for both wave conditions:  $0.12 \text{ m}^3/\text{m}$  for the accretive test and  $0.08 \text{ m}^3/\text{m}$  for the erosive test.

To obtain better insight into the effects of the nourishments on the bed profile development, the relative increase of sand volume in the coastal zone is shown in the right plots of Figure 14 and Figure 15. The low nourishment results in a relative increase of sand volume, 20% for the accretive condition and 40% for the erosive condition. The high nourishment has the largest relative increase of sand volume: 60% for both wave conditions.

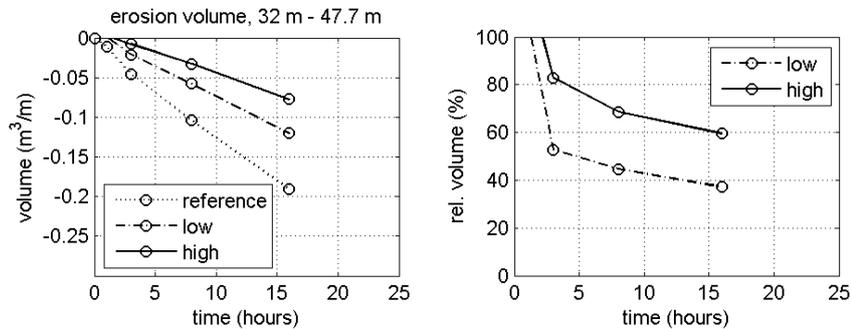
Figure 15. Left: absolute erosion volumes for the erosive tests for the reference profile, the low nourishment design and high nourishment design from  $x = 32\text{m}-47.7\text{m}$ . Right: temporal development of same volume, relative to the reference profile.

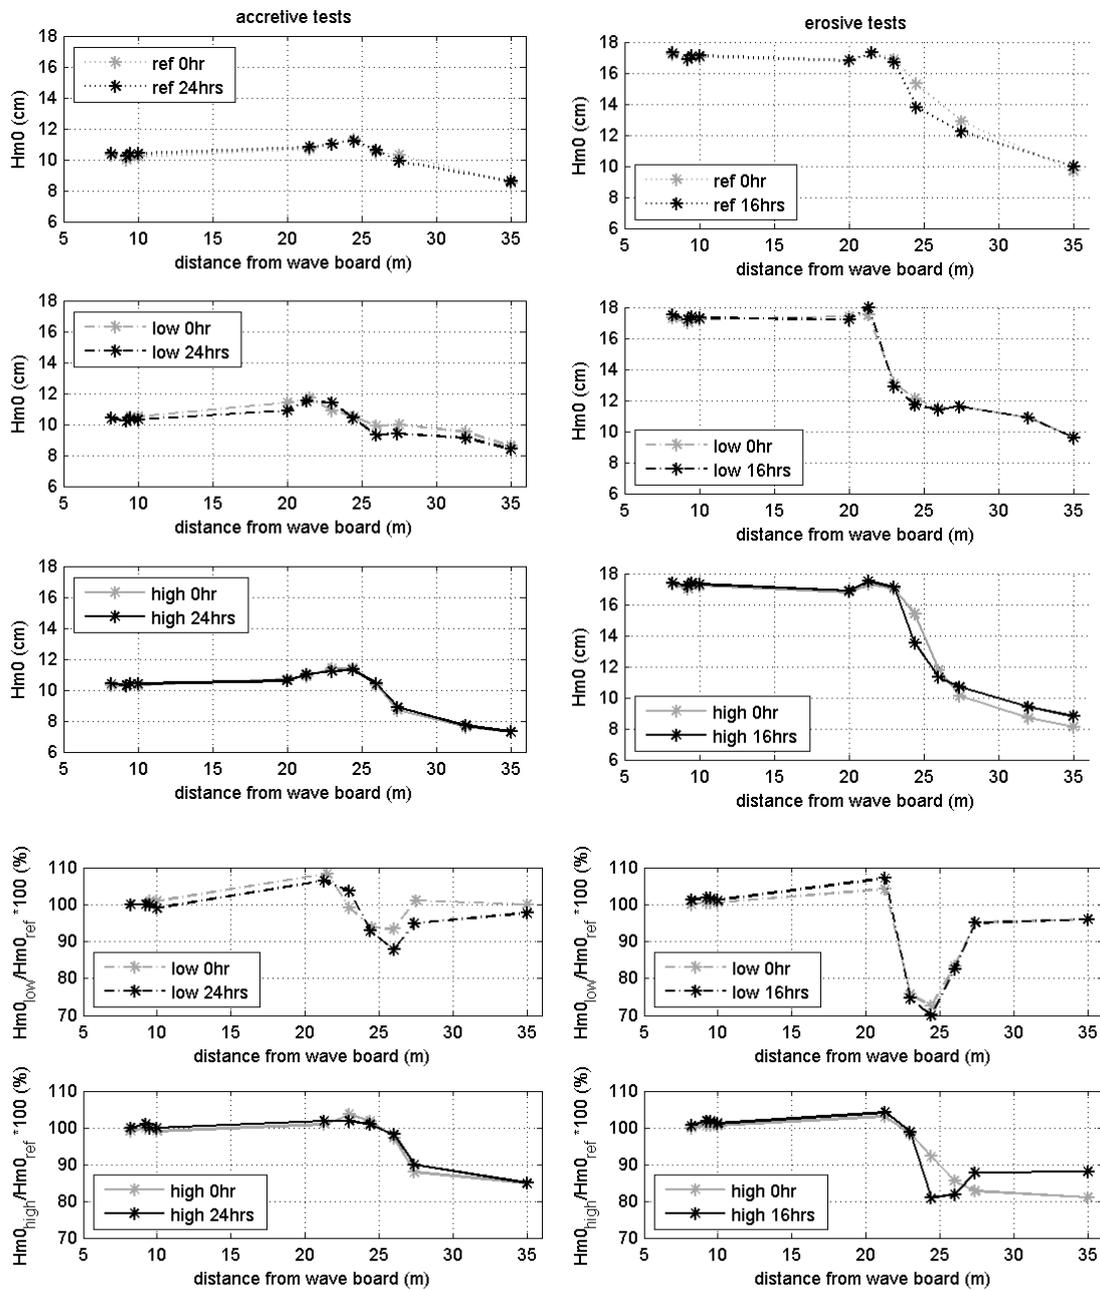
Figure 16. Cross-shore Wave height distribution for the accretive (left) en erosive conditions (right). Top row: reference profile, 2<sup>nd</sup> row: low nourishment design, 3<sup>rd</sup> row: high nourishment design, 4<sup>th</sup> row: ratio of wave height for low nourishment and reference profile and bottom row: ratio of wave height for high nourishment and reference profile.

For the initial and final profile the observed cross-shore wave height distribution is shown in Figure 16 for all nourishment designs and both accretive and erosive wave conditions. Both nourishment designs have a major impact on the local wave height at the nourishments. For the upper part of the profile the low nourishment has no sheltering effect as can be seen from the fourth row of plots. The high nourishment results in a wave height decrease across the entire profile for both the accretive and erosive wave conditions.

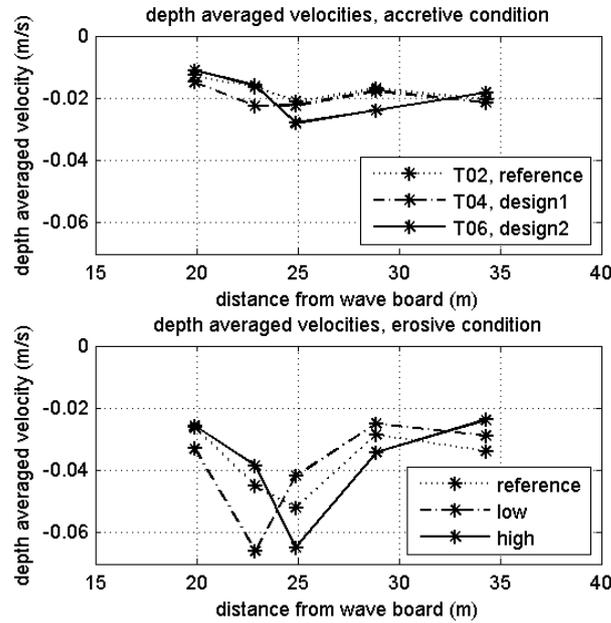
Figure 17. Depth-averaged velocities for the accretive (top) and erosive (bottom) wave conditions.

The associate depth averaged wave induced return flow is compared in Figure 17. Enhanced velocities are present at the nourishments due to wave breaking. Near shore the effect of the nourishment is negligible for the accretive wave conditions, but for the erosive wave conditions the depth-averaged velocities have reduced noticeably for both nourishment designs.

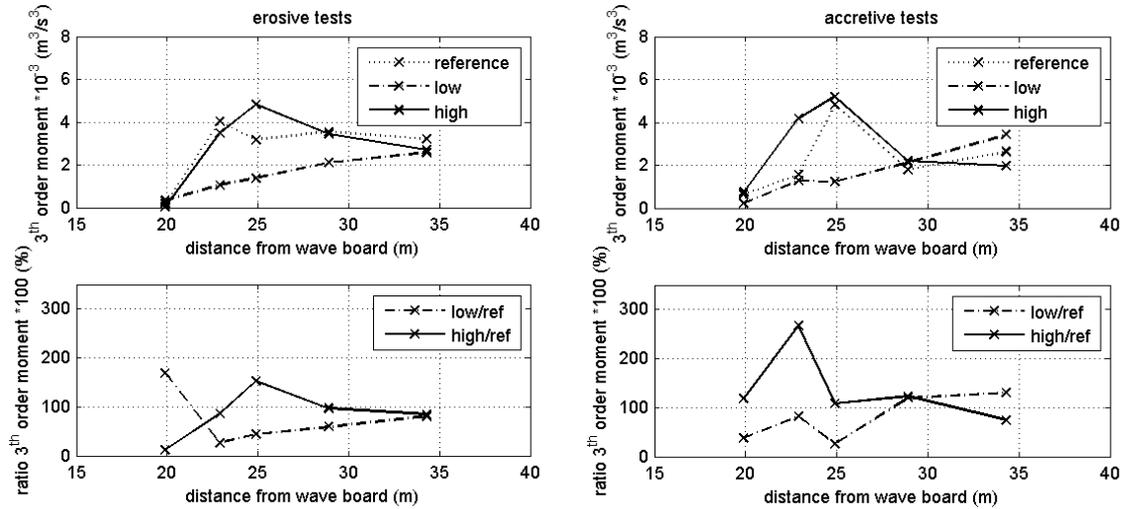
Figure 18. 3<sup>rd</sup> Order velocity moments for the erosive conditions (left) and accretive conditions (right). Top row: absolute values, bottom row: ratio of the velocity moments of the nourishment designs and the reference profile.

Third order velocity moments, shown in Figure 18, are an indicator for the transport due to wave skewness. For the erosive condition, on top of the high nourishment, the third-order velocity moments are significantly larger than the other two tests. The third order velocity moments close to the coastline are more or less the same. However, as the wave heights are lower in the upper part of the profile, similar velocity moments imply increased wave skewness.
