INTEGRATED BEACH MANAGEMENT AT IGEEA MARINA, ITALY: RESULTS OF TEN-YEARS MONITORING

This contribution analyses the hydro-morphological effects induced by low crested structures confined by lateral groynes at Igea Marina beach, Northern Adriatic Sea, Italy. The site has been monitored since the works started for these last ten years. Results from bathymetric surveys, sediment samplings, video monitoring and numerical modelling are presented and discussed.

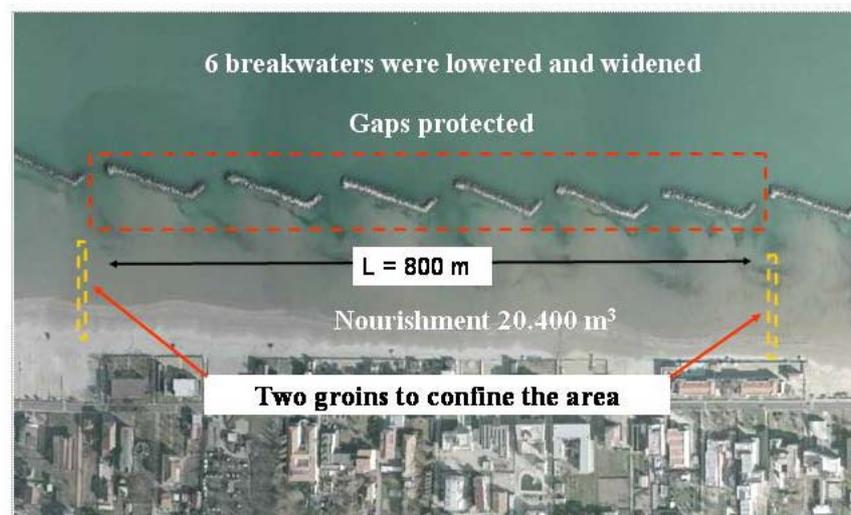
Figure 4 Lay out of experimental project carried out in Igea Marina (2003)

- the lowering of the crest of six emerged barriers to mean sea level, reaching a crest width of 18 m, and the partial closure of the gaps in between, with an alternate depth of 0.5 and 1 m (Spring 2003), the nominal diameter D_{n50} of the barrier was the same as the previous emerged barrier ($D_{n50}=1.0$ m);
- the confinement of the renewed cell with two lateral groynes, which start at a 1 m top crest on the beach and progressively reach -0.5 m at the structure roundheads (October 2003). Design plan of the scheme and design conditions are described in Preti et al., (2005).

A scheme of the new lay out is presented in Figure 4.

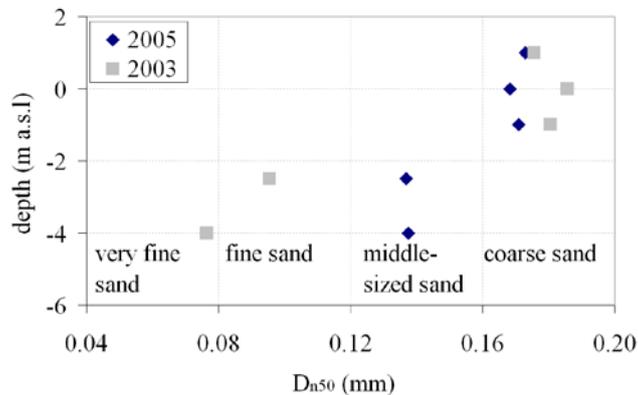
Figure 5. Grain size: comparison between 2003 and 2005 samples.

Grain size on the beach (at +1.0, 0.0 and -1.0 m of depth) is approximately the same in both surveys, whereas at the depths of -2.0 and -4.0 m an increase in grain mean diameters from 2003 to 2005 can be appreciated (Figure 5.). The increase in grain size in the leeward side of the protected area is caused partially by the removal of fine materials due to a greater wave overtopping behind the low crested barriers and partially by yearly nourishments of sand dredged from a nearby harbour.

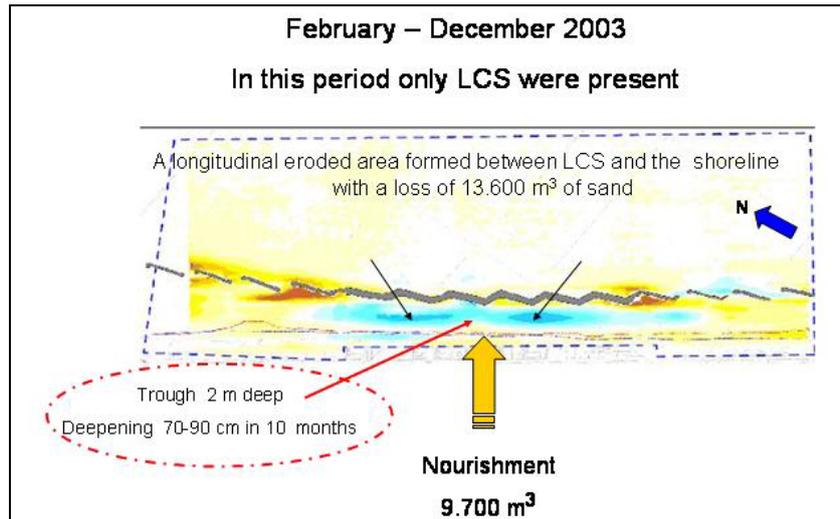
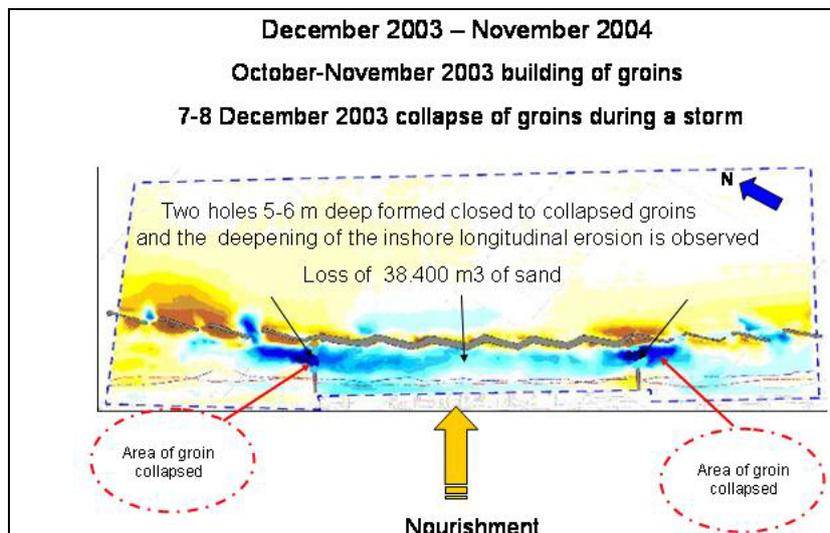
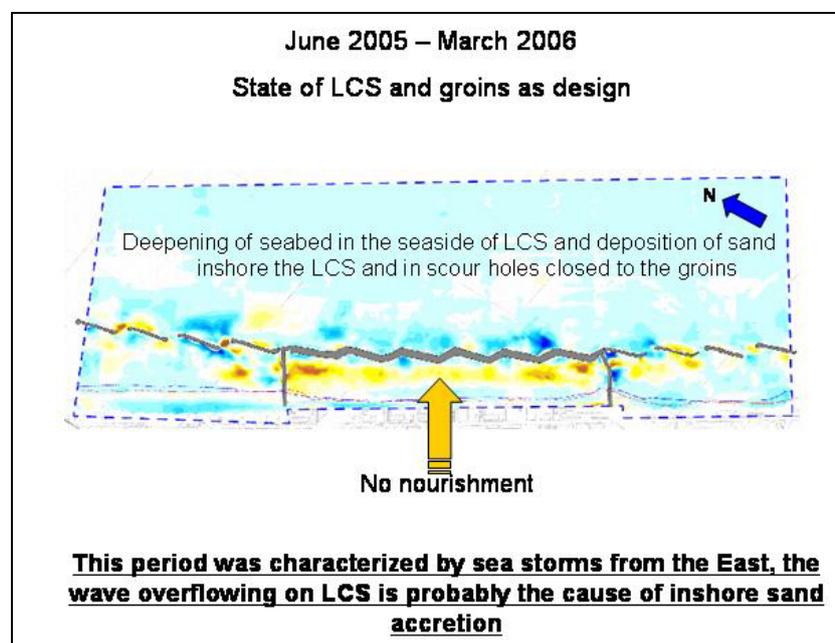
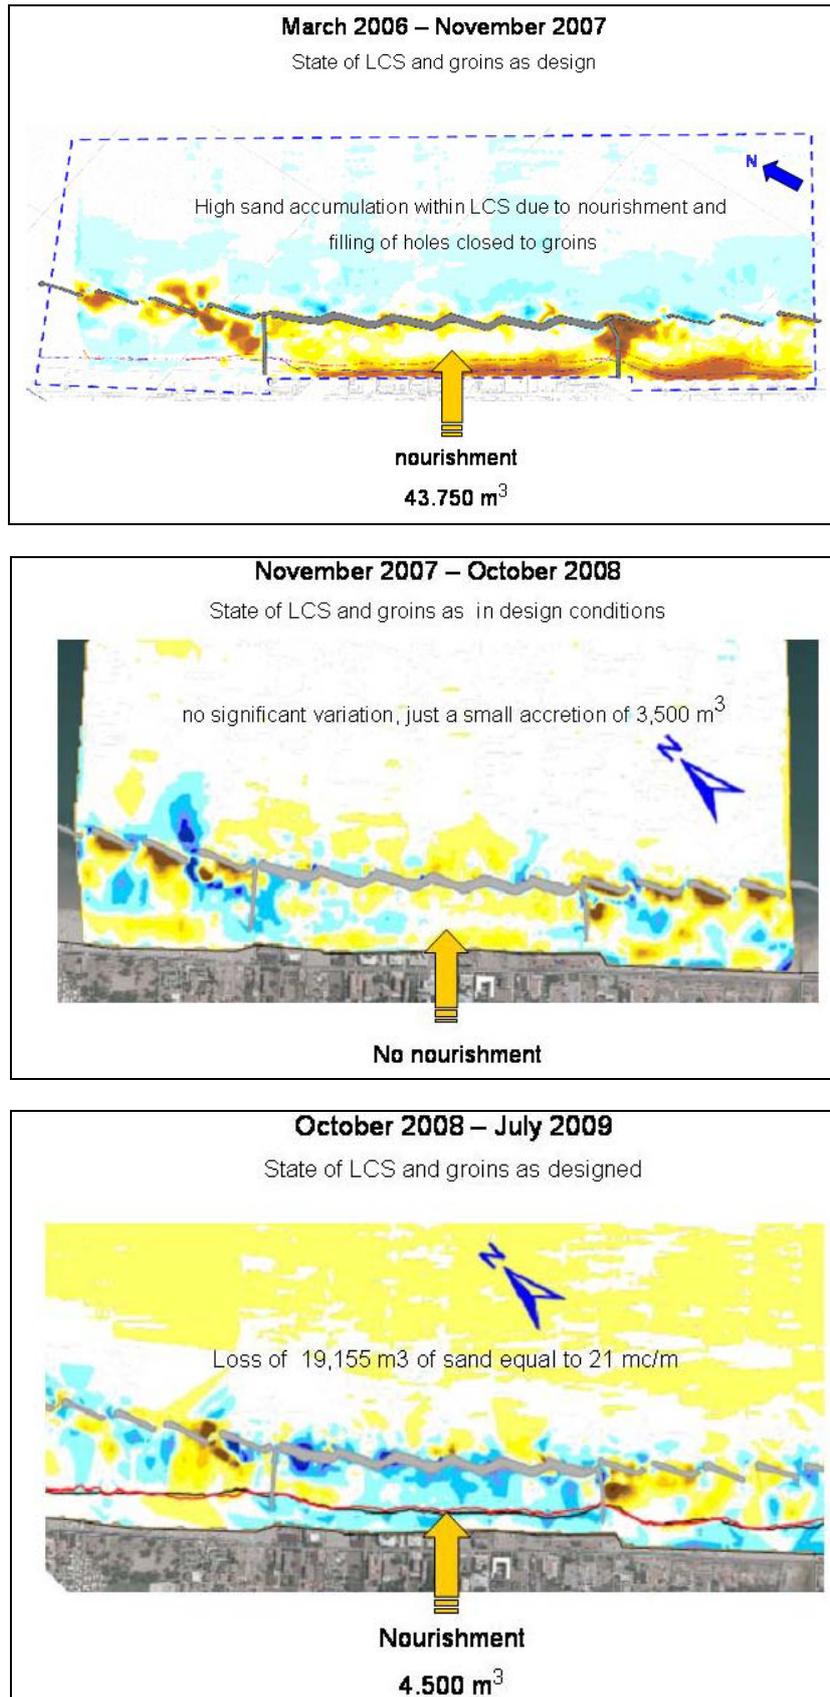
Figure 6. Results of bathymetric analysis: differences of volume sand between following surveys.

Maps in Figure 6. show different performances depending breakwaters and groins assets and sea storms directions.

In between 2005 and 2009, just after groins rebuilding, two different performances has been observed in the experimental area: from June 2005 to October 2008 no sand loss has been detected, from October 2008 to July 2009 a relevant loss of sand has been measured (around 30 m³/m).

The first period was dominated by sea storms from North-East; the second period was characterized by sea storms from South-East.

From December 2003 to June 2005 a relevant loss of sand was caused by the absence of groins or by their collapse.

In the next Figure 6. the results of the comparison among following bathymetric surveys are presented.

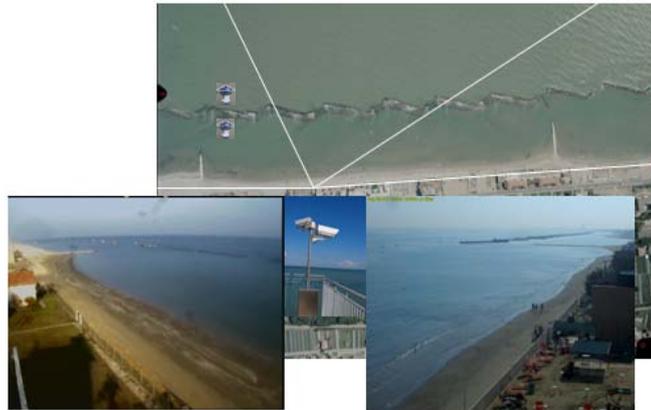
Figure 7. The video station in Igea Marina and The positions of the two ADCPs

The video station in Igea Marina has been installed in October 2006 by the DISTART University of Bologna and has been working for 2 years. The station was composed of two video systems. The first video system looks to the North and the second video system looking towards the South is composed of two 8 megapixel digital still cameras Olympus SP500UZ mounted in a single housing. The systems were set to collect snapshot and timex images (Figure 7.).

During the period December 2007-March 2008 a field campaign was performed by installing two ADCPs seaward and landward the barriers to monitor wave transmission and current intensity at gaps. The seaward and the inshore ADCPs were placed on a 2.5 m and 2.4 m bottom depth respectively. The positions of the two ADCPs are shown in Figure 7.

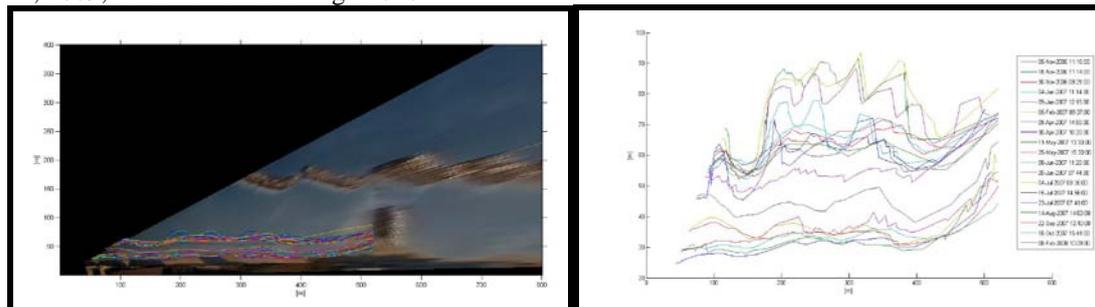
Figure 8. A total of 20 shorelines plotted on plan-view images during a 16 month period.

In order to quantify changes in coastal features and nearshore processes, and to have at any time the information on the state of the beach (width, shoreline position), the shoreline at selected times was detected on orthorectified images (Figure 8). The shorelines keep constant during winter 2007 with same small fluctuation of the order of few meters in coincidence with storm events. The behaviour of different sections is comparable, except for section 400 which shows more evident retreat during storms. The same behaviour was observed also looking at the past data. In April, beach nourishment produced an advance in the shoreline position varying from 20 to 40 m in different sections of the beach. After the first nourishment assessment, the beach dimension was maintained.

The study of various shoreline features and processes is facilitated by transforming the images into real world coordinates. The reference system of the survey has the origin at the video camera location and is rotated 36° in order to have the orientation of the x-axis normal to the shoreline, with the positive x-axis pointing in seaward direction. The y-axis is directed perpendicular to the x-axis, such that the coordinate system thus obtained is positive in mathematical sense. In this reference the structures parallel to the shore are y-oriented and the groins x-oriented (Figure 8.).

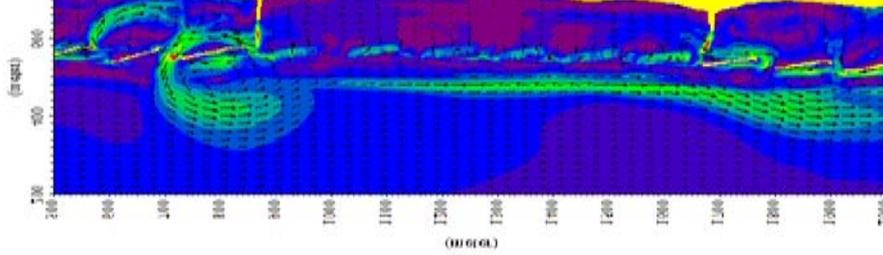
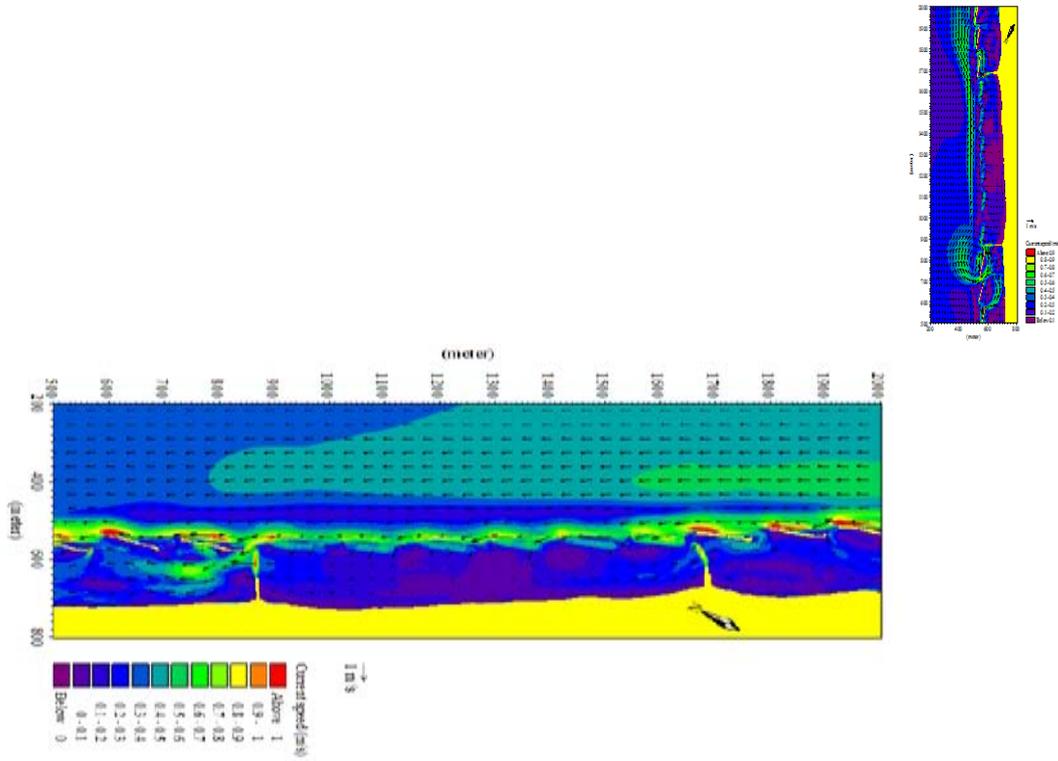
Figure 10. Current velocities and intensities in colour scale and directions obtained from Mike 21 HD for a typical storm from Bora (top) and from Scirocco (bottom).

The most intense currents (up to 1 m/s) develop around the barriers and at the roundheads of the groynes. Since these currents are directed inshore there is no potential risk for swimmers, with the exception of the area between the Northern groyne and the gap of the first barrier to the North during Waves 1 and 2.

The circulation pattern along the barrier appears to be substantially independent from the long-shore currents in the surf zone and rip currents at gaps are particularly intense when the direction of wave attack differs from the perpendicular to the barrier axis, i.e. from the prevailing metoemarine condition (Scirocco) on which the barrier design is based.

Table 2. summarises the representative wave climate extracted from the NSW module in front of the barriers, over a 4 m depth, together with the most relevant results obtained from the simulations. Typical current circulation for Bora and Scirocco storms is shown in Figure 4.
