## CHAPTER 53

# COASTAL PROTECTION WORKS AND RELATED PROBLEMS IN JAPAN

Masashi Hom-ma and Kiyoshi Horikawa

Department of Civil Engineering, University of Tokyo

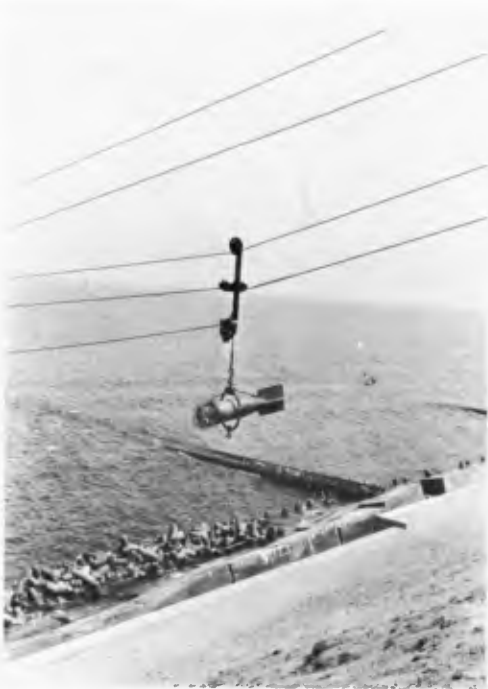
Plate. 2. Current Meter

- D. Special installations to investigate surf-zone characteristics - A cableway system which was developed to make the investigation activities during winter storms possible, was designed to carry the following units to the zones in and out of the breaking point.
1. A self-contained current meter and a cross-blade float to measure current velocities and directions at an arbitrary level above the bottom. (See Plate 2.)
  2. Fujiki-type sampler for measuring instant concentration of suspended materials (See Plate 3.) and a tube trap for cumulative arresting of suspended sediment.
  3. Fujiki-type electric lead for sounding of the bottom topographies near the surf-zone. (See Plate 4.)

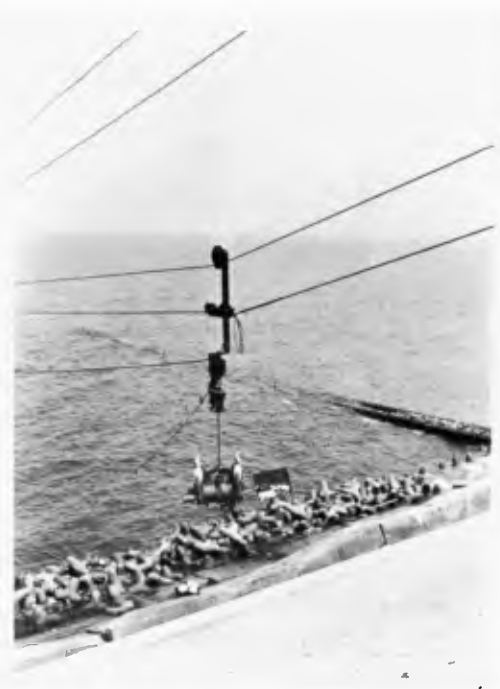
Plate. 3. Fujiki-type Sampler

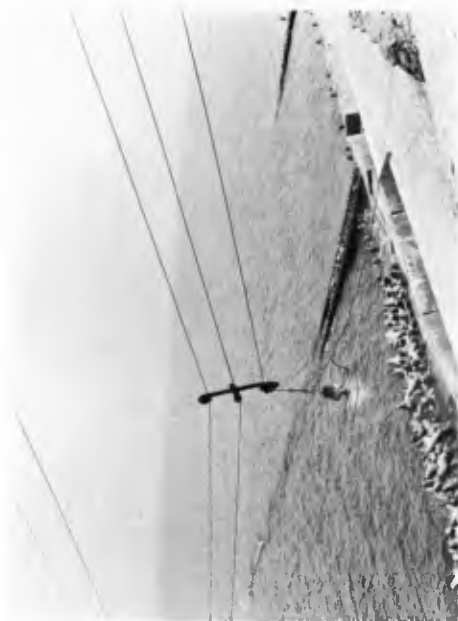
Plate. 4. Fijiki-type Electric Lead
