## CHAPTER 68

### EXECUTION OF TRAINING DIKES AT THE OUTLET OF A DIVERSION CHANNEL ON THE COAST OF JAPAN SEA

#### ABSTRACT

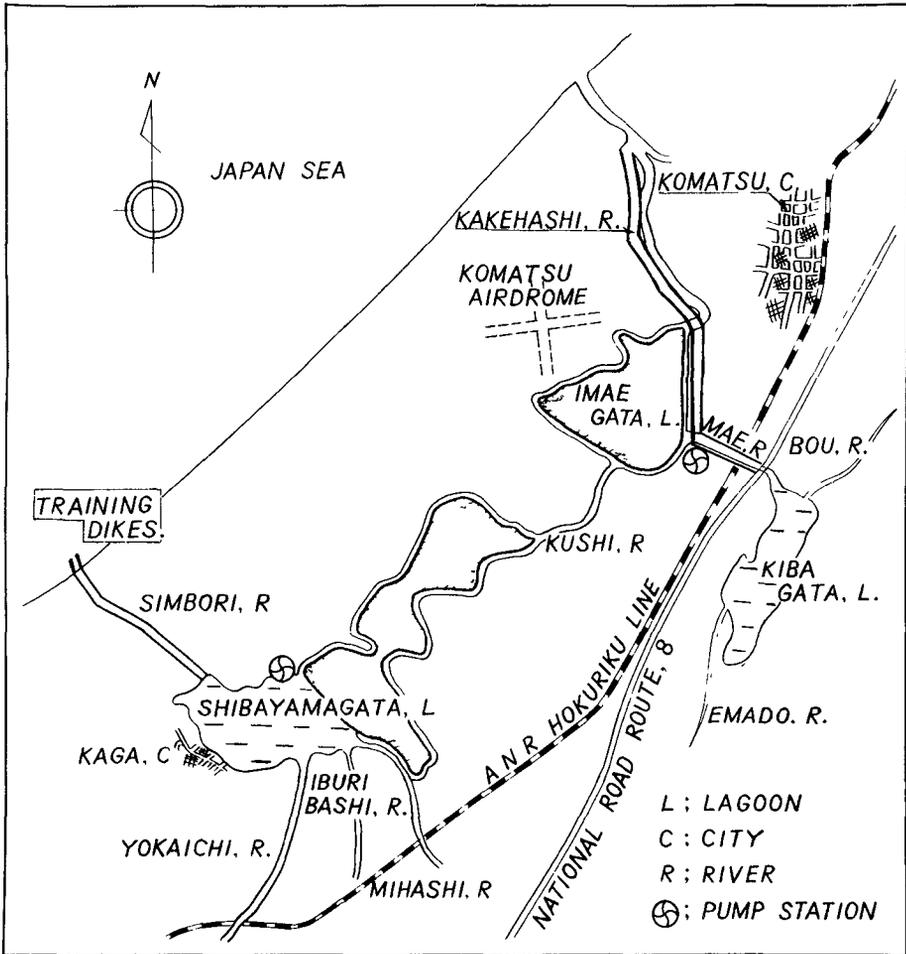
Fig. 1. General plan of Kaga-Sanko reclamation project.

Shibayama-gata, Imae-gata, (called collectively the Kaga-Sanko) are located in central Japan on the coast of the Japan Sea (Fig. 1). The low land around these lagoons used to suffer from frequent floods due to counter-currents from the river Kakehashi, which was the only outlet for the water from these three lagoons. Nevertheless its drainage capacity is rather poor and the most of the farm land here was frequently flooded.

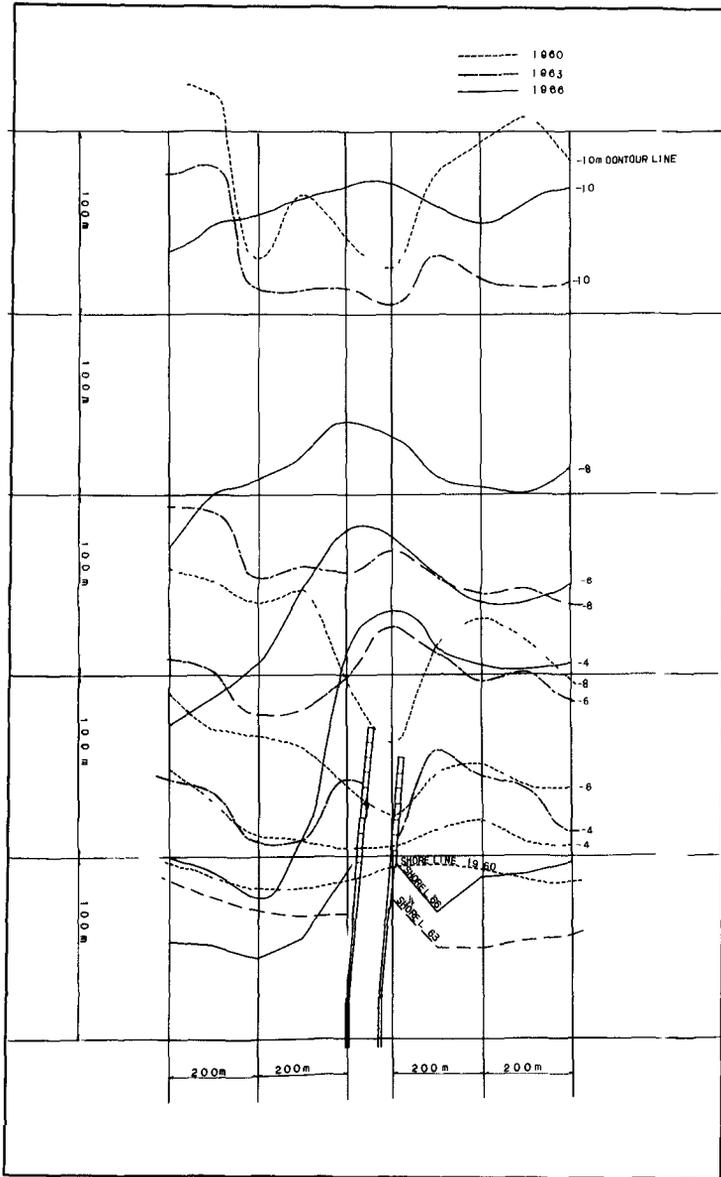
Fig. 5. Map of shore line and bottom contour lines.

As has been stated above the construction of the dikes was executed from 1960 to 1965. During this period the sea bottom was sounded once or twice every year (Fig. 5). As a result, it was known that sand deposit raised the bottom level 3 to 4m at a place 50m apart from the head and 2 to 3m, 100m away from the head, but no great change was found over 150m away from the outlet.

If we observe the contourline map of sea bottom for the latest coastal change, it is noticed there was distinct elevation of the bottom along the center line of the dikes and the contour lines there advanced by 50 to 80m but the change was not large at the depth exceeding 9~10m.

On the right side of the dikes, the contour lines advanced 40 to 70m and so did the shore line by 20 to 40m but there was not recognisable influence any farther east than the spot 400

to 500m away from the dikes. On the left side, the contour lines receded 30 to 50m within the zone of about 200m west of the dikes and the shore line likewise receded approximately 30m. Therefore the dikes are protected by tetrapods, both dikes have shoals deposited 70 to 100m along the shore from the channel and they are thus securely imbedded.

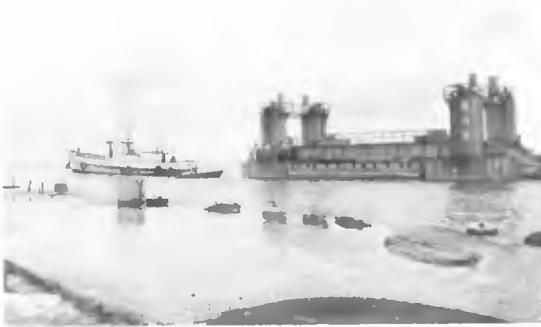
Fig. 6. Tugging a caisson with the aid of floats.

week or ten days, and for the succeeding few days were needed for reopening the mouth closed by the waves) a caisson slipway and two platforms for constructing caissons were built in the channel about 150m inland from the shore line (Fig. 4). The slipway was 15m wide and about 8m long; the platforms were 13.0 m wide and 10.0m long. Caissons were constructed upon the platforms and those with a bottom were launched as soon as they were completed and cellular blocks were launched with the aid of floats. Both were tentatively placed inside the channel and then tugged to the construction site and sunk when the sea was fairly calm. After caissons were sunk, the pile space was filled with gravel and then concrete was poured in with pressure. The central space was filled with sand by a suction dredger and then immediately topped with concrete lest the sand should be washed away by waves.

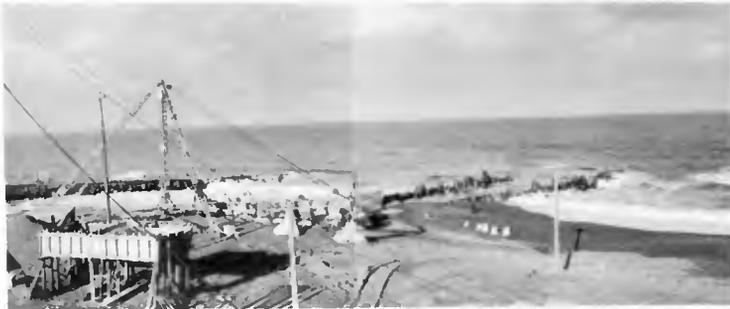
Fig. 7. Training dikes.

Structure of dikes : Due to an unexpectedly great strength of wind waves the original project to build compound dikes of block mounds and caissons was altered into that of building upright training dikes mainly composed of caissons with some cellular blocks but no block mounds (Fig. 2, Fig. 3).

From the shoreline to the depth of 3.0m, wave is not so powerful and four 5M caissons were used, which are 5.0m high, 6.0m long and 9.0m wide (Fig. 4). Farther than this point the caissons of three different heights and four kinds of cellular blocks were used in combination. Although, as for the structure, 5m to 8m high caissons would be appropriate for this part of the dikes, the water at the slipway has to be 8m deep for the launching and 6.5m deep for the tugging. No harbor maintaining such a depth is to be found nearby and the expense of building such a construction would be too great to sustain. Hence caissons and cellular blocks mentioned above were used in combination. The dikes inside the shoreline are of well type.

For the protection of the dikes, 4 ton tetrapods along the well dikes and 2 to 6 layers of 8 ton tetrapods along the caissons are installed to decrease the wave energy.

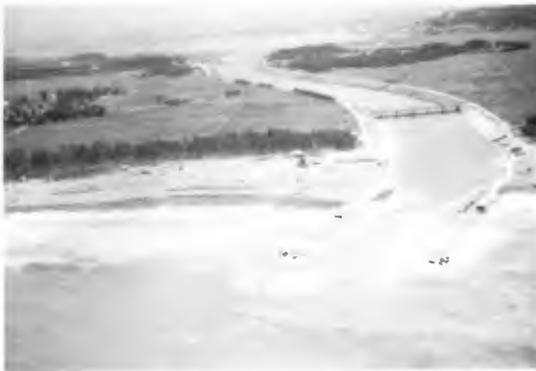
Fig. 8. Mouth of Simbori River diversion channel.
