## CHAPTER 75

### DURABILITY OF CONCRETE IN COAST PROTECTION WORKS

R.T.L. Allen<sup>1</sup> and F.L. Terrett<sup>2</sup>

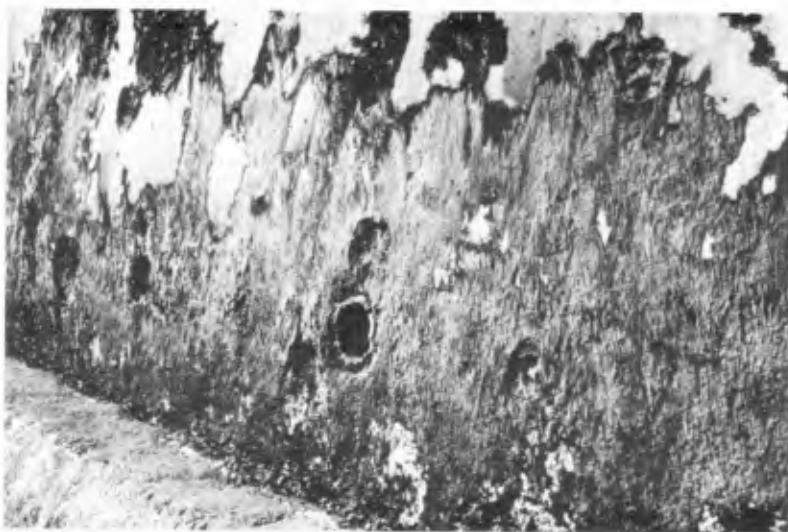
Plate I - Surface deterioration possibly  
due to seaweed growth

Biological attack is not likely to occur in marine structures as stagnant conditions are generally required for the growth of the microbes. It is possible however that microbes may contribute to chemical attack on porous or honeycombed concrete where the conditions necessary for their growth may obtain in the pores of the concrete. Chemical secretions from the growth of seaweed on concrete structures may also contribute to surface deterioration (Plate I).

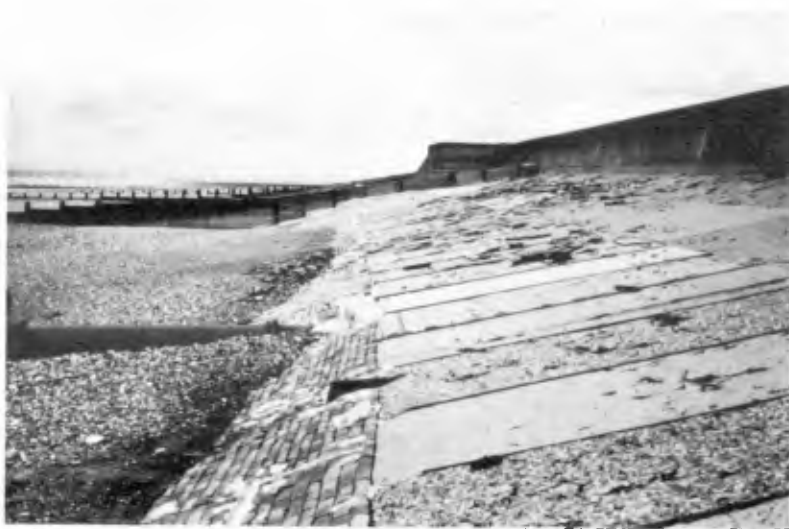
Plate II - Experimental wearing panels at  
Fleetwood

In order to compare the performance of different materials a series of experimental panels was constructed in 1961 (Plate II) and records have been kept of the rate of loss by abrasion. Twenty eight concrete panels each 15 ft. x  $6\frac{1}{2}$  ft. x 6 in. thick were constructed over a 200 ft. length of apron, the mix designs being all based on the same water/cement ratio and workability.

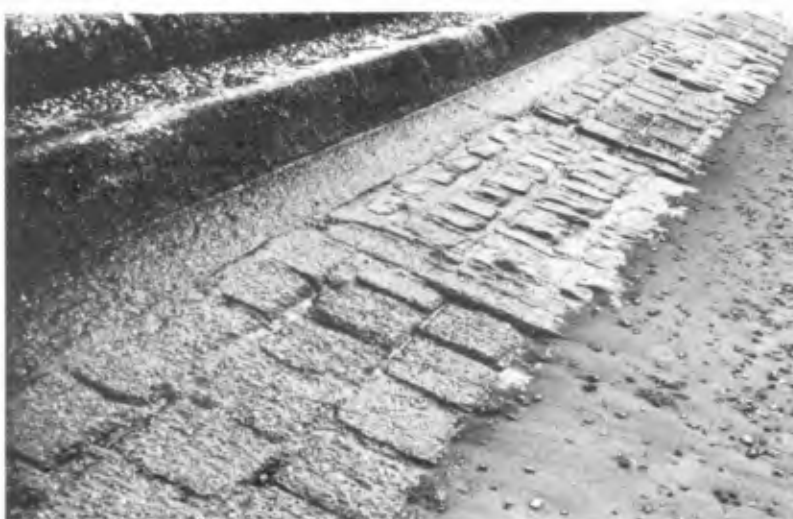
Plate III - Aprons at Dymchurch with granite and concrete blocks as wearing surfaces

A full-scale experiment, but more limited than the trials at Fleetwood, is being carried out by the Kent River Authority at Dymchurch, where a sloping apron was reconstructed in 1963. The work consists mainly of panels of precast concrete blocks surrounded by ribs of in-situ concrete, but some panels of granite blocks have been included for purposes of comparison (Plate III). In order to compare the performance of different types of concrete, some of the precast concrete blocks were made with gap-graded aggregate and some with continuously graded aggregate. Flint coarse aggregate of  $1\frac{1}{2}$  in. maximum size was used and in the gap-graded concrete was single size. The aggregate/cement ratio was 5 and the cement ordinary Portland. Concrete test cubes made during the course of the work had crushing strengths of about 6,000 lb./in.<sup>2</sup> at 7 days and 7,300 lb./in.<sup>2</sup> at 28 days. So far there has not been enough abrasion for any significant differences to be seen between the granite and the various concretes.

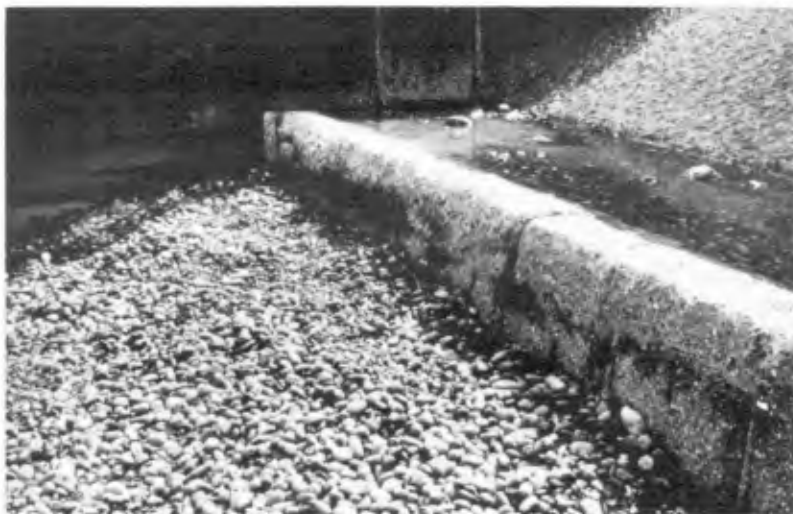
Plate IV - Sea Wall at Sheringham constructed with precast concrete retaining wall units as permanent formwork

An interesting example of a concrete sea wall exposed to very severe abrasive conditions is at Sheringham on the coast of Norfolk. The beach material consists of a very hard flint shingle and the exposure is severe. The sea wall was built in the summer of 1967 using concrete containing a coarse aggregate consisting of irregular flint gravel ( $1\frac{1}{2}$  in. maximum) similar to the beach material and sand from the same source. The proportion of sand in the total aggregate was 34% and the aggregate/cement ratio of the concrete was 7.1 with ordinary Portland cement. Precast reinforced concrete retaining wall units that were part of a manufacturer's standard range were used as permanent formwork. These units were not designed to withstand such severe exposure and in places they have almost completely disappeared (Plate IV). The concrete in the main structure is showing some signs of abrasion but is wearing more slowly.

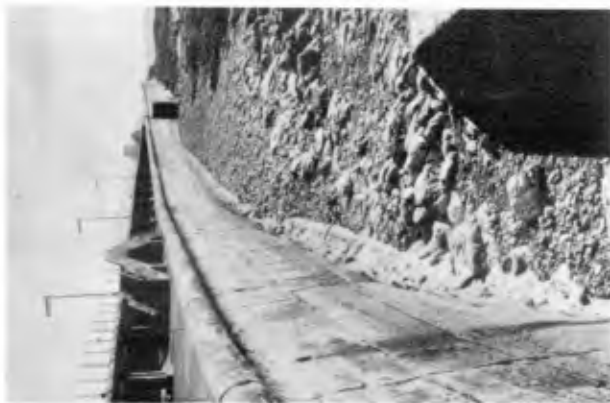
Plate V  
Abrasion at base of  
sea wall at Porthcawl

Coast protection works at a number of places on the coasts of Wales and the West of England where concrete has suffered from abrasion have been examined. Plate V showing a sea wall at Porthcawl in Glamorgan is a typical example. In most cases the work was constructed fifteen or more years ago, and in much of it concrete having nominal mix proportions 1:2:4 by volume was used and the concrete was compacted by hand. Although the performance of structures in different situations cannot be compared, owing to differences in exposure, a general inspection does suggest that the older structures, in which the concrete was probably not very well compacted and in which little quality control was exercised, have not proved as durable as more modern structures incorporating carefully designed concrete mixes with better standards of quality control and compaction.

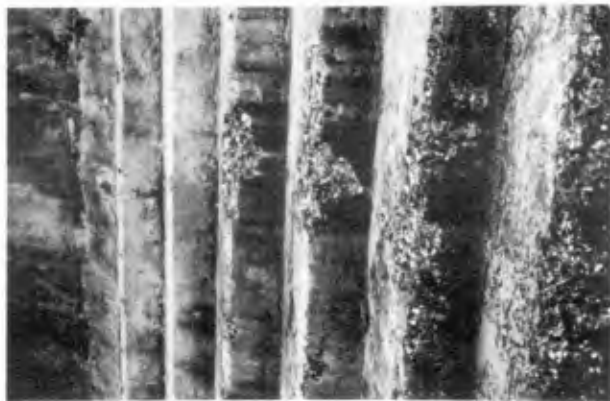
Plate VI  
Spalling of stepped  
concrete apron possibly  
initiated by crystal  
growth in hair cracks

Salt crystals growing in cracks in concrete structures may exert enough pressure to cause spalling of the concrete. This is particularly likely near high water level and in the splash zone. It has been suggested to the authors that sodium sulphate formed through the double decomposition of sodium chloride and gypsum is more likely to cause this trouble than crystals of sodium chloride. One of the authors has seen some concrete sea walls in Lincolnshire on the east coast of England in which spalling of concrete has started from fine shrinkage cracks (Plate VI) and this may well have been due to crystal growth.
