CHAPTER 81

DEPARTMENT OF PUBLIC WORKS OF CANADA
DESIGN DIRECTORATE

EXPERIENCE WITH SELF-DREDGING HARBOUR ENTRANCES

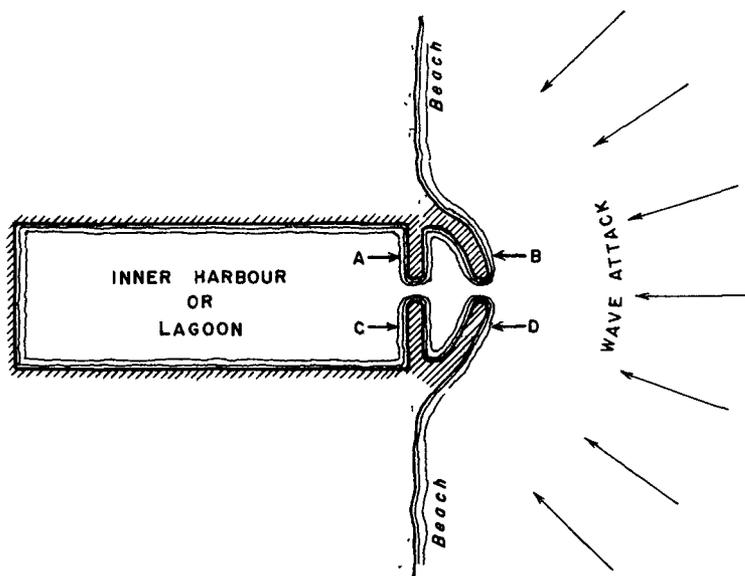
FIG. 1 SPECIAL ENTRANCE CONFIGURATION

The concept of the entrance configuration is illustrated diagrammatically in Fig 1

Rubble mound breakwater construction has been used for structures A, B, C and D. Typical lengths of these structures are

Structures A and C – 240 ft

Structures B and D – 325 ft

The entrance width is approximately 100 feet

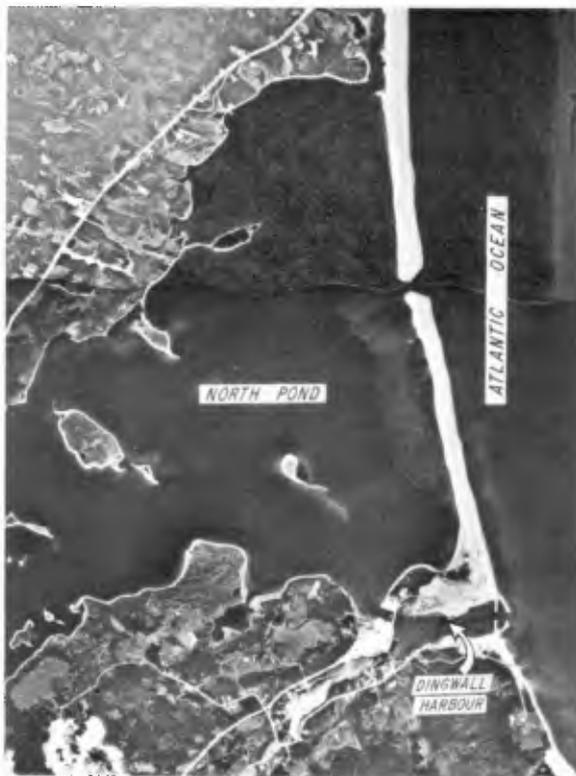
FIG. 2 AERIAL PHOTOGRAPH OF DINGWALL, N.S.

The design was developed from model studies about 1960 at the National Research Council of Canada, for the fishing harbour at Dingwall, Nova Scotia, shown in Fig 2. Shoaling of the entrance of this harbour was so severe that it was often possible to walk across the harbour entrance in rubber boots within a few months of completion of dredging to a depth of 13 feet.

Prior to the studies which resulted in the design described herein, an attempt had been made to reduce the siltation problem by connecting the harbour with the "North Pond" (See Fig 2) to channel a larger tidal prism through the harbour entrance. This, however, failed to solve the problem.

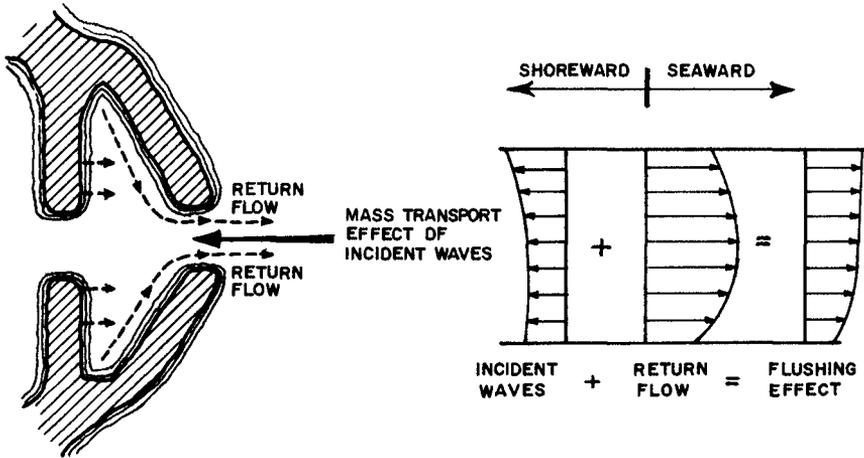
FIG. 8 TENTATIVE ILLUSTRATION OF SELF-FLUSHING ACTION

While tidal currents undoubtedly play a part, it seems that this entrance configuration serves to harness the mass transport aspect of wave motion to produce a periodic seaward directed current through the entrance. The incident waves, entering through the gap between the outer breakwaters, transport a certain mass of water into the harbour. As the bulk of the incident wave energy which enters the harbour is spent on the two inner breakwaters and in the shallow areas to each side of the central channel, a hydraulic head is built up within the breakwater system and the consequent return flow is directed seaward in the form of a periodic flushing current through the gap in the outer breakwaters. This effect is illustrated diagrammatically in Fig. 8.

The existence of a seiche either in the harbour or within the breakwater system, brought about by the disturbing force of the incident waves impinging on the harbour entrance, has not been proven. If such a seiche does exist it could be a factor contributing to the flushing effect.

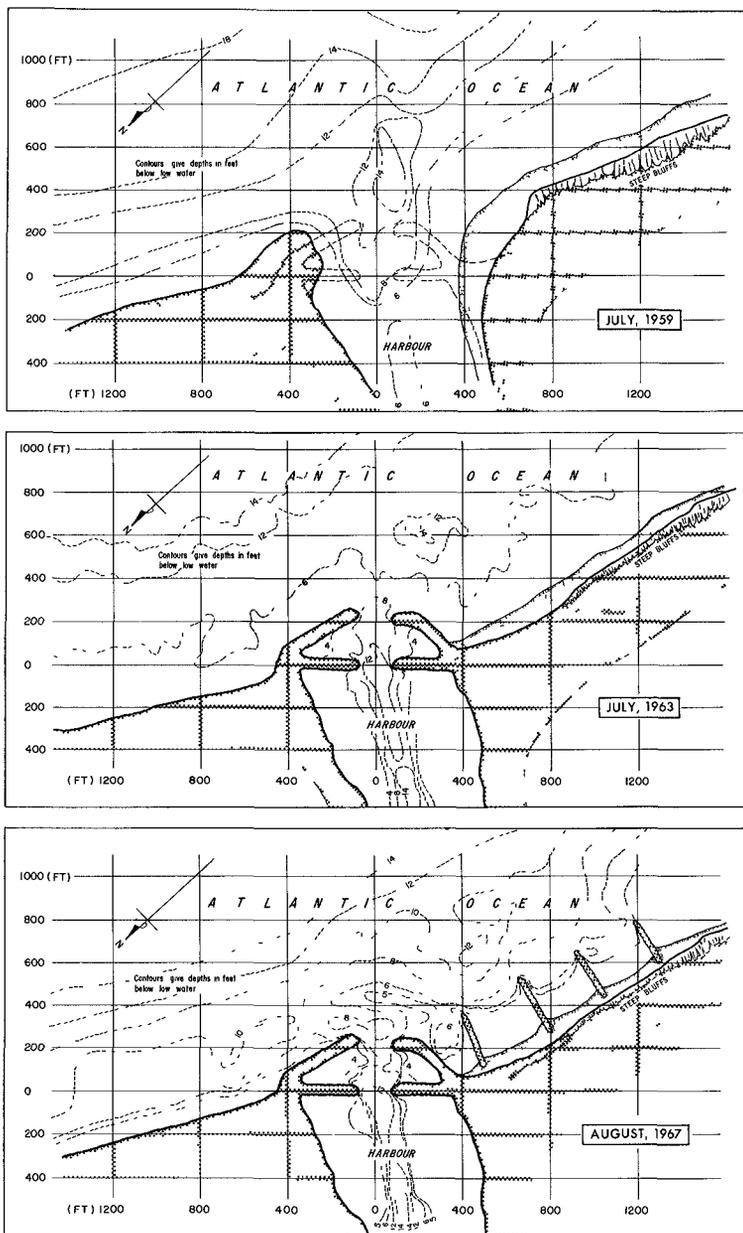
FIG. 5 CONTOUR CHANGES AT HARBOUR ENTRANCE
DINGWALL, NOVA SCOTIA 1959-1967

An indication of developments at the harbour entrance is given in Fig. 5 which compares surveys made in 1959 (before construction), 1963 and 1967. Profiles through the centre line of the harbour entrance for 1961, '62, '63, '64, '65 and '67 are shown in Fig. 6.

It is evident that the action of the structures has enabled an undetermined combination of wave action and tidal currents to bypass the littoral drift on a bar in front of the entrance while maintaining a minimum depth of 5 feet as compared to almost complete blockage before the structures were constructed. The tendency of the bar to advance into the harbour entrance (Fig. 6) is anticipated to be controllable with a very moderate amount of dredging.

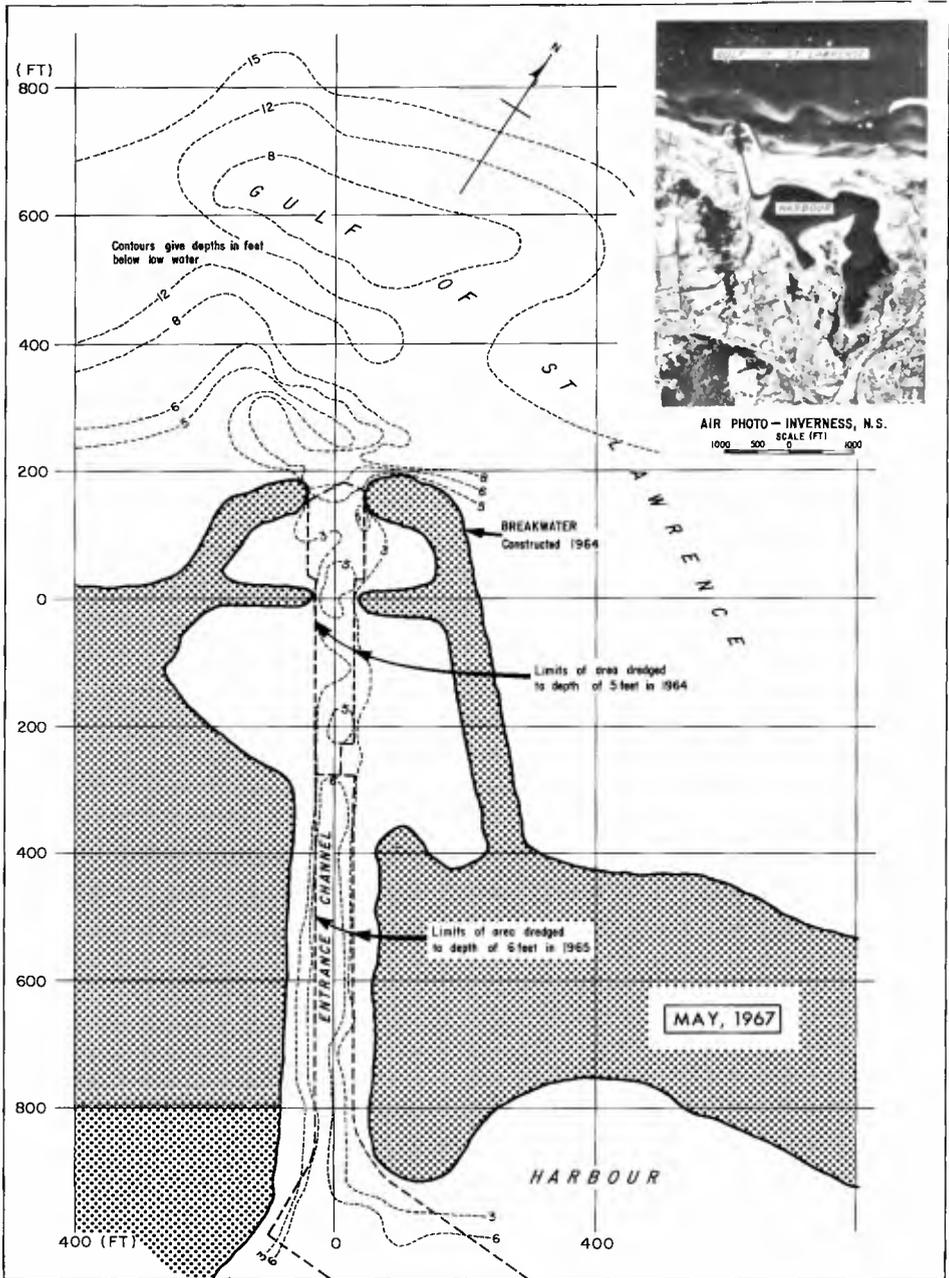
FIG. 7 CONTOUR CHANGES AT HARBOUR ENTRANCE INVERNESS, N. S. 1964 - 1967

The conditions recently prevailing at Inverness which was built in 1965 are shown in Fig. 7. The shoal areas in the channel (min. depth 3 feet) are in all probability derived from "caving-in" of the steep sloped banks of the channel. Dredging to remove these shoals has recently been completed.
