PERFORMANCE OF SAND-FILLED TUBE SHORE PROTECTION  
TUKTOYAKTUK, NORTH WEST TERRITORIES, CANADA

V.K. SHAH, M. Sc., C. Eng., M.I.C.E., P. Eng.  
PUBLIC WORKS CANADA, OTTAWA, CANADA

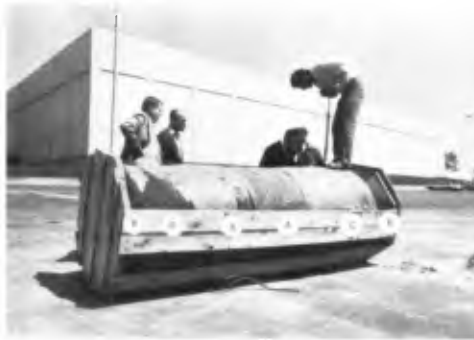
Hand slashing tests were carried out using a hunting knife. The uncoated tube offered very little resistance to hand slashing. Among the coated sections of the tube the double coating type 4 (glue - sand/glue - sand) offered the most resistance to slashing. Another advantage of coating observed during these tests was that the cuts made in the coated sections remained simply as closed cuts while the cuts made in the uncoated sections opened out allowing the sand-fill to run out.

PROTOTYPE TESTING OF SAND COATED  
TUBES USING A HUNTING KNIFE

The results of the penetration tests carried out using the hunting knife and Proctor Needle Assembly are tabulated below (figure 7).

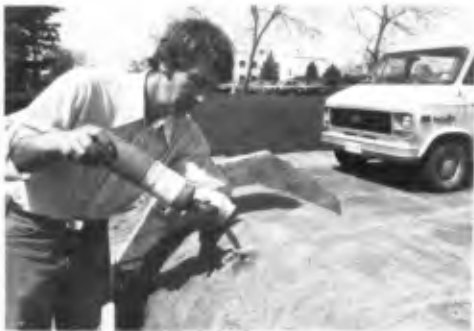
Figure 7

PROTOTYPE TESTING OF SAND COATED  
TUBES FOR RESISTANCE AGAINST FIRES

The fire resistance tests with a propane torch showed the following results (figure 7).

| Type of Coating | (1) | (2) | (3) | (4) | (5) |
|---|---|---|---|---|---|
| Time in seconds required to burn through coating | 5 | 100 | 45 | 120 | - |
